**Citywide  
Facility Condition Assessment**

**Report of  
Facility Condition Assessment**

**For  
City of Novato  
Carlile House  
853 Reichert Avenue, Novato, CA**

***March 4, 2013***

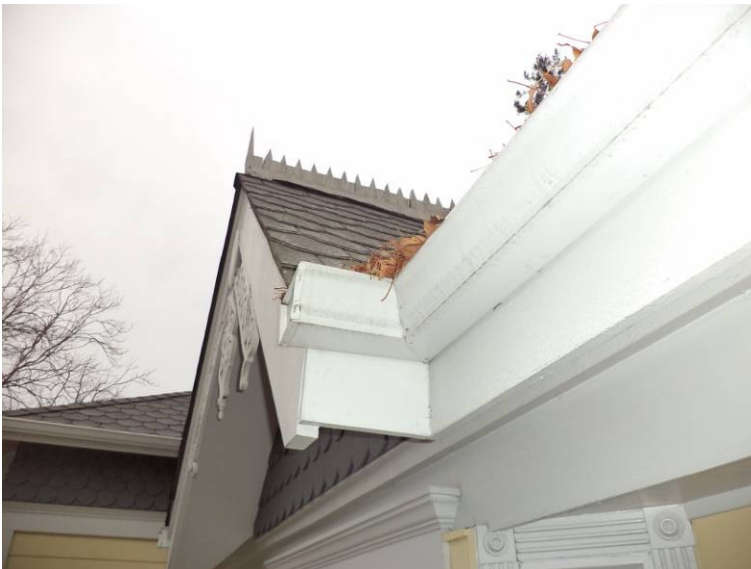
**Photograph No. 5**

At high level we noted wooden soffits and fascias which are part of the underside of the overhanging roof structure, these contained decorative moldings that crown the gable eaves (reference Photograph 5 in Appendix B).

The storm water collection gutters and downspouts appeared to be in good condition with no anticipated replacement actions during the study period, besides repainting with the exterior elevations. However we observed debris such as leaves at the north elevation (reference Photograph 5 in Appendix B) and therefore we recommend that they are periodically checked and cleaned to prevent blockages.

View of the fascia detailing and roof covering. Also shows the debris that's collected in the gutters.

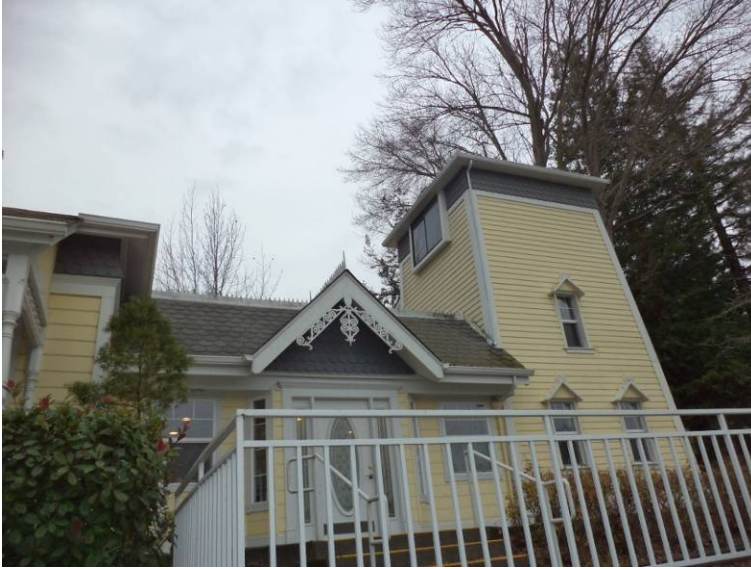
**Photograph No. 10**

The asphalt roof coverings generally appeared to be in fair condition, we are unaware when the coverings were last installed; we assume them to be more than fifteen-years old. This type of roof covering has a typical EUL of forty-years and based on observed conditions and the age of the roof material we anticipate that all of the steep-sloped roof levels will last beyond the study period without replacement necessary.

View of the asphalt single roof coverings.

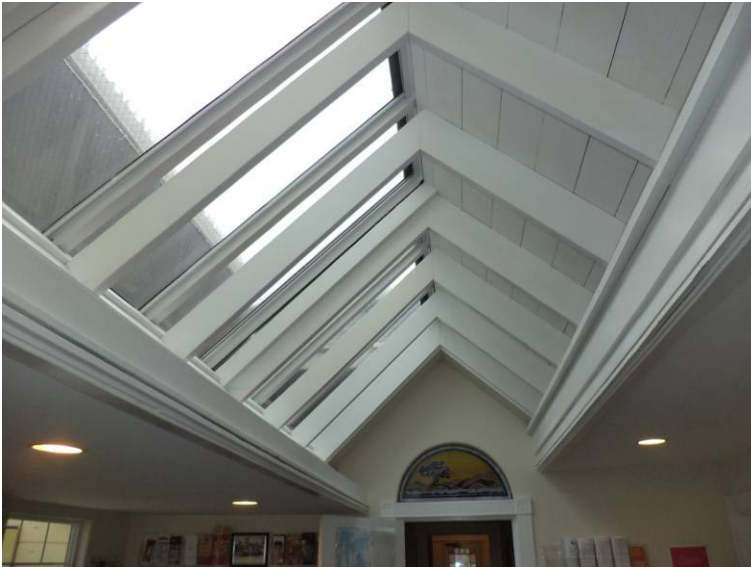
**Photograph No. 11**

The sloped glazing system appeared to be in fair to good condition, we noted signs of historic moisture ingress which has been resolved with caulking applied at roof level. We understand that there are no issues at this current time. We do not anticipate any replacement actions during the cost study period.

View of the sloped glazing system.

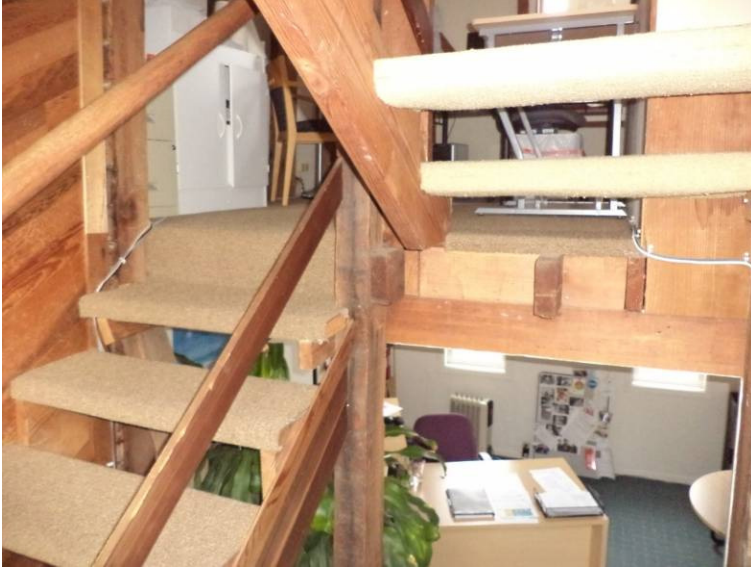
**Photograph No. 13**

The staircase appeared to be in a fair to good condition with no issues reported or identified to the section of staircase that is present. However the staircase to the upper floor is missing and therefore we recommend that it is continued to allow safe access.

View of the wood constructed staircase.

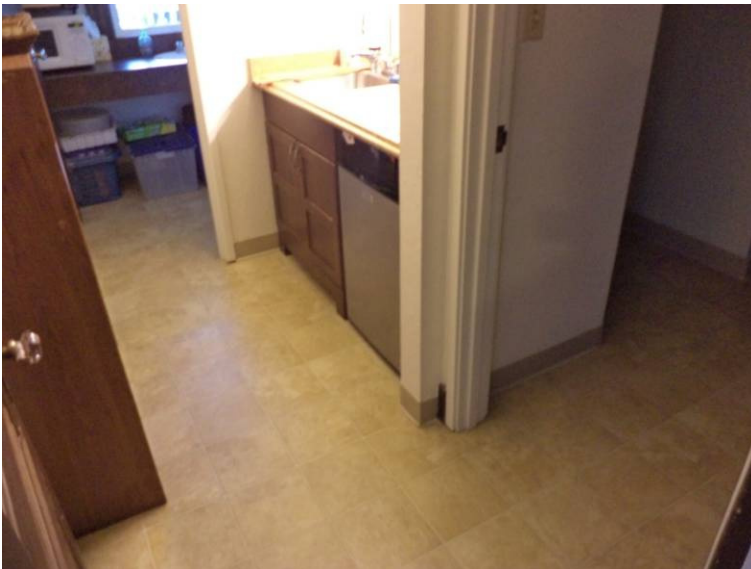
**Photograph No. 17**

The vinyl sheet floor finish appeared to be in good condition, we understand it was installed along with the break room and restroom repainting works. Vinyl flooring has a typical EUL of eighteen-years and therefore based on the RUL and observed conditions the vinyl sheet is recommended for replacement later in the study period to maintain the appearance of the building.

View of the vinyl sheet.

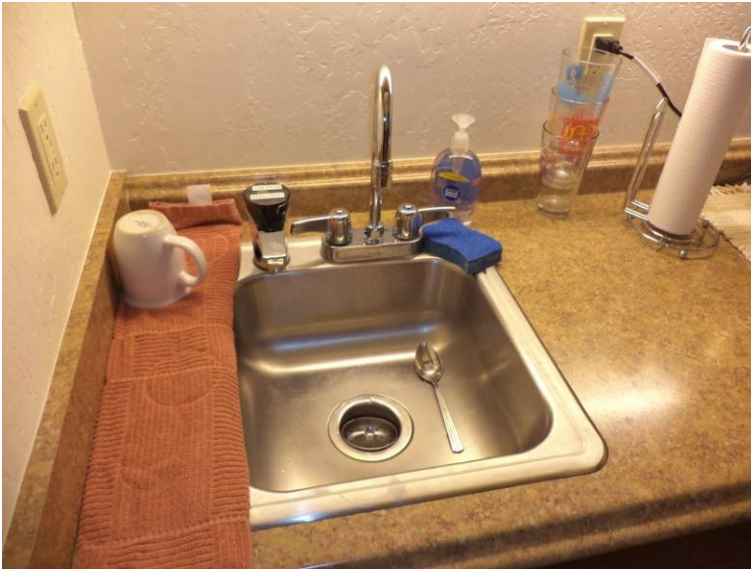
**Photograph No. 20**

We noted one stainless steel single sink within the break room (reference Photograph 20 in Appendix B). The sink contained non-metering swan neck with lever handles. The stainless steel sink is self rimming and is mounted within a counter that consisted of a plastic laminated faced counter top.

View of the single stainless steel sink.
