Novato Parks Facility Condition Assessment and Maintenance Analysis
Executive Summary Report

Updated: December 11, 2013

Faithful+Gould, Inc.

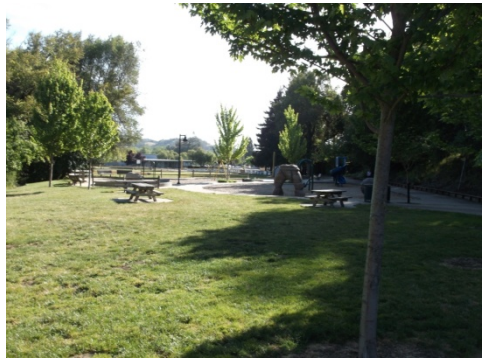
CONDITION SUMMARY			
<p style="text-align: center;">Arroyo Avichi Park</p>		<p>The park was observed to be generally in fair-to-good condition at the time of our assessment. We understand that the park was rebuilt in 2002. Beyond expansion joint sealant replacement and other routine maintenance items such as seal coating and restriping the parking lot every five years, we have included refinishing the wood picnic tables and benches every eight years, and a cyclical allowance every five years for repairs to the irrigation system (reference Photographs 6 through 8 in Appendix B).</p> <p>The park's drinking fountain appeared to be in fair-to-good condition. The fountain has a typical EUL of 20 years; therefore, replacement is anticipated mid-term in the study period (reference Photograph 4 in Appendix B).</p> <p>The playground equipment appeared to be in fair-to-good condition (reference Photograph 3 in Appendix B). The typical EUL for public playground equipment is 15 years. However, due to observed conditions, we recommend extending the RUL by six years and, therefore, replacement is recommended mid-term in the study period.</p> <p>The run through water feature appeared to be in fair-to-good condition and working properly. The water feature's pump and filter have a typical EUL of 20 years. Therefore, we anticipate replacement will be required around mid-term in the study period.</p>

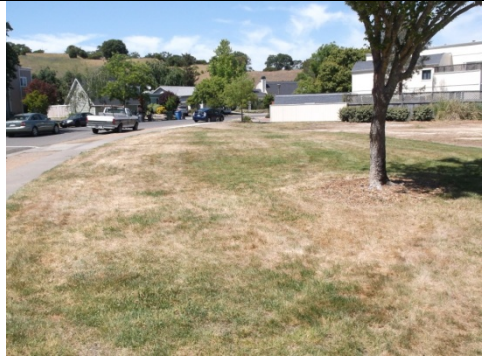
CONDITION SUMMARY			
<p>Bahia Mini Parks</p>		<p>The six mini parks are generally in fair condition overall. We understand that the playground equipment, drinking fountains or restroom facilities were removed in the last five years. Anticipated expenditures are recommended such as adding decomposed granite to the foot paths, reseeding bare ground areas, and routine maintenance items such as refinishing the wood benches every eight years, and a cyclical allowance every five years for repairs to the irrigation system (reference Photographs 1 through 4 in Appendix B). We recommend a budget of \$ 200,000 for new playground equipment at Bahia Mini Park A (across from Misty Road).</p>

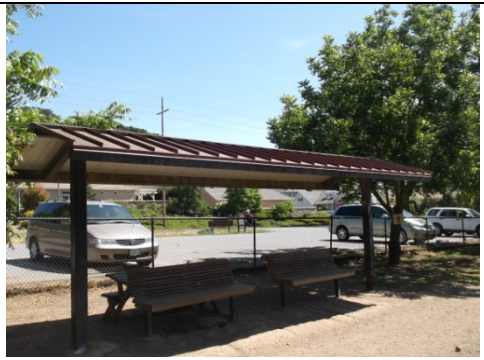
CONDITION SUMMARY		
<p>Dogbone Meadow</p>		<p>The park picnic tables, dog wash area, and signage appeared to be in fair condition overall. Routine maintenance expenditures include a cyclical allowance for annual grassy area maintenance, seal coating and restriping the parking lot, adding decomposed granite to the foot paths and repairs to the irrigation system every five years, as well as refinishing the wood benches every eight years (reference Photograph 4 in Appendix B).</p> <p>The bench shade appeared to be in poor-to-fair condition due to corrosion at the base of the metal post supports. Therefore, we recommend it be replaced early in the study period (reference Photograph 3 in Appendix B).</p> <p>The perimeter chain link fence appeared to be in fair condition. The fence appears to be more than eight years old (we are unaware when it was installed). We recommend that the fence is replaced prior to mid-term as we anticipate that it will corrode and deteriorate over time (reference Photograph 5 in Appendix B).</p>

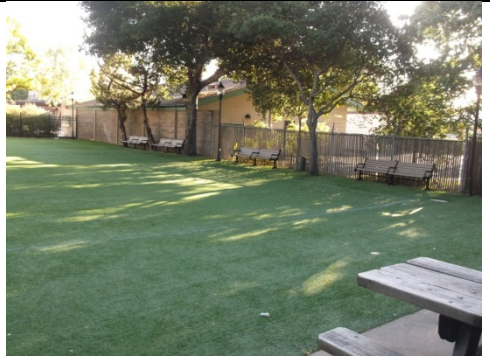
CONDITION SUMMARY		
<p>Downtown Recreation Center Park</p>		<p>The park area was observed to be generally in fair-to-good condition at the time of our assessment. The park area has an artificial turf covering which appeared to be in good condition. The typical EUL for artificial turf is ten years; however, due to the observed conditions and assumed usage, we recommend replacement is undertaken mid-term in the study period and we have extended its RUL in this instance (reference Photograph 1 in Appendix B). However, we also recommend that the surface is reviewed at that time to ascertain if replacement is necessary or if it will last longer.</p>

<p>Downtown Recreation Center Park</p>		<p>The park benches are made of plastic with a metal frame and appeared to be in good condition. The typical EUL for a plastic bench is 15 years; however, due to the good condition we do not anticipate replacement will be necessary until mid-term in the study period at the same time as the turf replacement.</p> <p>The park's site lighting is provided by cast-iron light fixtures that appeared to be in good condition. The typical EUL for a cast-iron light is 20 years. Therefore, we do not anticipate replacement will be necessary mid-term in the study period (reference Photograph 3 in Appendix B).</p> <p>The park's perimeter has a wrought iron fence that appeared to be in good condition. We are unaware when the fence was last painted, therefore we recommend that it is repainted prior to mid-term and then every ten years in the study period to maintain the appearance of the facility (reference Photograph 2 in Appendix B).</p>

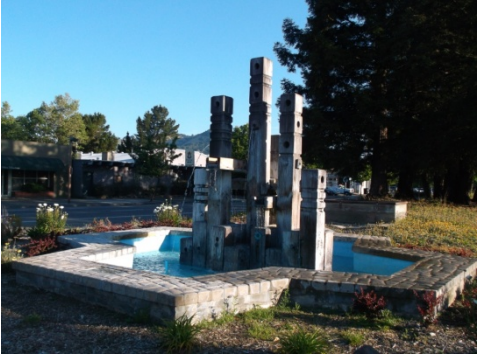
<p>CONDITION SUMMARY</p>		
<p>Grant Avenue Fountain</p>		<p>The fountain was observed to be generally in fair-to-good condition at the time of our assessment. We observed routine maintenance work that include cyclical allowance every five years for repairs to the irrigation system that surround the fountain.</p> <p>The fountain's interior finish appeared to be in fair to good condition. The typical EUL for a fountain's finish is ten years. Therefore, based on condition and EUL, we anticipate replacement will be necessary early in the study period (reference Photograph 1 in Appendix B).</p> <p>The fountain's pump and filter system appeared to be in fair-to-good condition. The typical EUL for a fountain's pump system is 15 years, (we are unaware when it was installed). Therefore, based on condition and EUL, we anticipate replacement will be necessary mid-term in the study period (reference Photograph 2 and 3 in Appendix B).</p>

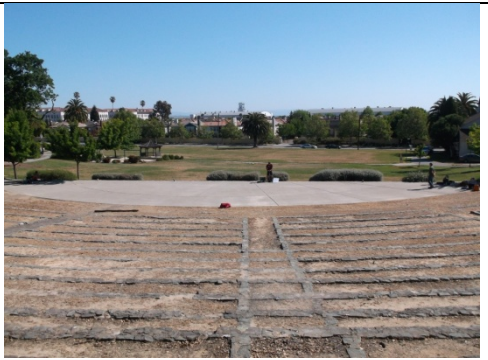
CONDITION SUMMARY		
<p>Hamilton Amphitheater</p>		<p>The amphitheater and park area were observed to be generally in fair-to-good condition at the time of our assessment. Routine maintenance items include cyclical allowance for seal coating and restriping the parking lot every five years, repainting the restroom building and gazebo, along with refinishing the wood picnic tables and benches every eight years, and repairs to the irrigation system every five years (reference Photographs 2, 7, 8 and 12 in Appendix B).</p> <p>The park's drinking fountains appeared to be in fair-to-good condition. The fountain has a typical EUL of 20 years; therefore, replacement is anticipated early the study period (reference Photograph 4 in Appendix B).</p> <p>The park's site lighting fixtures appeared to be in poor-to-fair condition. The typical EUL for site lighting is 20 years. Therefore, based on condition and EUL, we anticipate replacement will be necessary early in the study period to maintain lighted areas through the park.</p> <p>The playground equipment appeared to be in fair-to-good condition. We assume the equipment to have been installed within the last five years. Therefore, with a typical EUL for of 15 years, replacement is anticipated mid-term in the study period to maintain a safe environment for children to play (reference Photograph 3 in Appendix B).</p>

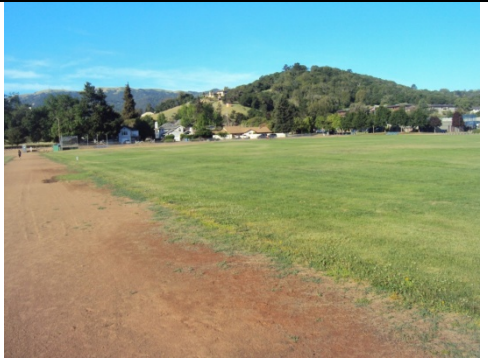
CONDITION SUMMARY		
<p>Hill Recreation Area Fields</p>		<p>The track and athletic fields were observed to be generally in fair condition at the time of our assessment. Routine maintenance items include a cyclical allowance every five years for repairs to the irrigation system (reference Photograph 1 in Appendix B).</p> <p>The field's irrigation system contains a pressure booster pump that appeared to be in fair condition, this is housed in the pump house (reference Photograph 3 in Appendix B). The typical EUL for equipment such as this is 15 years; therefore, replacement is anticipated early in the study period.</p> <p>The track appeared to be in poor condition with low areas and drainage ruts. It needs to be graded, compacted and decomposed granite placed on the surface and rolled (reference Photograph 5 in Appendix B).</p> <p>The pump house appeared to be in poor-to-fair condition due to the condition of the roof covering and exterior finish. The roof covering consist of asphalt shingles that are in poor condition and will need to be replaced early in the study period. The pump house exterior painted plywood siding appeared to be poor-to-fair condition and will need to be repainted early in the study period (reference Photograph 2 in Appendix B).</p> <p>The bleachers appeared to be in poor-to-fair condition. The bleachers appear to be more than 15 years old with a typical EUL of 20 years. Therefore, based on their EUL and observed condition, we recommend they are replaced early in the study period to maintain suitable safe seating for spectators (reference Photograph 4 in Appendix B).</p>

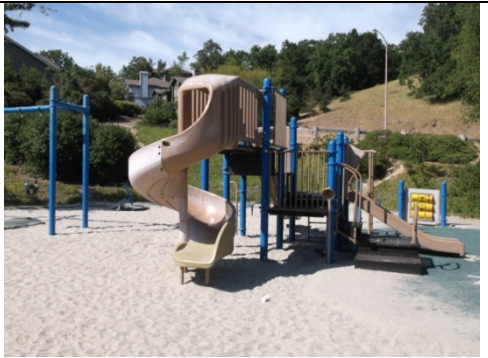
CONDITION SUMMARY		
<p>Hillside Park</p>		<p>The park was observed to be generally in fair-to-good condition at the time of our assessment. Routine maintenance items include painting the exterior and interior of the restroom building, refinishing the wood picnic tables and benches every eight years, and a cyclical allowance every five years for repairs to the irrigation system (reference Photograph 1 in Appendix B).</p> <p>The restroom building appeared to be in fair-to-good condition. The roof covering consists of pre-formed corrugated metal panels that are in good condition; therefore, we do not anticipate replacement will be necessary until toward end of the study period. The building's exterior consists of painted plywood siding and appeared to be fair condition. It will need to be repainted early in the study period (reference Photograph 4 in Appendix B). Three hollow metal doors appeared to be in fair condition with a typical EUL of 25 years. Therefore, based on a RUL of five years, we anticipate they will need to be replaced early in the study period. The plumbing fixtures including lavatories, urinal and water closets appeared to be in fair to good condition. The plumbing fixtures have a typical EUL of 35 years; therefore, replacement is anticipated towards the end of the study period.</p> <p>The park's site lighting fixtures appeared to be in fair condition. The typical EUL for a bollard style light is 20 years; therefore, based on condition and EUL, we anticipate replacement will be necessary early in the study period to maintain safely lit areas (reference Photograph 8 in Appendix B).</p> <p>The park's electrical distribution panel at the restroom facility appeared to be in poor-to-fair condition. The electrical panel has a typical EUL of 30 years; therefore, based on observed condition and estimated RUL, replacement is anticipated early in the study period (reference Photograph 7 in Appendix B).</p>

<p>Hillside Park</p>		<p>There are settlement and movement cracks in sections of the concrete sidewalk that make the surface to be in poor condition and over time could progress into tripping hazards. We recommend that the concrete sidewalks are repaired/replaced so that any cracks and potential tripping hazards are removed near-term in the study period (reference Photograph 2 in Appendix B). In addition, the sealant between the concrete walkway slabs has started to deteriorate with missing and cracked sections of sealant occurring. We also recommend that the sealant is replaced in the near term.</p> <p>The park's drinking fountain appeared to be in fair-to-good condition. The fountain has a typical EUL of 20 years; therefore, replacement is anticipated mid-term in the study period to maintain adequate supply (reference Photograph 5 in Appendix B).</p> <p>The park has a split rail fence along the walkways that appeared to be in fair condition. The fence appeared to be more than ten years old (we are unaware when it was installed) with a typical EUL of 20 years for a split rail fence. Therefore, based on its EUL and observed condition, we recommend it be replaced prior to mid-term in the study period (reference Photograph 6 in Appendix B).</p> <p>The playground equipment appeared to be in fair-to-good condition. The typical EUL for public playground equipment is 15 years (reference Photograph 3 in Appendix B). The replacement is anticipated mid-term in the study period to maintain a safe environment for children to play and also the appearance of the park.</p>

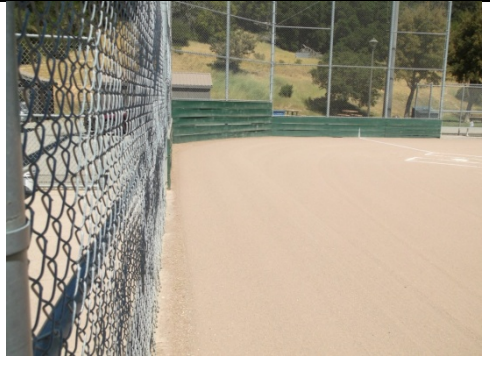
CONDITION SUMMARY		
<p>Indian Valley Fields</p>		<p>The park is owned by the College of Marin and is maintained by the City of Novato per agreement, and was observed to be generally in fair-to-good condition at the time of our assessment. Routine maintenance items include painting the exterior and interior of the restroom and storage/equipment buildings, refinishing the wood picnic tables and benches every eight years, and a cyclical allowance every five years for repairs to the irrigation system (reference Photographs 1 and 2 in Appendix B).</p> <p>The restroom building appeared to be in fair-to-good condition. The roof covering consists of pre-formed corrugated metal panels that are in good condition; therefore, we do not anticipate replacement will be necessary until near the end of the study period. The building's exterior consists of painted cementitious siding that appeared to be fair condition. We observed damaged sections at the surface of the siding that we recommend is repaired and then the surface receives a painted finish at the start of the study period to maintain the appearance of the building (reference Photographs 3 and 4 in Appendix B).</p> <p>The hollow metal doors at the restroom and storage buildings appeared to be in fair condition with a typical EUL of 25 years. We anticipate they will need to be replaced mid-term in the study period.</p> <p>The baseball field's restroom plumbing fixtures appeared to be in fair-to-good condition. The plumbing fixtures have a typical EUL of 35 years; therefore, to maintain the appearance of the restrooms, we have recommended that they are replaced towards the end of the study period (reference Photograph 5 in Appendix B). In addition, we recommend that the faucets are replaced every ten years to maintain suitable operation; and, therefore, their first replacement will fall prior to mid-term.</p> <p>The baseball field's electrical main distribution panel, field lighting controls and panel board which is located in the storage/equipment building all appeared to be in fair-to-good condition. The electrical panels have a typical EUL of 30 years; therefore, based on RUL of 14 years and observed condition, replacement will be necessary after mid-term in the study period (reference Photographs 7 and 8 in Appendix B).</p>

<p>Indian Valley Fields</p>		<p>The walkways and driveways are constructed of asphalt paving and appeared to be in fair condition. To maintain the condition and extend the Remaining Useful Life (RUL), we recommend that the asphalt surface be seal coated and restriped at the start of the study period and then every five years (reference Photographs 12 through 14 in Appendix B).</p> <p>The baseball field's drinking fountain appeared to be in fair condition. The fountain has a typical EUL of 20 years; therefore, replacement is anticipated early in the study period to maintain an adequate supply of suitable drinking water at the park for park users (reference Photograph 6 in Appendix B).</p> <p>The baseball field's chain link fence and backstop appeared to be in fair-to-good condition. The fence and backstop has exceeded the typical EUL of 15 years for a chain link fence. Therefore, based on its EUL and observed condition, we are extending the RUL ten years to mid-term in the study period (reference Photograph 9 in Appendix B).</p> <p>The bleachers appeared to be in fair-to-good condition. The bleachers have a typical EUL of 20 years; therefore, based on its EUL and observed condition, we are extending the RUL to mid-term in the study period as they appear to be free from defects at this time (reference Photograph 10 in Appendix B).</p> <p>The baseball field's high site lighting fixtures appeared to be in fair condition (as observed from the ground). The high lighting fixtures have a typical EUL of 20 years; therefore, based on the EUL, replacement is anticipated early in the study period (reference Photograph 11 in Appendix B).</p>

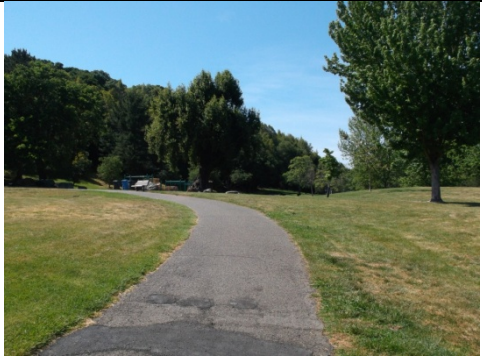
CONDITION SUMMARY		
<p>Josef Hoog Park</p>		<p>The park was observed to be generally in fair-to-good condition at the time of our assessment. Routine maintenance items include painting the exterior and interior of the restroom building, refinishing the wood picnic tables and benches every eight years, and a cyclical allowance every five years for repairs to the irrigation system (reference Photographs 2 through 5 in Appendix B).</p> <p>The restroom building appeared to be in fair-to-good condition. The roof covering consists of pre-formed corrugated metal panels that are in good condition; therefore, we do not anticipate replacement will be necessary until late in the study period. The building's exterior consists of painted metal siding and appeared to be fair condition, although it will need to be repainted early in the study period.</p> <p>The restroom building's three hollow metal doors appeared to be in poor-to-fair condition, with a typical EUL of 25 years; therefore, we anticipate they will need to be replaced early in the study period.</p> <p>The park's restroom plumbing fixtures included wall-hung lavatories and water closets that appeared to be in fair-to-good condition. The plumbing fixtures have a typical EUL of 35 years; therefore, replacement is anticipated near the end of the study period (reference Photographs 6 and 7 in Appendix B).</p> <p>The park's electrical distribution panel at the restroom facility appeared to be in poor-to-fair condition. The electrical panel has a typical EUL of 30 years (we are unaware when it was installed); therefore, based on observed condition and estimated RUL, replacement is anticipated early in the study period.</p> <p>The walkways, basketball court and parking lot are constructed of asphalt paving and appeared to be in fair condition. We recommend that the asphalt surfaces be seal coated and restriped early in the study period and then every five years (reference Photograph 1 in Appendix B).</p> <p>The park's drinking fountain appeared to be in fair condition. The fountain has a typical EUL of 20 years; therefore, replacement is anticipated early in the study period (reference Photograph 8 in Appendix B).</p> <p>The playground equipment appeared to be in fair condition. The typical EUL for public playground equipment is 15 years; therefore, due to RUL and observed conditions, we have recommended replacement prior to mid-term (reference Photograph 9 in Appendix B).</p>

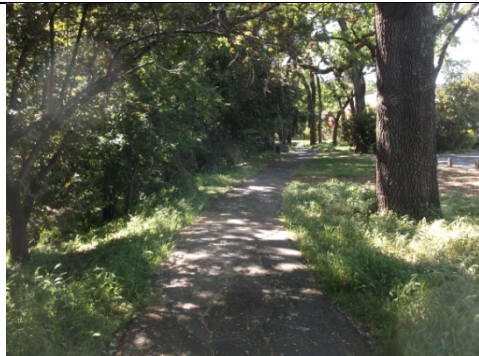
CONDITION SUMMARY		
<p>Lee Gerner Park</p>		<p>The park was observed to be generally in fair condition at the time of our assessment. Routine maintenance items include refinishing the wood picnic tables and benches every eight years and a cyclical allowance every five years for repairs to the irrigation system (reference Photographs 1, 3 and 5 in Appendix B).</p> <p>The park's site lighting fixtures appeared to be in fair condition. The typical EUL for this type of site lighting is 20 years, (we are unaware when it was installed). Therefore, based on condition and EUL, we anticipate replacement will be necessary early in the study period (reference Photograph 6 in Appendix B).</p> <p>The walkways are constructed of asphalt paving and generally appeared to be in fair condition. We noted some damaged areas that need to be repaired at the start of the study period and then seal coated and restriped every five-years (reference Photograph 4 in Appendix B). The foot bridge over Novato Creek is in good condition as repairs were recently made to the bridge and the walkway planks have been recently replaced.</p>

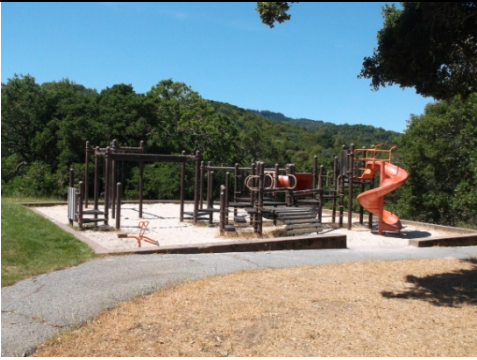
CONDITION SUMMARY			
<p>Marin Highlands Park</p>		<p>The park was observed to be generally in fair-to-good condition at the time of our assessment. Routine maintenance items include refinishing the wood picnic tables every eight years, and a cyclical allowance every five years for repairs to the irrigation system (reference Photographs 2 and 3 in Appendix B).</p> <p>The retaining wall around the playground area has graffiti that we recommend be removed at the start of the study period (reference Photograph 4 in Appendix B).</p> <p>The walkway is constructed of asphalt paving and appeared to be in fair-to-good condition. We recommend that the asphalt surface be seal coated and restriped early in the study period and then every five years (reference Photographs 6 and 7 in Appendix B).</p> <p>The playground equipment appeared to be in fair condition and is assumed more than 15 years old. The typical EUL for public playground equipment is 15 years. Therefore, due to its RUL, observed deteriorated conditions, and that the equipment does not adhere to today's standards with sand beneath, we recommend replacement of the equipment is undertaken early in the study period to maintain the usefulness and appearance of the park (reference Photograph 5 in Appendix B).</p>

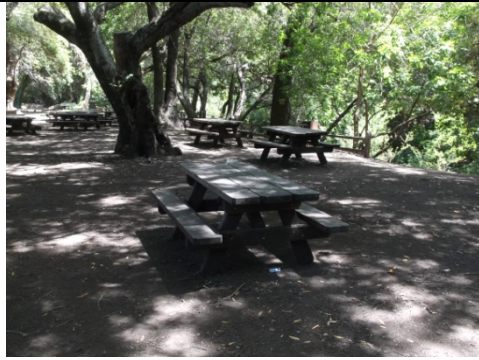
CONDITION SUMMARY		
<p>Miwok Park</p>		<p>The park was observed to be generally in fair-to-good condition at the time of our assessment. Routine maintenance items include painting the exterior trim and interiors of the restroom building, refinishing the wood picnic tables and benches every eight years, and normal repairs to the irrigation system (reference Photographs 2 and 3 in Appendix B).</p> <p>The parking lot is asphalt paving, the walkways are combination asphalt and concrete that appeared to be in fair-to-good condition. We recommend that the asphalt surface be seal coated and restriped early in the study period and then every five years (reference Photographs 7 and 8 in Appendix B).</p> <p>The park's site lighting fixtures appeared to be in fair condition. The typical EUL for pole mounted site lights is 20 years; therefore, based on observed condition and EUL, we anticipate replacement will be necessary early in the study period (reference Photograph 5 in Appendix B).</p> <p>The playground equipment appeared to be in fair condition. We assumed the equipment to be approximately ten years old. The typical EUL for public playground equipment is 15 years; therefore, based on the RUL and observed conditions, we recommend that replacement is undertaken mid-term in the study period to maintain the appearance of the park and create a safe environment (reference Photograph 6 in Appendix B).</p>

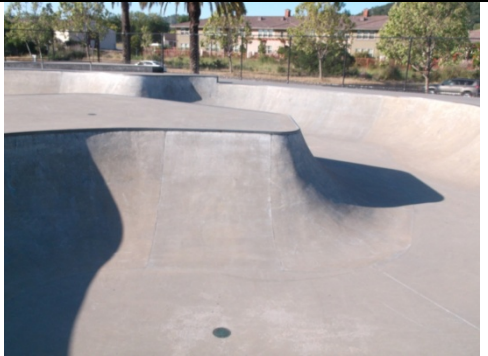
CONDITION SUMMARY		
<p>Novato Skate Park</p>		<p>The park was observed to be generally in good condition at the time of our assessment. Routine maintenance items include refinishing the wood picnic tables and benches every eight years and normal repairs to the irrigation system (reference Photograph 6 in Appendix B). Park signage appeared to be in good condition; however, they may need to be replaced mid-term in the study period due to weathering.</p> <p>The concrete skate board course appeared to be in fair-to-good condition. However, we noted some cracks in the course that are in need of repair at the start of the study period (reference Photographs 1 through 3 in Appendix B).</p> <p>The expansion joints in the concrete walkways are cracking and appeared to be in poor condition. We recommend the expansion joint sealant be replaced at the start of the study period and then every 15 years (reference Photograph 8 in Appendix B).</p> <p>The park's drinking fountain appeared to be in fair condition. The fountain has a typical EUL of 20 years; therefore, replacement is anticipated late in the study period (reference Photograph 5 in Appendix B).</p> <p>The parking lot is asphalt paving that appeared to be in fair-to-good condition. We recommend that the asphalt surface be seal coated and restriped early in the study period and then every five years (reference Photograph 9 in Appendix B).</p> <p>The park's site lighting fixtures appeared to be in good condition. The typical EUL for pole mounted site lights is 20 years; therefore, based on condition, we anticipate replacement will be necessary late in the study period (reference Photograph 7 in Appendix B).</p>

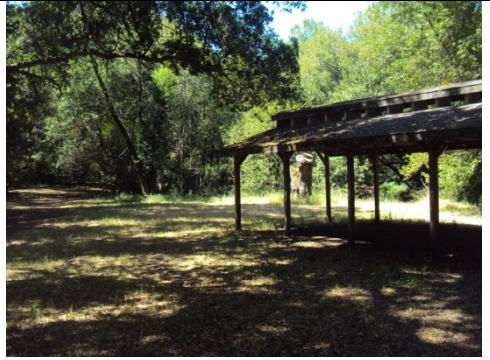
CONDITION SUMMARY		
<p>O'Hair Park</p>		<p>The park was observed to be generally in good condition at the time of our assessment. Routine maintenance items include refinishing the wood shade structure every eight years (reference Photographs 5 in Appendix B).</p> <p>The park contains two bridges that provide access across a seasonal creek and Novato Creek respectively. The bridge over Novato Creek was observed to be in poor condition with structural cracking issues present. We recommend that the traffic across the bridge be restricted to foot traffic only; no motor vehicles permitted (reference Photographs 3 and 4 in Appendix B). The wood foot bridge over the seasonal creek was observed to be in good condition with no actions anticipated; however, we do recommend a structural review of the bridges periodically for safety.</p> <p>The shade structure needs the mold damaged trim board replaced at the start of the study period (reference Photograph 6 in Appendix B).</p> <p>The shade asphalt shingles roof covering appeared to be in fair condition. The typical EUL for asphalt shingles is 40 years; therefore, based on condition, we anticipate replacement will be necessary early in the study period (reference Photograph 5 in Appendix B).</p>

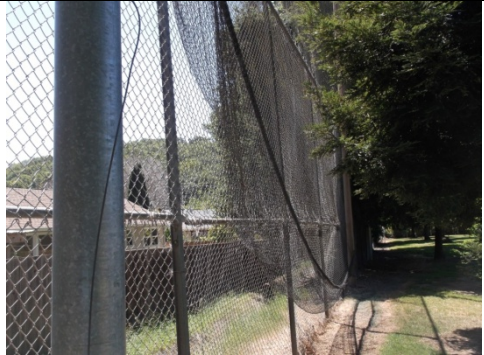
CONDITION SUMMARY			
<p>Olive School – Hamann Field</p>		<p>There is baseball protective netting beyond left field at the fence line, which appeared to be in poor-to-fair condition. The netting has exceeded the typical EUL of 15 years for this type of netting; however, based on condition, we recommend it be replaced early in the study period (reference Photograph 3 in Appendix B).</p>

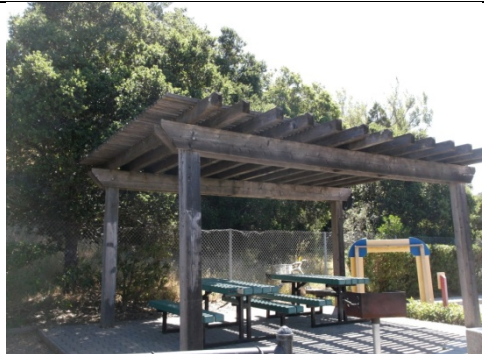
CONDITION SUMMARY		
Olive Tot Lot		<p>The park was observed to be generally in good condition at the time of our assessment. Routine maintenance items include refinishing the wood shade every eight years and normal repairs to the irrigation system (reference Photograph 1 in Appendix B).</p> <p>The park's drinking fountain appeared to be in fair-to-good condition. The fountain has a typical EUL of 20 years; therefore, replacement is anticipated mid-term in the study period (reference Photograph 2 in Appendix B).</p> <p>The playground equipment appeared to be in fair-to-good condition. The typical EUL for public playground equipment is 15 years (we are unaware when it was installed). However, due to observed condition, we recommend that it be replaced mid-term in the study period.</p>
PANSY TONG LO PARK		
Pansy Tong Lo Park	2	<p>At the time of assessment, Pansy Tong Lo Park contained a play area with wood playground equipment, benches, asphalt sidewalks, and open native grass play area. At the time of publication of this report, the playground structure had been removed. There are no restrooms or onsite parking.</p>

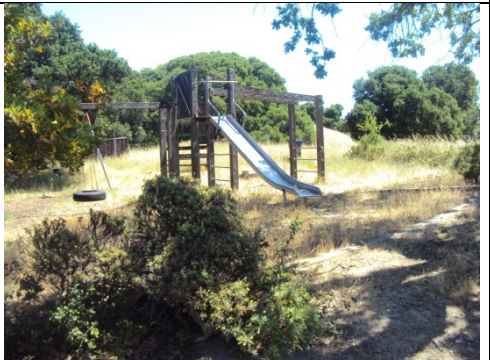
CONDITION SUMMARY		
Pansy Tong Lo Park		<p>The park was observed to be generally in poor condition at the time of our assessment. Routine maintenance items include general landscaping monthly, refinishing the wood park benches every eight years, and normal repairs to the irrigation system (reference Photograph 3 in Appendix B).</p> <p>The wood park benches appeared to be in poor condition. We recommend that they be replaced at the start of the study period (reference Photographs 5 and 6 in Appendix B).</p> <p>The walkway is constructed of asphalt paving and appeared to be in fair condition, with some cracked sections. We recommend that the asphalt walkway be repaired; seal coated and restriped at the start of the study period and then every five years (reference Photographs 4 in Appendix B).</p>

<p>Pansy Tong Lo Park</p>		<p>The park has a split rail fence along the walkway that appeared to be in fair condition. The fence appeared to be more than ten years old (we are unaware when it was installed) with a typical EUL of 20 years for a split rail fence. Therefore, based on its EUL and observed condition, we recommend it be replaced prior to mid-term in the study period (reference Photograph 7 in Appendix B).</p> <p>At the time of our assessment, the playground areas and playground equipment appeared to be in poor condition. The playground equipment was subsequently removed as it was aged and in poor condition. The typical EUL for public playground equipment is 15 years. We recommend that the playground equipment be replaced early in the study period (reference Photographs 1 and 2 in Appendix B).</p>
<p>PIONEER PARK</p>		
<p>Pioneer Park 1007 Simmons Lane</p>	<p>8.89</p>	<p>Pioneer Park consists of large grassy areas, a sand playground with playground equipment, drinking fountains, barbeque grills, shaded picnic tables, benches, a gazebo, four lighted tennis courts and a historic cemetery. The park also contains restrooms, paved walkways and onsite parking.</p>

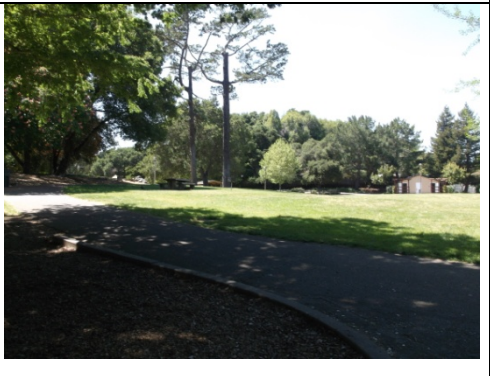
<p>CONDITION SUMMARY</p>		
<p>Pioneer Park</p>		<p>The park was observed to be generally in fair-to-good condition at the time of our assessment. Routine maintenance items include painting the exterior trim and interior of the restroom building, refinishing the gazebo, wood picnic tables and benches every eight years, and normal repairs to the irrigation system (reference Photographs 1 through 4 in Appendix B).</p> <p>The park's drinking fountains appeared to be in fair-to-good condition. The fountains have a typical EUL of 20 years; therefore, replacement is anticipated mid-term in the study period.</p> <p>The parking lot is of asphalt paving. The walkways are combination asphalt and concrete that appeared to be in fair to good condition. We recommend that the asphalt surface be seal coated and restriped early in the study period and then every five years (reference Photographs 12 and 13 in Appendix B).</p>

<p>Pioneer Park</p>		<p>The park's tennis courts appeared to be in fair condition. The typical EUL for tennis court surfaces is seven years, (we are unaware when it was installed). Therefore, based on condition and EUL, the court repairs and resurfacing will be necessary at the start of the study period and then every seven years (reference Photograph 5 and 6 in Appendix B).</p> <p>The park's wood retaining wall along Simmons Lane appeared to be in poor condition. We would recommend that the retaining wall be replaced (reference Photographs 7 and 8 in Appendix B). However, we understand that there is another study under way to address the condition of City-maintained retaining walls and, in order to avoid double-counting, we have excluded this item from the financial projections.</p> <p>The wood steps through the cemetery appeared to be in poor-to-fair condition. There are sections of the steps that are starting to deteriorate from weathering, leaving an uneven and cracked walking surface. We recommend that the uneven and cracked sections be replaced at the start of the study period (reference Photographs 9 and 10 in Appendix B).</p> <p>The park's site lighting fixtures appeared to be in fair condition. The typical EUL for pole mounted site lights is 20 years, (we are unaware when it was installed); therefore, based on condition and EUL, we anticipate replacement will be necessary early in the study period (reference Photograph 11 in Appendix B).</p> <p>The park's irrigation system contains a pressure booster pump that is housed in the pump vault. It appeared to be in fair condition (reference Photograph 15 in Appendix B). The typical EUL for equipment such as this is 15 years; therefore, replacement is anticipated early in the study period.</p> <p>The playground equipment appeared to be in good condition, and assumed to be recently installed. The typical EUL for public playground equipment is 15 years; therefore, based on observed conditions, replacement is anticipated after mid-term in the study period (reference Photograph 14 in Appendix B).</p>

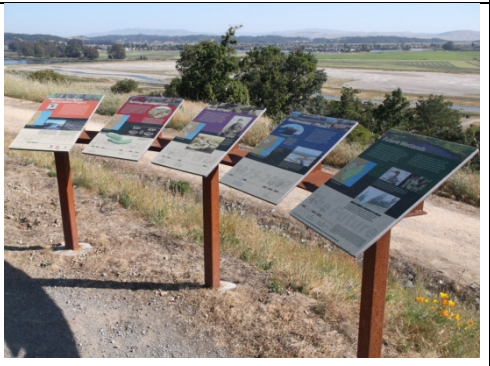
CONDITION SUMMARY		
<p>Reservoir Hill Vista Trail</p>		<p>The park was observed to be generally in good condition at the time of our assessment. Routine maintenance items include refinishing the wood benches every eight years.</p> <p>The parking lot is of asphalt paving that appeared to be in fair-to-good condition. We recommend that the asphalt surface be seal coated and restriped early in the study period then every five years (reference Photograph 4 and 5 in Appendix B). The retaining wall at the parking lot appeared to be in good condition.</p> <p>The path to the vista and around the park has a decomposed granite surface that appeared to be in fair condition. We recommend that granite is added to the paths early in the study period then every ten years (reference Photograph 2 in Appendix B).</p> <p>The park's vista viewing area has interpretive signs describing interesting items in the view at different locations. The signs appeared to be in fair-to-good condition. The typical EUL for this type of signage is ten years (we are unaware when they were installed). Therefore, based on condition, we anticipate replacement will be necessary early in the study period (reference Photograph 3 in Appendix B).</p>

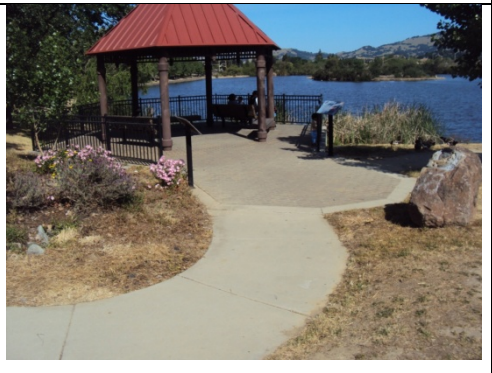
CONDITION SUMMARY		
Scottsdale Marsh and Pond		<p>The park appeared to be in fair condition. Routine maintenance expenditures include refinishing the wood shade, wood benches, wood fence, paint the metal fencing and gazebo every eight years, adding decomposed granite to the foot paths every five years and normal repairs to the irrigation system (reference Photograph 1 through 5 in Appendix B).</p> <p>The park's drinking fountains appeared to be in fair-to-good condition. The fountains have a typical EUL of 20 years; therefore, replacement is anticipated mid-term in the study period (reference Photograph 11 in Appendix B).</p> <p>The pond has two sets of pumps, three directional circulation pumps and two aeration pumps that appeared to be fair-to-good condition. The pumps have a typical EUL of 15 years; therefore, we anticipate they will need to be replaced mid-term in the study period.</p> <p>The pond has a handicap accessible fishing pier that appeared to be in fair-to-good condition. The pier appears to be more than 11 years old with a typical EUL of 30 years; however, they need to be refinished every eight years. Therefore, based on its EUL and observed condition, we recommend it be refinished at the start of the study period and then every eight years (reference Photograph 6 and 7 in Appendix B).</p> <p>The paths along the south and west elevation of the pond have a decomposed granite surface that appeared to be in fair condition. We recommend that granite is added to the paths early in the study period then every ten years (reference Photograph 9 in Appendix B).</p> <p>The sealant in the concrete sidewalks expansion joints appeared to be in poor condition. The sealant has a typical EUL of 15 years; therefore, replacement is needed at the start of the study period and then every 15 years (reference Photograph 8 in Appendix B).</p> <p>The marsh and pond have interpretive signs describing interesting items in the view at different locations. The signs appeared to be in fair-to-good condition. The typical EUL for this type of signage is ten years; therefore, based on condition, we anticipate replacement will be necessary early in the study period (reference Photograph 10 in Appendix B).</p>

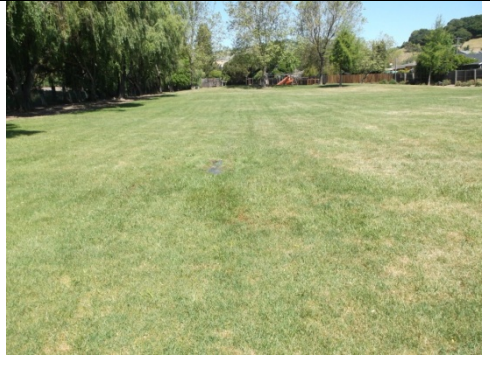
CONDITION SUMMARY		
<p>Slade Park</p>		<p>The park was observed to be generally in fair condition at the time of our assessment. Routine maintenance items include refinishing the wood shade, wood picnic tables and benches every eight years, and normal repairs to the irrigation system (reference Photographs 1, 7 and 8 in Appendix B).</p> <p>The park's drinking fountain appeared to be in fair-to-good condition. The fountains have a typical EUL of 20 years; therefore, replacement is anticipated mid-term in the study period (reference Photograph 6 in Appendix B).</p> <p>The parking lot is asphalt paving and, along with the walkways, appeared to be in poor-to-fair condition. We recommend the parking lot be repaired and the asphalt parking lot and walkways be seal coated and restriped at the start of the study period and then every five-years (reference Photographs 9 and 10 in Appendix B). The asphalt basketball court is in fair condition; however, to extend to life of the asphalt we recommend that it be seal coated at the same time as the parking lot.</p> <p>The perimeter chain link fence appeared to be in poor-to-fair condition. The fence appears to be more than 15 years old (we are unaware when it was installed) with a typical EUL of 15 years for a chain link fence. Therefore, based on its EUL and observed condition, we recommend it be replaced at the start of the study period (reference Photograph 11 in Appendix B).</p> <p>The playground equipment appeared to be in fair condition and assumed to be more than ten years old. The typical EUL for public playground equipment is 15 years. However, due to observed condition, we recommend that it be replaced early in the study period (reference Photograph 2 in Appendix B).</p>

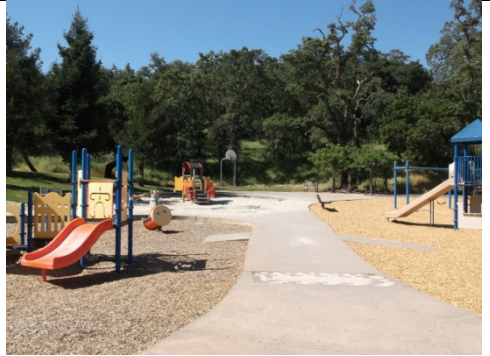
CONDITION SUMMARY		
<p style="text-align: center;">South Hamilton Park</p>		<p>The park and baseball field were observed to be generally in fair-to-good condition at the time of our assessment. Routine maintenance items include refinishing the wood shades, wood picnic tables and benches every eight years, and a normal cyclical allowance every five years for repairs to the irrigation system (reference Photographs 1 and 2 in Appendix B).</p> <p>The park's drinking fountain appeared to be in fair-to-good condition. The fountain has a typical EUL of 20 years; therefore, replacement is anticipated mid-term in the study period (reference Photograph 3 in Appendix B).</p> <p>The parking lot's asphalt paving appeared to be in fair-to-good condition. We recommend that the asphalt surface be seal coated and restriped early in the study period and then every five years (reference Photograph 7 in Appendix B).</p> <p>The park's concrete walkways appeared to be in fair condition. However, we noted cracked section of walkways that need to be repaired at the start of the period (reference Photograph 8 in Appendix B).</p>

<p>South Hamilton Park</p>		<p>The park's site lighting fixtures appeared to be in fair condition. The typical EUL for bollard type light fixtures is 20 years, (we are unaware when it was installed). Therefore, based on condition and EUL, we anticipate replacement will be necessary early in the study period (reference Photograph 4 in Appendix B).</p> <p>The playground equipment appeared to be in fair condition. The typical EUL for public playground equipment is 15 years (we are unaware when it was installed); however, due to observed condition, we recommend that it be replaced mid-term in the study period (reference Photographs 5 and 6 in Appendix B).</p> <p>The perimeter chain link fence and backstop appeared to be in fair-to-good condition. The fence and backstop appears to be more than eight years old, with a typical EUL of 15 years for a chain link fence. We recommend the fence and backstop chain link be scheduled for replacement mid-term in the study period (reference Photograph 9 in Appendix B).</p> <p>The bleachers appeared to be in fair condition although they were assumed to be more than 15 years old. Based on a typical EUL of 20 years and observed conditions, we have anticipated replacement prior to mid-term in the study period (reference Photograph 9 in Appendix B) so that safe and suitable seating is maintained at the facility.</p> <p>The snack shack appeared to be in fair condition; therefore, with regular maintenance it will last well beyond the study period. The snack shack and baseball field is maintained by the Little League on behalf of the City.</p>

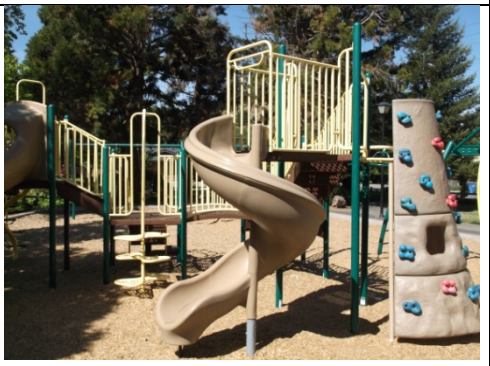
CONDITION SUMMARY		
Stafford Grove Park		<p>The park was observed to be generally in fair-to-good condition at the time of our assessment. Routine maintenance items include refinishing the gazebo, wood picnic tables and benches every eight years, and normal repairs to the irrigation system (reference Photograph 1 and 2 in Appendix B).</p> <p>The park's site lighting fixtures appeared to be in fair condition. The typical EUL for pole style lighting is 20 years; therefore, based on condition and EUL, we anticipate replacement will be necessary early in the study period (reference Photograph 5 in Appendix B).</p> <p>The park's drinking fountain appeared to be in fair-to-good condition. The fountain has a typical EUL of 20 years; therefore, replacement is anticipated mid-term in the study period (reference Photograph 3 in Appendix B).</p> <p>The park has a split rail fence along the walkways appeared to be in fair-to-good condition. The fence appeared to be more than ten years old (we are unaware when it was installed) with a typical EUL of 20 years for a split rail fence. Therefore, based on its EUL and observed condition, we recommend it be replaced prior to mid-term in the study period (reference Photograph 6 in Appendix B).</p> <p>The playground equipment appeared to be in fair condition and assumed more than ten years old. The typical EUL for public playground equipment is 15 years; however, due to observed condition, we recommend that it be replaced early in the study period to maintain the appearance of the park (reference Photograph 4 in Appendix B).</p>

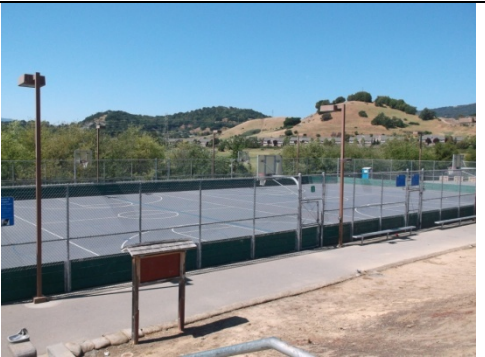
CONDITION SUMMARY		
<p>Thigpen Sports Courts</p>		<p>The park was observed to be generally in fair-to-good condition at the time of our assessment. Routine maintenance items include normal repairs to the irrigation system.</p> <p>The park's drinking fountains appeared to be in fair-to-good condition. The fountains have a typical EUL of 20 years; therefore, replacement is anticipated mid-term in the study period (reference Photograph 1 in Appendix B).</p> <p>The parking lot is asphalt paving and the walkways are a combination of asphalt and concrete that appear to be in fair-to-good condition. We recommend that the asphalt surface be seal coated and restriped early in the study period and then every five years (reference Photographs 7 and 8 in Appendix B).</p> <p>The park's tennis and sport courts appeared to be in fair condition. The typical EUL for tennis court surfaces is seven years (we are unaware when it was installed). Therefore, based on condition and EUL, the court repairs and resurfacing are recommended every seven years (reference Photographs 2 and 3 in Appendix B).</p> <p>The tennis and sport courts lighting fixtures appeared to be in fair condition. The typical EUL for pole mounted lighting is 20 years; therefore, based on condition and EUL, we anticipate replacement will be necessary early in the study period (reference Photograph 4 in Appendix B).</p>

<p>Thigpen Sports Courts</p>		<p>The parking lot lighting fixtures appeared to be in fair condition. The typical EUL for pole lighting fixtures is 20 years (we are unaware when it was installed); therefore, based on condition and EUL, we anticipate replacement will be necessary early in the study period (reference Photograph 5 in Appendix B).</p> <p>The tennis and sport courts lighting controls system appeared to be in fair condition. The typical EUL for court lighting controls is 15 years, (we are unaware when it was installed); therefore, based on condition and EUL, we anticipate replacement will be necessary early in the study period (reference Photograph 6 in Appendix B).</p>
-------------------------------------	--	--
