Citywide
Facility Condition Assessment

Report of
Facility Condition Assessment

For
City of Novato
Archery Shed
Miwok Park, Novato, CA

March 4, 2013

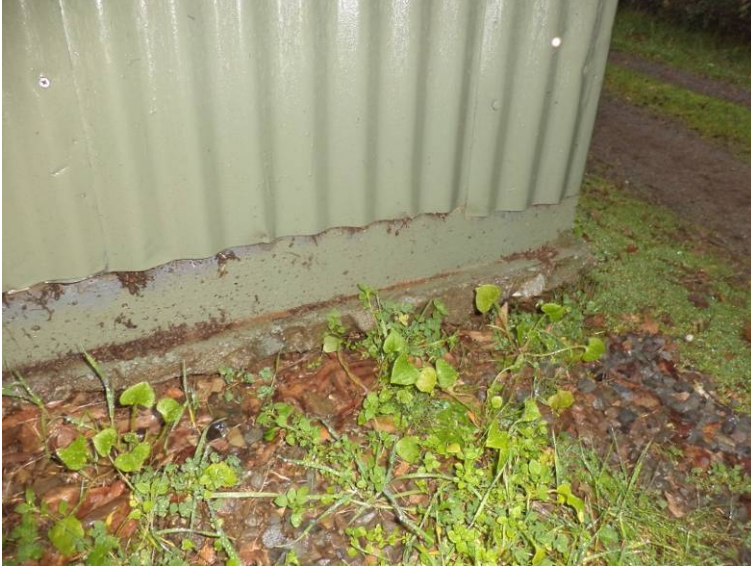
Photograph No. 1

The floor slab appeared to be in fair condition. The floor surface appeared flat, with no visible signs of damage or deterioration to the floor slab (reference Photograph 1 in Appendix B).

View of the thickened edge concrete floor slab.

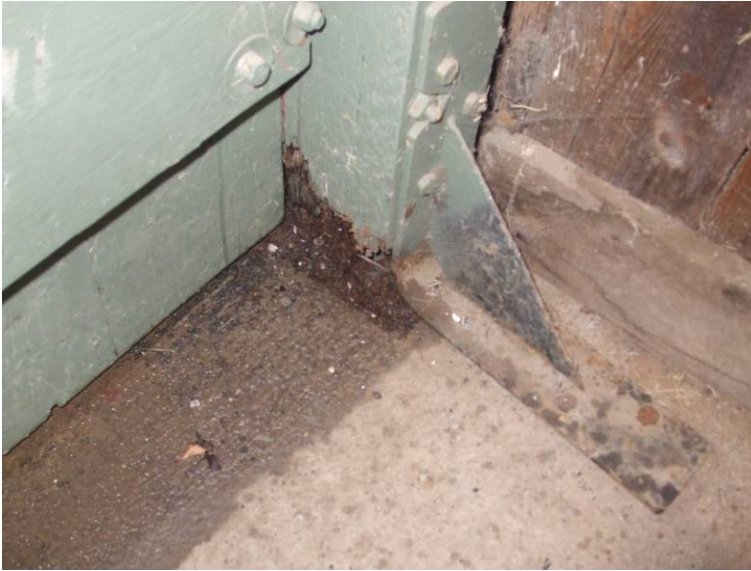
Photograph No. 7

The wood doors appeared to be in fair condition with some deterioration to the bottom section of the frame on the main entrance door (reference Photograph 7 in Appendix B). We recommend that the doors should be replaced with new painted solid core doors set in metal frames and secured with mortice deadlocks.

View of deterioration to the frame of the main entrance door.

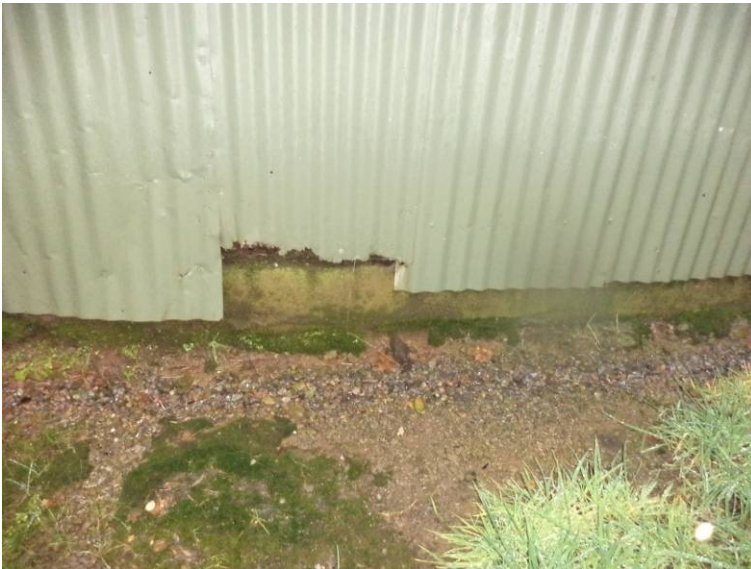
Photograph No. 8

The exterior wall systems at each of the buildings appeared to be in fair to poor condition for its age. We noted minor impact damage to the sheet metal siding together with loose and patch sections of metal siding (reference Photograph 8 in Appendix B). There were no deficiencies noted in the wood stud wall. We consider that the condition of the siding does not affect the current use of the building and as needed repairs should be carried out.

View of damaged section of the sheet metal.

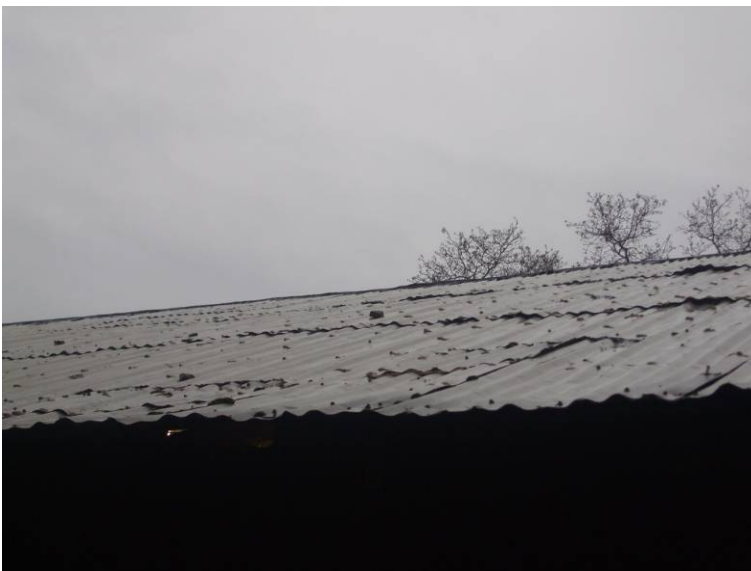
Photograph No. 9

The metal corrugated sheet roof to roof area 1 is in poor condition and typical for its age with damaged roof sheets and historic patches noted, however there were no reported issues with moisture ingress.

We consider the condition of the roof coverings 1 and 3 should warrant replacement however due to the current use it is acceptable to continue maintaining and repairing these systems to extend the life of the roof coverings.

View of the corrugated sheet metal roof covering.

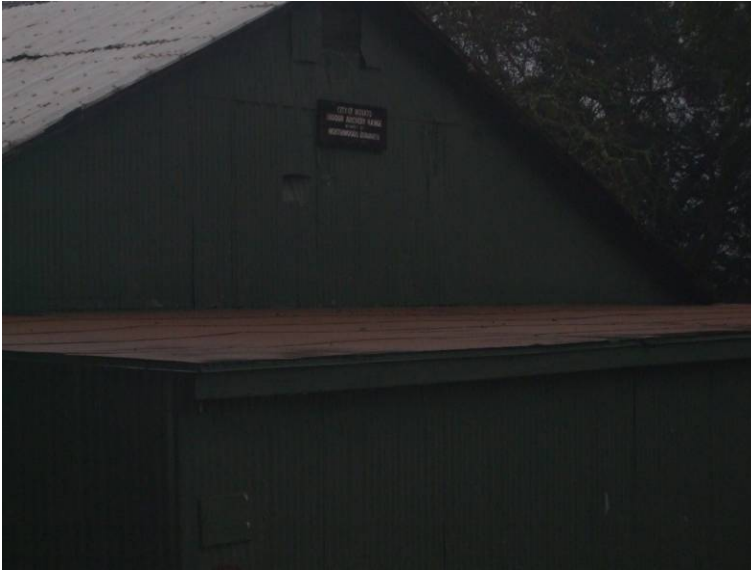
Photograph No. 10

The asphalt roll roof covering to roof area 2 appears to be in fair to good condition having been installed approximately ten-years ago. The roof covering to roof area 3 is older and in poor to fair condition.

View of the asphalt roll roof covering.

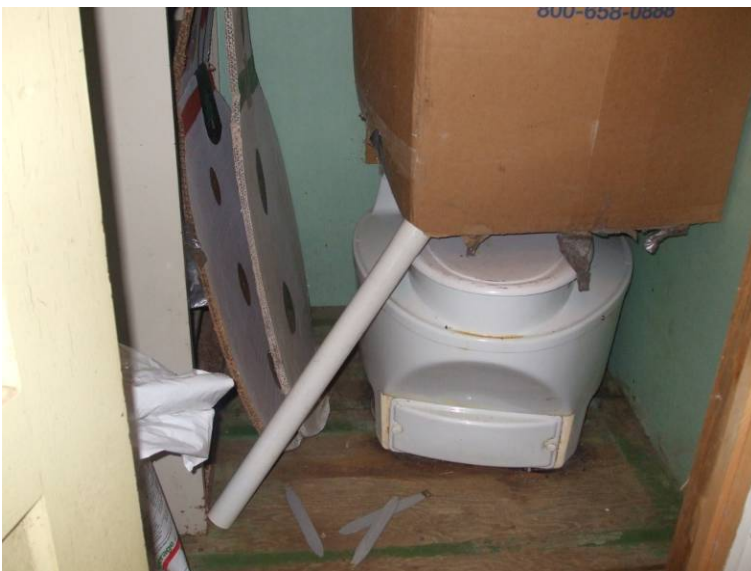
Photograph No. 12

The water closet is currently non-functional and building users are using an outdoor portable water closet (reference Photograph 12 in Appendix B).

View of a plastic non-functional water closet.

We recommend maintaining the self-contained water closet on a regular basis.

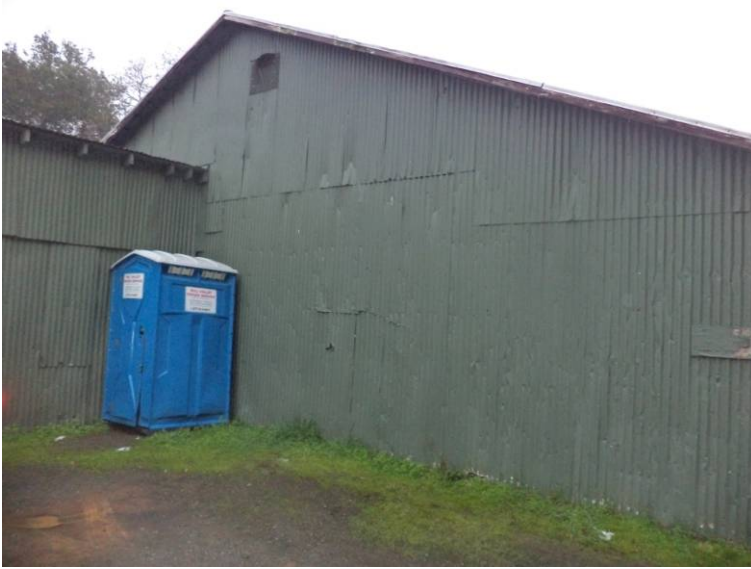
Photograph No. 13

View of the site portable toilet to replace the currently out of use water closet.

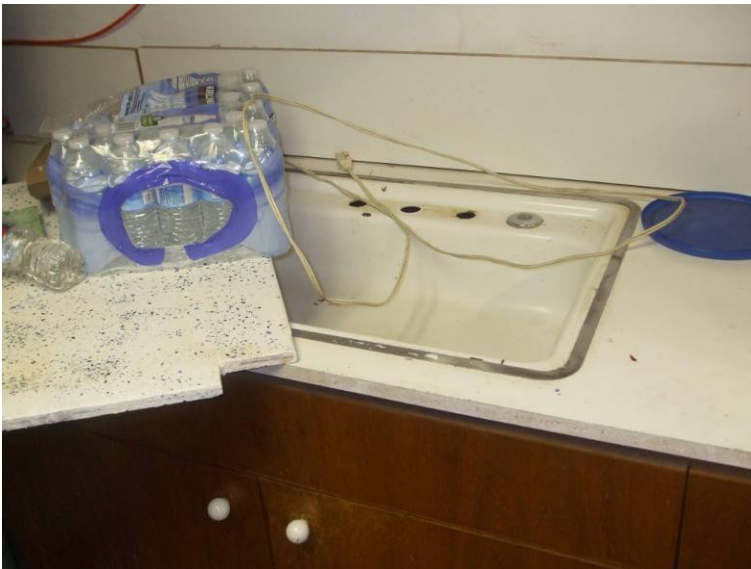
Photograph No. 14

The countertop sink to the kitchen area had no faucets present, therefore we assume the sink is non-functional.

View of a countertop sink with no faucets.

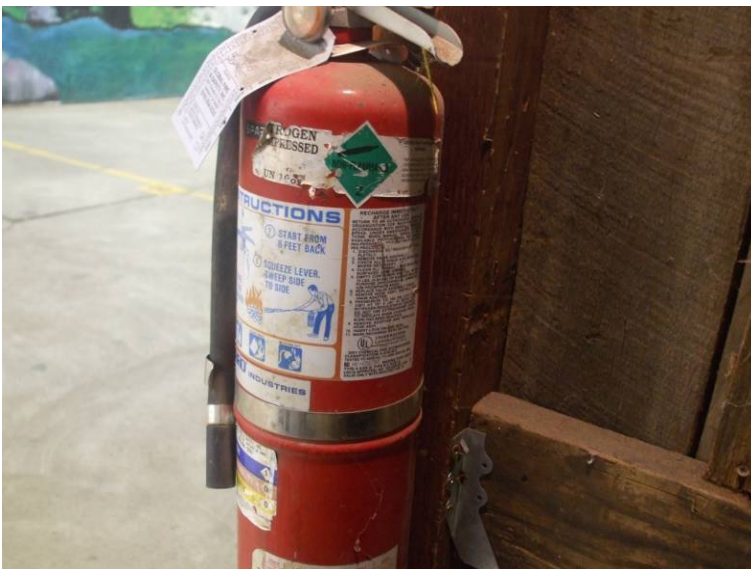
Photograph No. 15

Fire extinguishers appeared to be in fair condition. We noted that both extinguishers are out of inspection. One was last inspected in January 2003 and the other July 2008. We recommend that the fire extinguishers are tested and replaced if necessary.

View of a fire extinguisher.

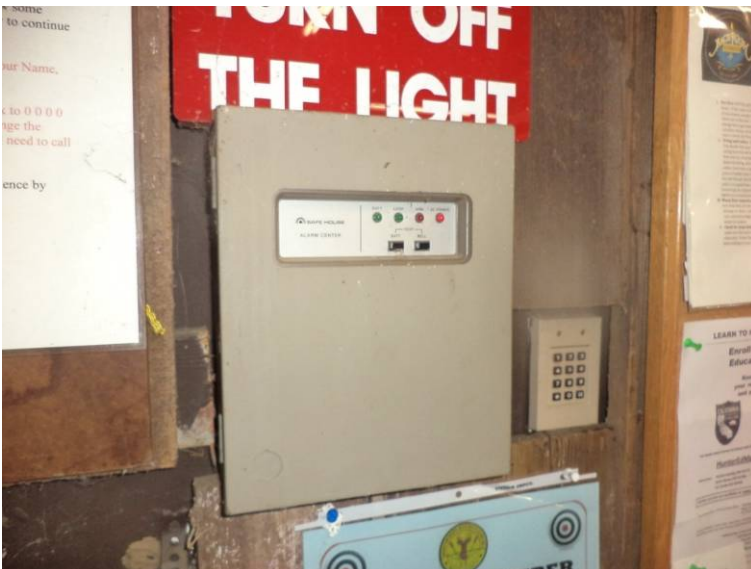
Photograph No. 18

The intruder alarm system appeared to be in fair condition. We are unaware of any operating issues with the system; however this type of system has a typical EUL of ten-years, therefore we recommend its replacement prior to mid-term in the study period.

View of the intruder alarm system.

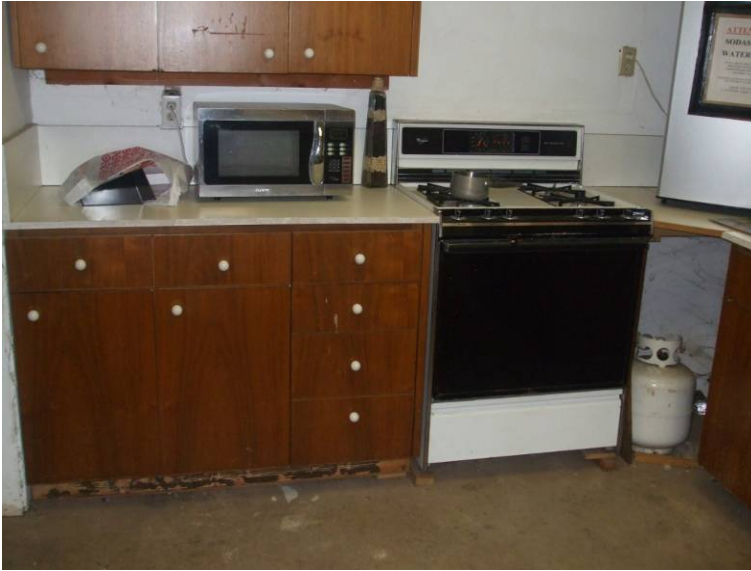
Photograph No. 19

The fixed cabinets appeared to be in fair condition and suitable for their use. Fixed cabinets usually have a typical EUL of twenty-years; therefore replacement is anticipated prior to mid-term in the study period.

View of the kitchen cabinets.

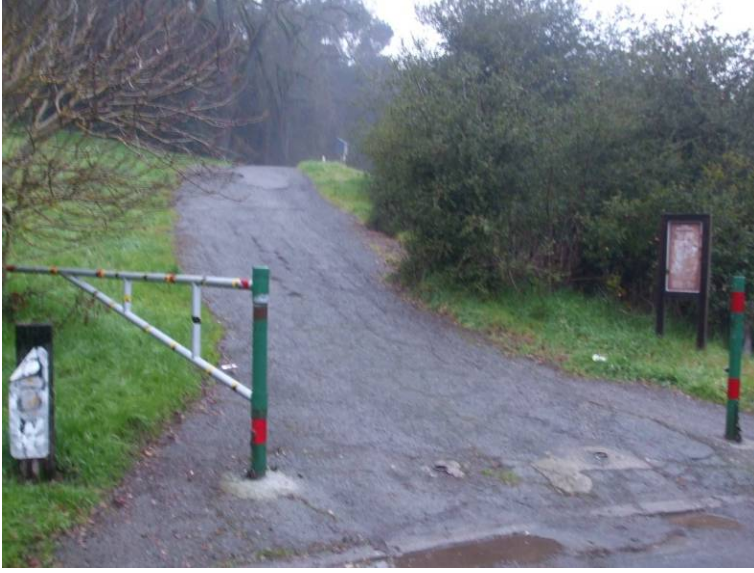
Photograph No. 22

The asphalt roadway section appeared to be in poor to fair condition. We noted the surface was uneven and contained sections of alligator cracking. Alligator cracking is a series of interconnected cracks caused by fatigue failure of the asphalt surface under repeated vehicle loading which is also indicative of sub-base and sub-grade deterioration (reference Photograph 22 in Appendix B). We recommend undertaking full depth asphalt repair.

View of the deteriorated asphalt at the start of the access road to the building.
