**Citywide  
Facility Condition Assessment**

**Report of  
Facility Condition Assessment**

**For  
City of Novato  
Council Chambers  
901 Sherman Avenue, Novato, CA**

***March 4, 2013***

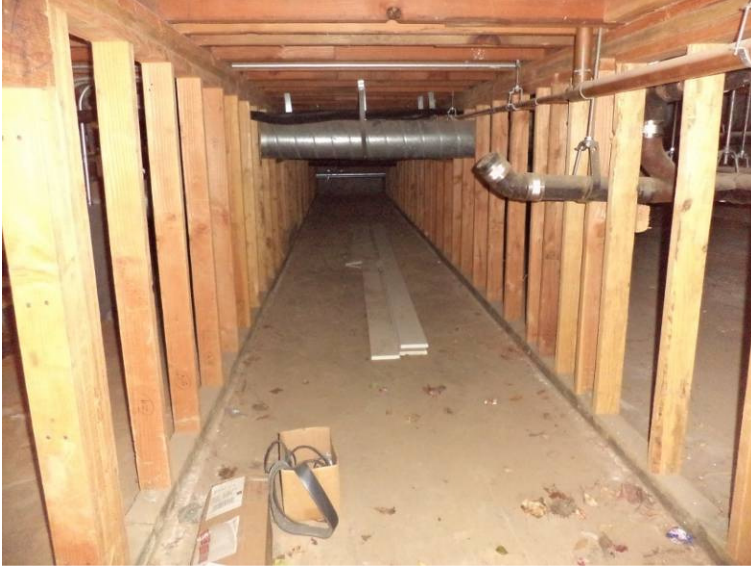
**Photograph No. 1**

The raised wood floor constructions appeared to be in good condition, and fully visible within the crawl space below the annex section of the building, and therefore the sections that were observed were in good condition having been constructed as part of a major renovation in 2010. There are no anticipated replacement actions during the study period.

View of the floor construction at the west section (Annex) of the building.

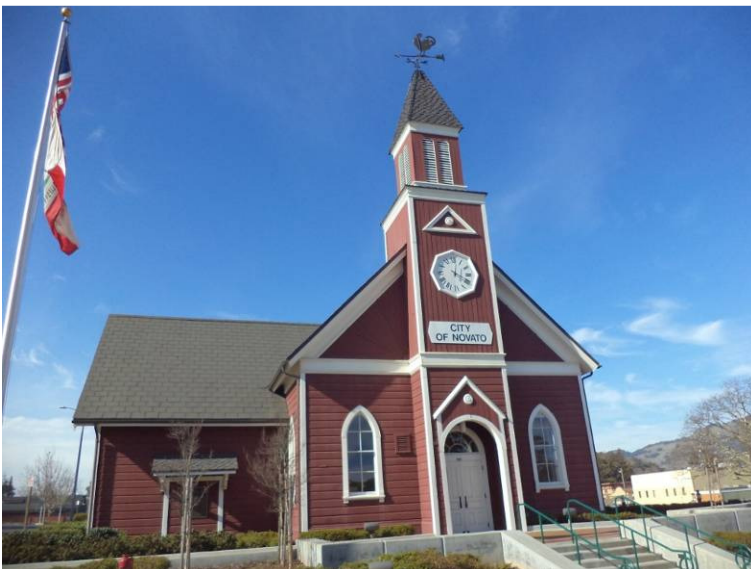
**Photograph No. 6**

At high level we noted wooden wide vented soffits and fascias which are part of the underside of the overhanging roof structures at each section of the building (reference Photographs 6 and 7 in Appendix B). Some of the detailing is original and decorative with the fascia made from redwood. The soffits contained sheet slotted vent strip to allow and promote cross ventilation through the roof space.

View of the entrance at the east elevation of the building.

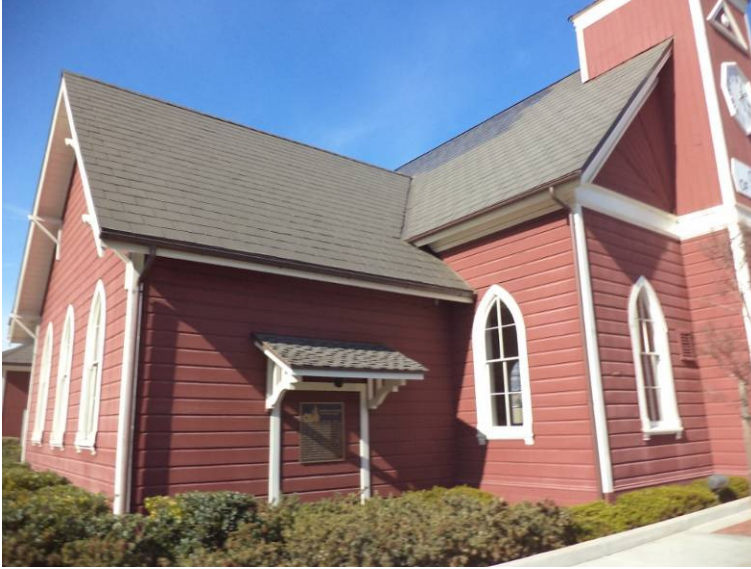
**Photograph No. 7**

View of the exterior siding and roof covering.

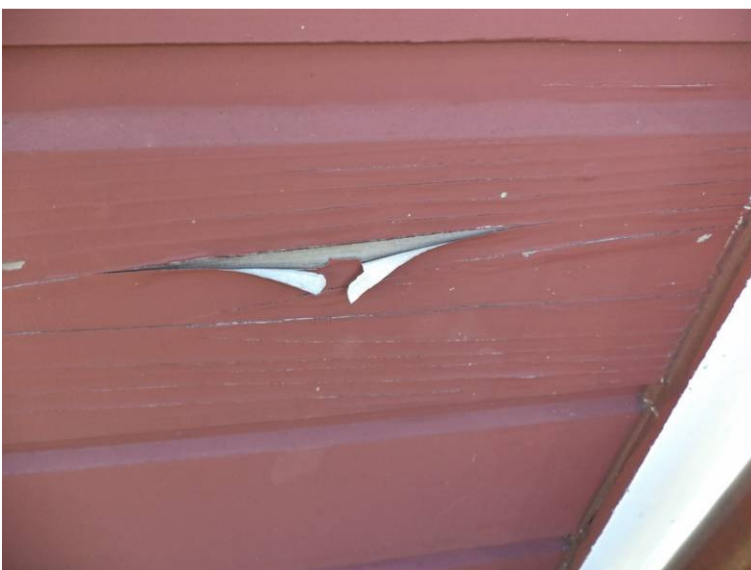
**Photograph No. 9**

The exterior wall construction appeared to be in good condition with no signs of deterioration, water ingress or general failure noted. We understand that the wood siding, soffits and fascia surfaces were last painted in 2010 at the time of the renovation and therefore based on their current observed conditions and the typical EUL of eight-years repainting of the painted surfaces are recommended towards mid-term in the study period and then every eight-years after to maintain the exterior appearance of the building. One exception was observed opposite the outdoor condenser units belonging to the split-system air conditioners. The painted surface has started to deteriorate in this section with blistering and peeling paint present (reference Photograph 9 in Appendix B). We recommend that this section is isolated, prepared and repainted immediately to maintain the appearance of the building as a one off re-painting action.

View of the section of the exterior paint that has started to blister and deteriorate.

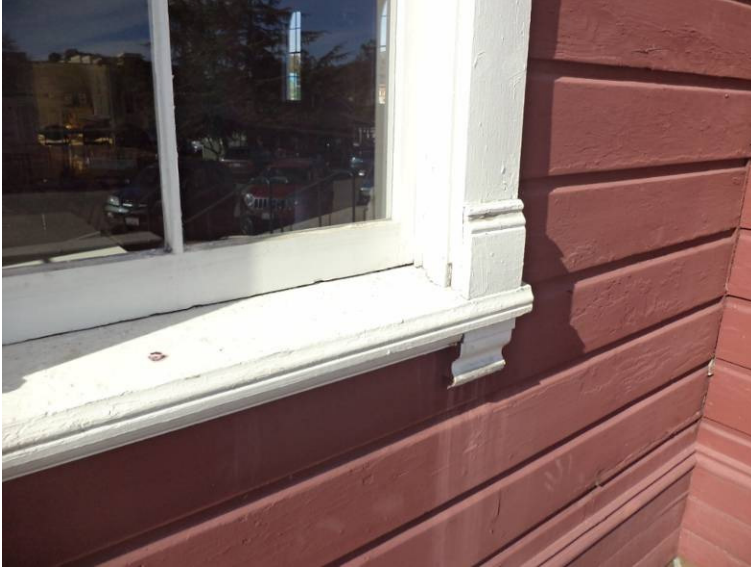
**Photograph No. 10**

The exterior window units appeared to be in good condition, although the single-pane design of the majority of the window units offers limited thermal insulation. Not all of the windows were assessed, however overall we did not find any major deficiencies and no areas of water ingress through the system. We understand that the aluminum window units were newly installed and the historic arched windows restored in 2010 at the time of the renovation and therefore based on a typical EUL of thirty-years these window units will last beyond the study period with no major replacement actions necessary. We do recommend that the wood windows are repainted during the study period to maintain their appearance. The cost of this work has been included within the exterior wood siding repainting works.

View of the wood sash window units.

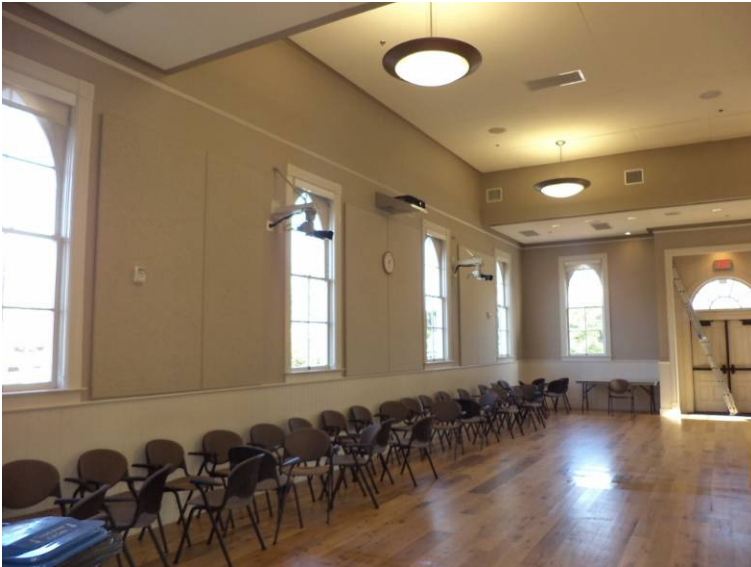
**Photograph No. 17**

The building contained a combination of floor coverings which consisted of vinyl sheet within the custodial room; 12" x 12" ceramic floor tiles within the restrooms and stained wood plank flooring within the council chamber, lobby, kitchen and storage area (reference Photographs 17 through 21 in Appendix B).

View of the interior finishes within the council chamber.

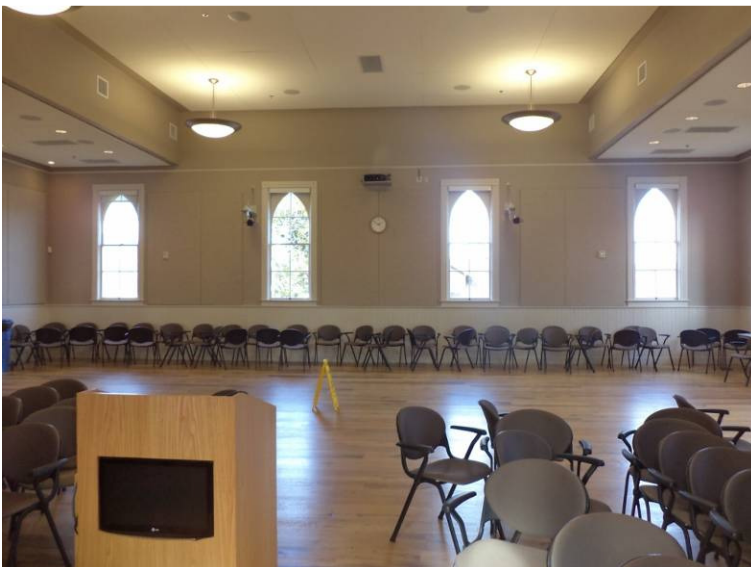
**Photograph No. 18**

View of the wood floor, painted walls and ceiling systems.

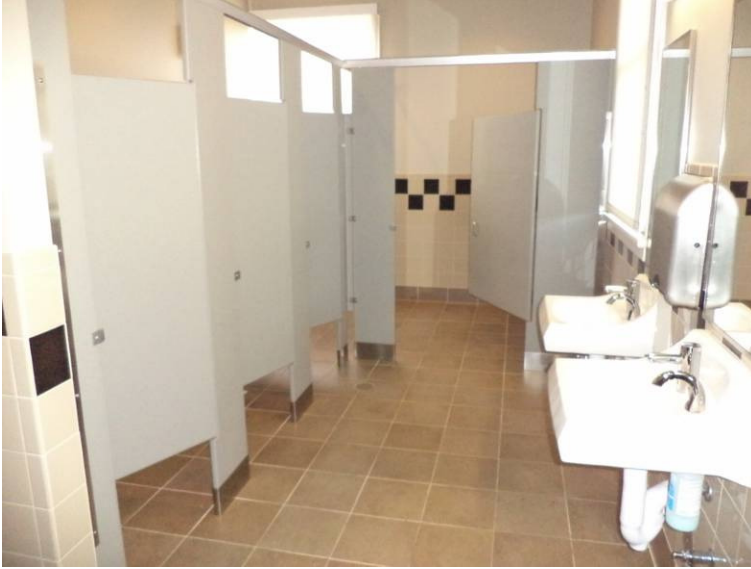
**Photograph No. 19**

View of the restrooms ceramic floor and wall coverings. Also the toilet cubicles.

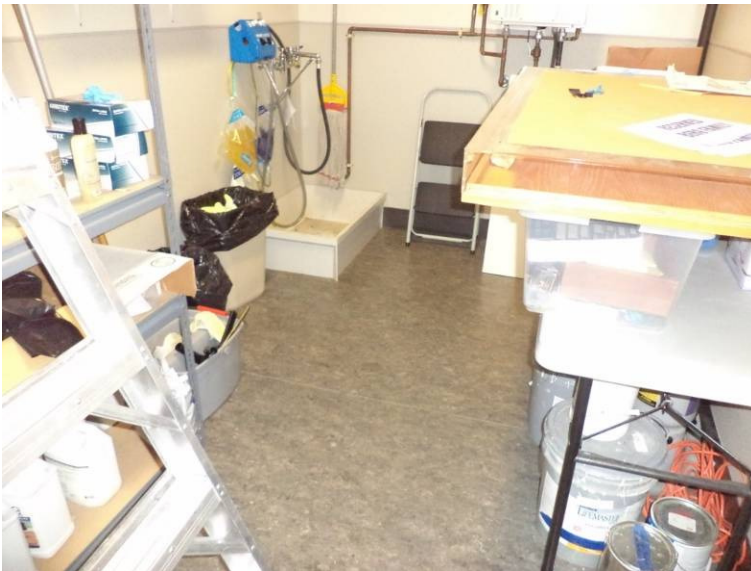
**Photograph No. 20**

Vinyl flooring has a typical EUL of eighteen-years and therefore based on observed conditions and likely light usage we have extended the RUL of the vinyl sheet and therefore it is anticipated to last beyond the study period without replacement necessary.

View of the vinyl sheet within the janitors room. Also the floor mounted sink.

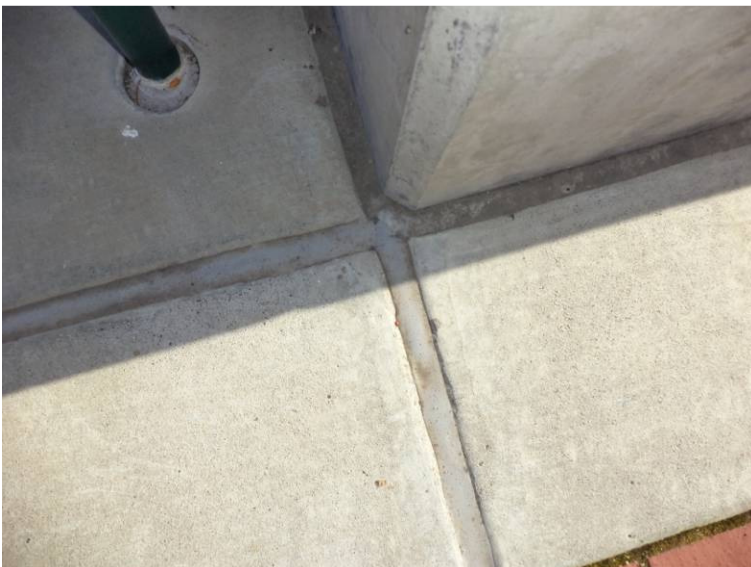
**Photograph No. 45**

View of the sealant between the concrete slab.
