**Citywide
Facility Condition Assessment**

**Report of
Facility Condition Assessment**

**For
City of Novato
Downtown Recreation Center
950 Seventh Street, Novato, CA**

March 4, 2013

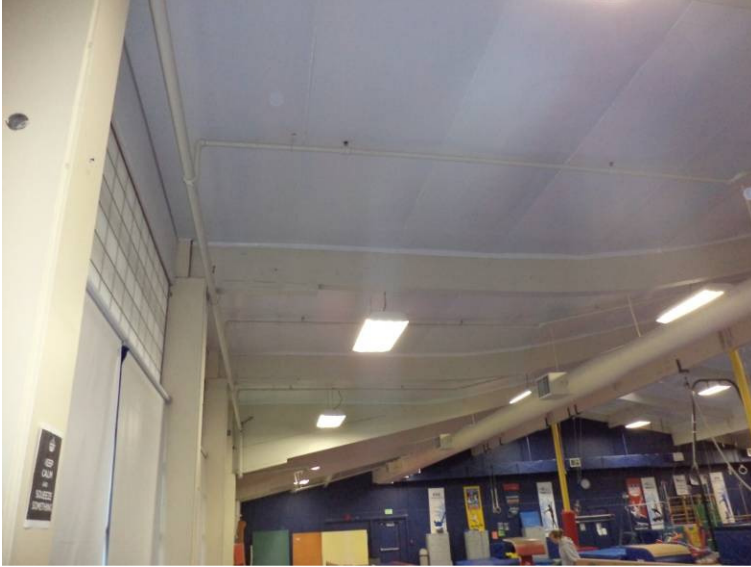
Photograph No. 1

The concrete columns appeared to be in good condition. We do not anticipate the replacement of such structural elements during the cost study period.

View of the concrete columns supporting the glulam beams.

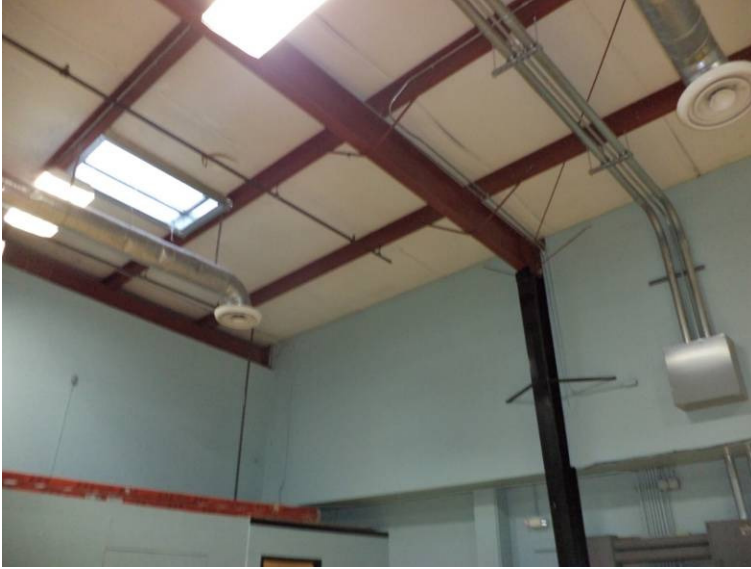
Photograph No. 4

The steel rigid frame structure appeared to be in good condition. We do not anticipate the replacement of such structural elements during the cost study period.

View of the steel rigid frame structure in building B.

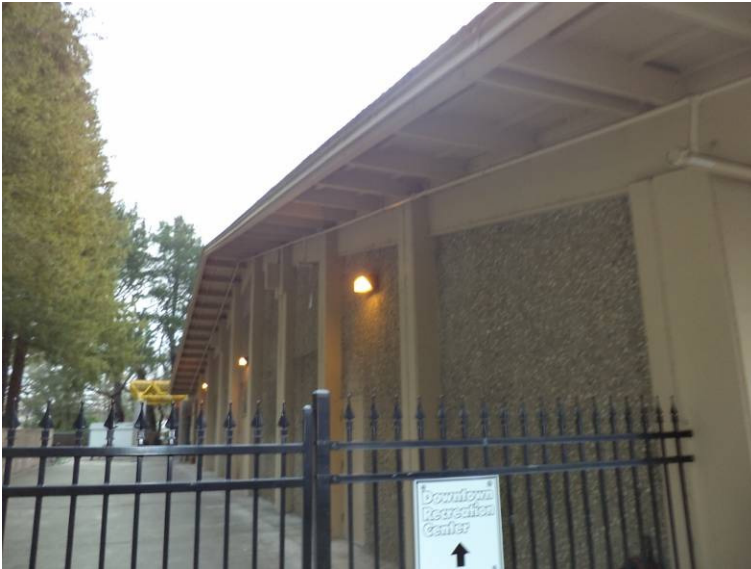
Photograph No. 8

At high level we noted wooden soffits and fascias which are part of the underside of the overhanging roof structures at sections of building A (reference Photograph 8 in Appendix B).

View of the concrete columns and inserted concrete tilt-up panels, as well as the roof overhang, wall mounted exterior wall pack light fixtures and the rail and post fence and gate.

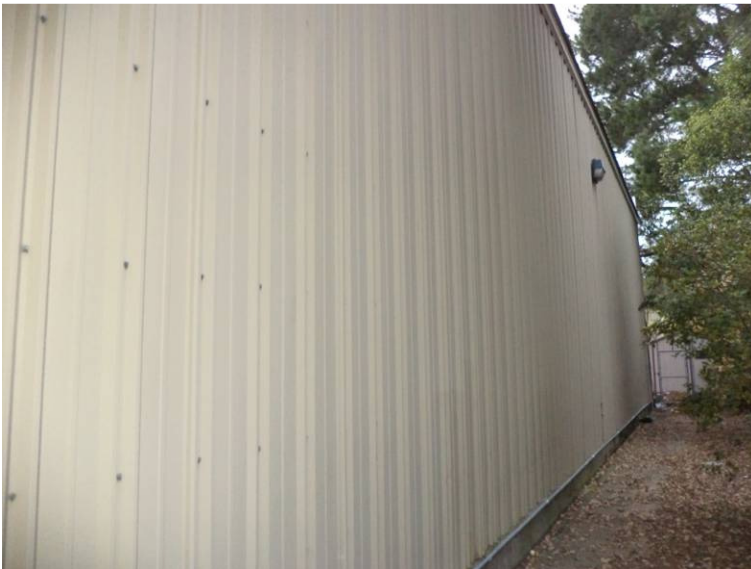
Photograph No. 9

The metal wall panels at building B appeared to be in fair to good condition. We are unaware of any moisture ingress issues at these elevations (as there is at roof level) and we observed no instances of failure or major damage. We anticipate that this system will last beyond the study period without replacement necessary. We recommend that a review of each of the screw fasteners is undertaken to confirm that each of them has the correct rubber washers which prevent moisture ingress through the screw hole.

View of the preformed metal wall panels.

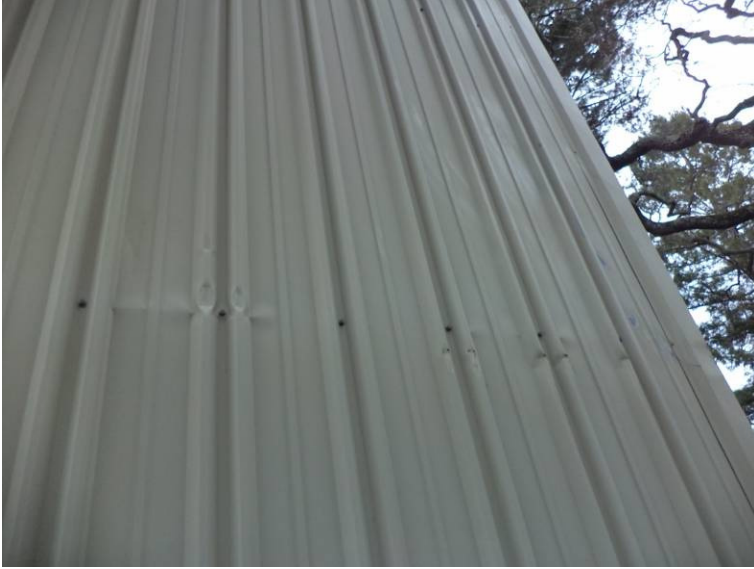
Photograph No. 10

View of the preformed metal wall panels.

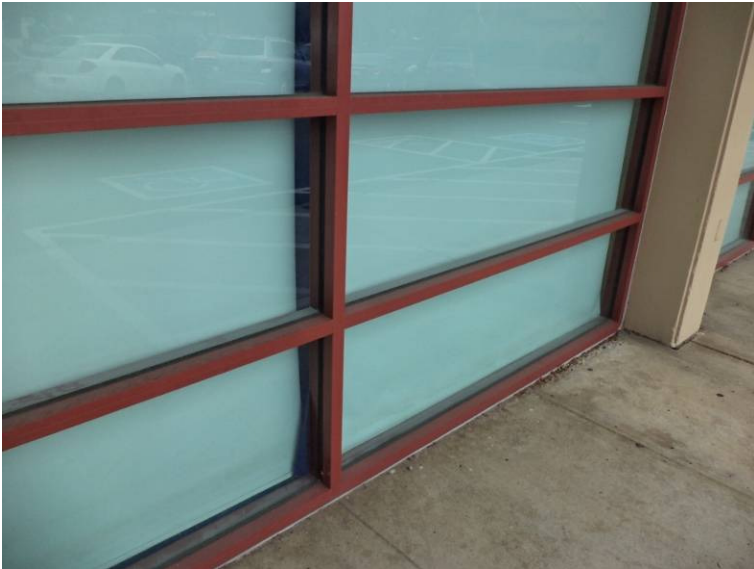
Photograph No. 11

At the west elevation we noted maroon colored/finished aluminum framing curtain walling systems with single-pane tempered glazing (reference Photograph 11 in Appendix B). Sealant was present at the junction of the aluminum framing and where it meets the concrete columns.

The exterior curtain wall systems appeared to be in good condition, no major deficiencies were observed. Based on a typical EUL of fifty-years replacement is not anticipated during the study period. However the perimeter sealant has dried out and shrunken (reference Photograph 12 in Appendix B), this is typically a result of exposure to moisture, heat and ultraviolet radiation, the sealant has lost its movement capabilities due to loss of plasticizers. The deformed sealant at some point, if not already done so will allow air and water to enter the building; no signs of moisture penetration at the interior was observed at the time of the assessment. Sealant such as this has a typical EUL of fifteen-years therefore we anticipate it will require replacement with a suitable polyurethane sealant early in the study period and again towards the end of the study period to maintain water integrity and prevent any water penetration.

View of the curtain walling system.

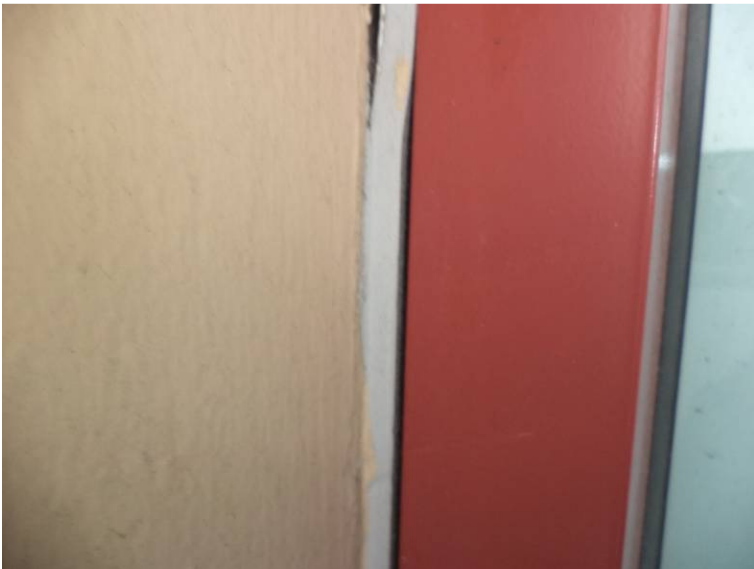
Photograph No. 12

View of the shrunken sealant between the curtain walling frame and the concrete column.

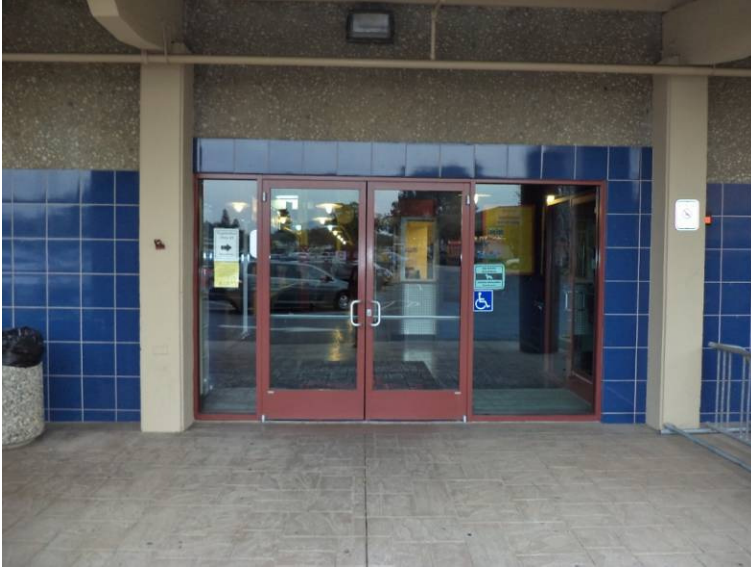
Photograph No. 13

The exterior storefront systems appeared to be in good condition, no major deficiencies were observed. Based on a typical EUL of fifty-years replacement is not anticipated during the study period. We do not anticipate a requirement for their replacement as they do not require any actions during the study period. However the perimeter sealant has started to deteriorate in the same way as the sealant at the curtain walling systems. We recommend that all of the sealant is replaced at the same occasion, and therefore we have included the cost of this work with the cost of the curtain walling sealant replacement.

View of the main entrance storefront entrance system. Also the ceramic wall ties.

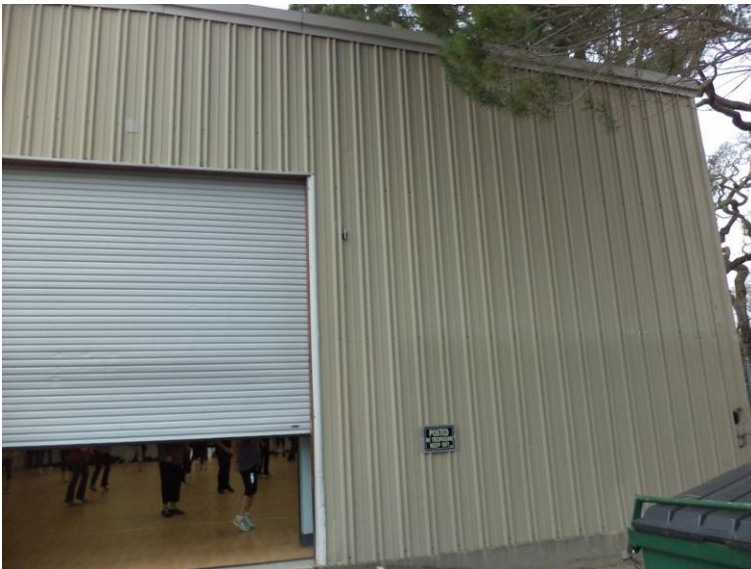
Photograph No. 14

The overhead door appeared to be in fair to good condition. We do not anticipate a requirement for its replacement at this time; however we recommend that the door is regularly maintained and serviced. Based on a typical EUL of thirty-years replacement is recommended based on industry standards later in the study period. At the time the door is scheduled to be replaced we recommend it is re-assessed for replacement suitability.

View of the roll-up over head door.

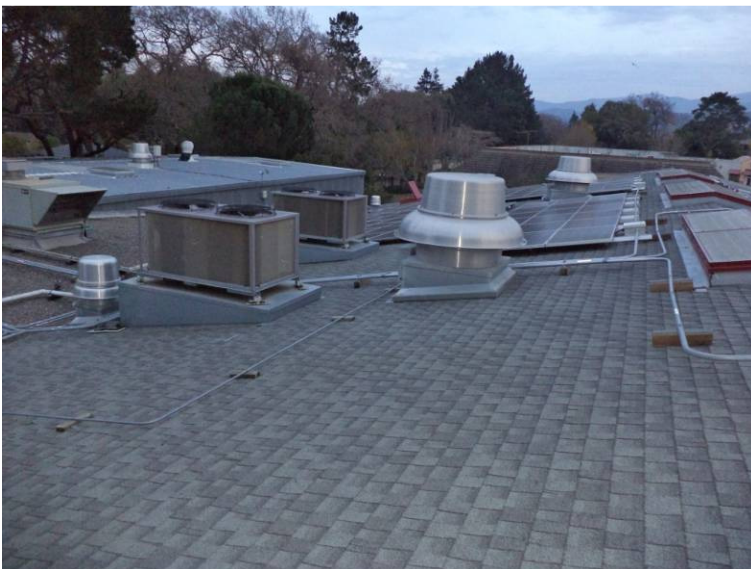
Photograph No. 15

The steep-sloped roof areas 1 and 2 contained an asphalt shingle roof covering (reference Photograph 15 in Appendix B). The low-sloped roof areas 3 and 4 each contained a tar and gravel Built-up Roof (BUR) system (reference Photographs 16, 17 and 19 in Appendix B) and roof level 5 contained a preformed metal panel roof covering (reference Photograph 20 in Appendix B). The metal roof is installed on structural steel purlins with screws which secure the panels to the purlins, but also stitch the panels together at the side and end laps.

The roof coverings appeared to be in poor to fair condition overall. We understand that the asphalt shingles, as well as the tar and gravel coverings were installed in 1999 and we assume that the metal roofing system is original (or more than thirty-years old). The normal estimated useful life expectancy of these types of roofing systems is forty-years for the asphalt shingle, twenty-years for the tar and gravel BUR covering and thirty-years for the metal roofing system. The BUR systems typically shows signs of deterioration accelerating after approximately fifteen-years, which in this instance is apparent, as they are approaching fifteen-years of age. It was also reported that there are issues regarding moisture ingress at the footings of the solar modules, through the steep-sloped asphalt shingle roof covering; these issues are ongoing and have to this time have not been fully resolved. In addition we noted sections of previous repairs (reference Photograph 19 in Appendix B), which suggests that the roof covering is nearing the end of its RUL.

View of the asphalt roof covering system at the steep-sloped roof.

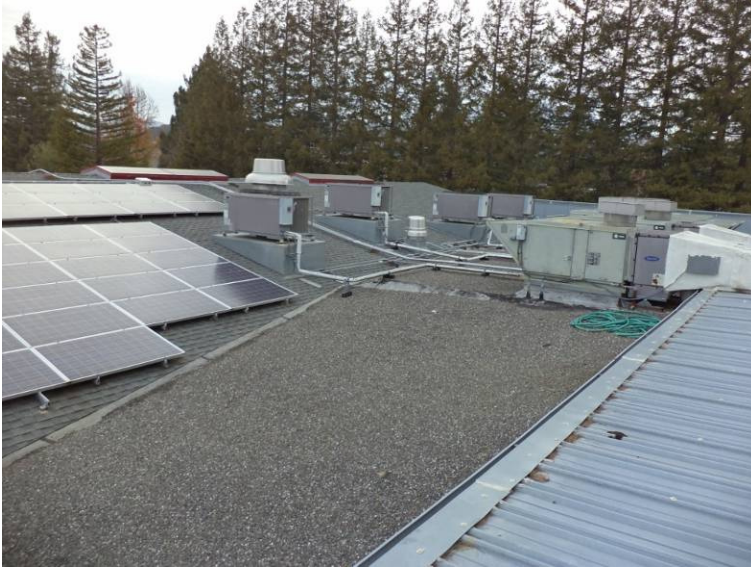
Photograph No. 16

View of the tar and gravel roof covering.

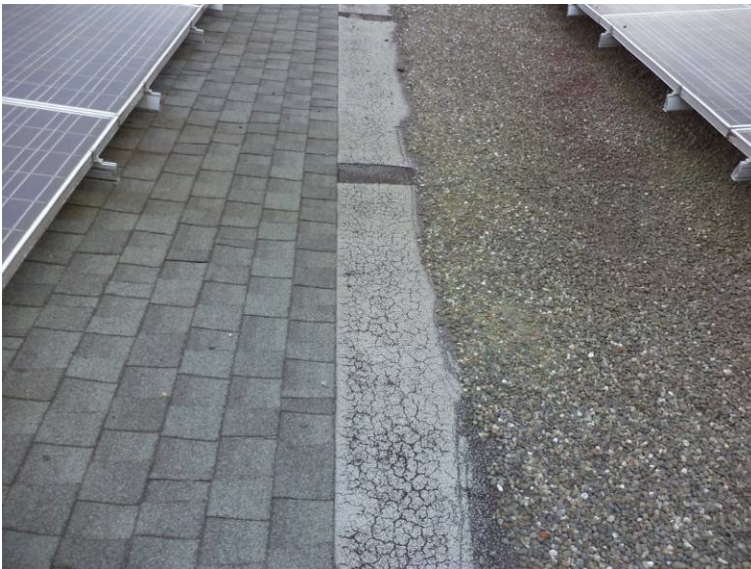
Photograph No. 17

View of the deteriorated and cracked mineral cap sheet at the transition.

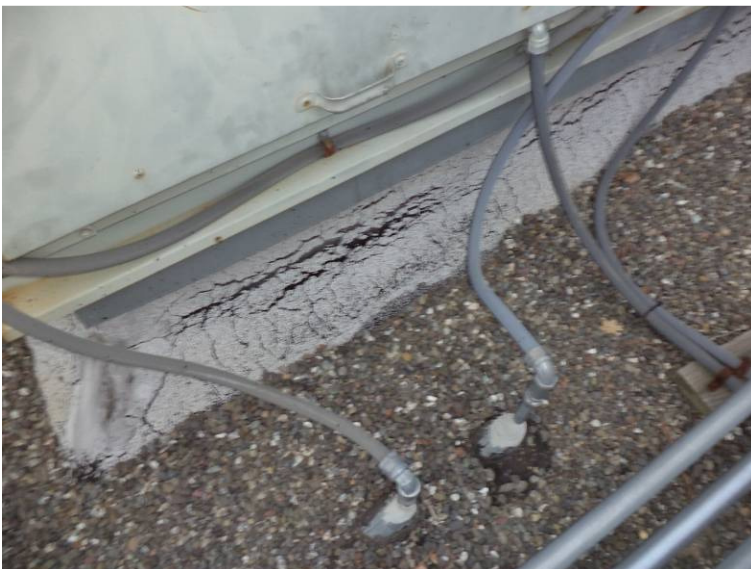
Photograph No. 18

View of the deterioration at the equipment upstands.

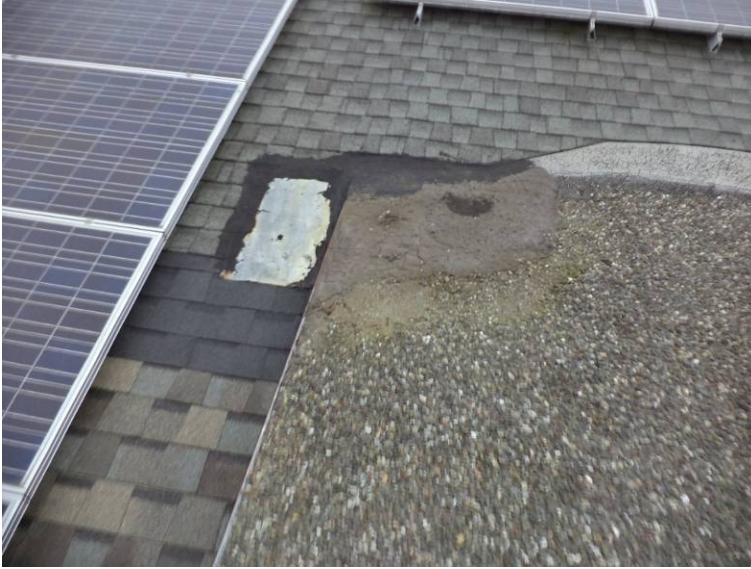
Photograph No. 19

View of an already repaired section.

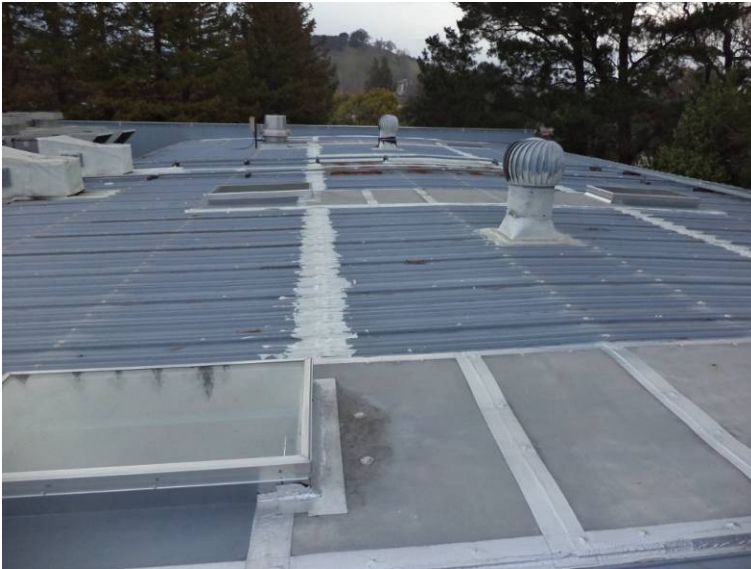
Photograph No. 20

View of the metal roof panel. Also shows the repairs undertaken at the main seam.

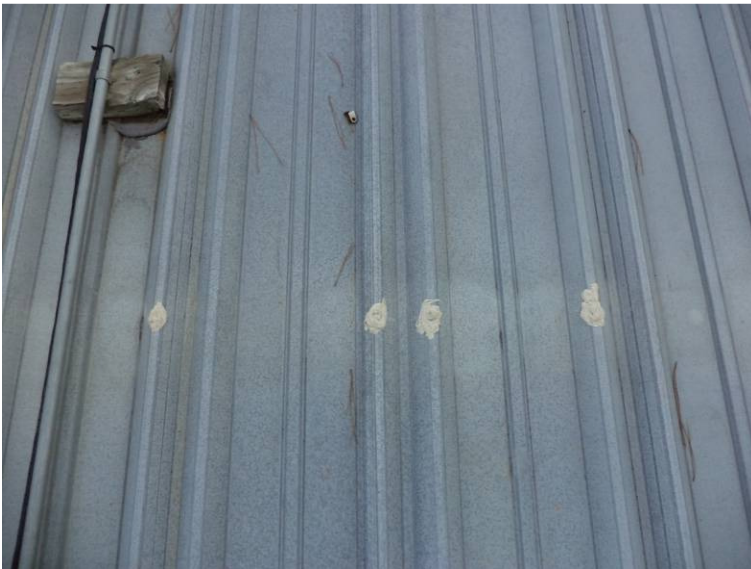
Photograph No. 21

View of the repairs undertaken at the screw fasteners.
