Citywide
Facility Condition Assessment

Report of
Facility Condition Assessment

For
City of Novato
Novato Arts Center
(Buildings 500, 781, 789 & Hamilton Cafe)
500 Palm Drive & 781/789 Hamilton Parkway, Novato, CA

March 4, 2013

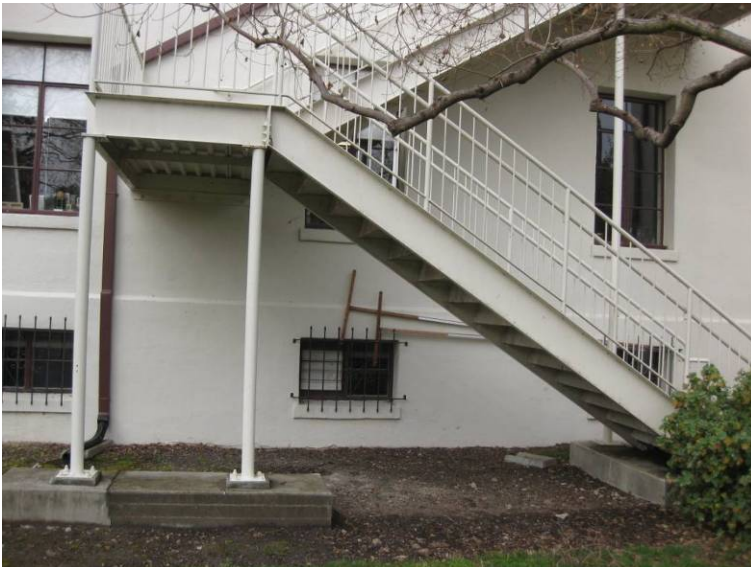
Photograph No. 4

View of the cracking in concrete around base of guardrail.

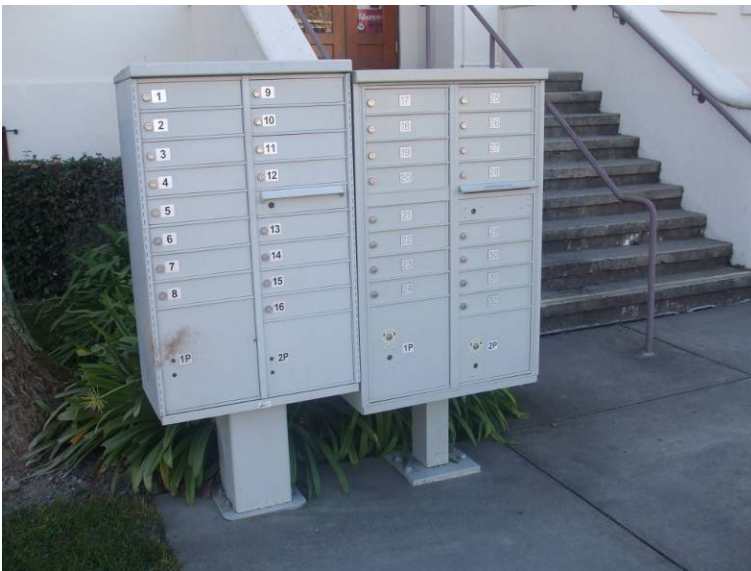
Photograph No. 50

View of deterioration on the concrete steps.

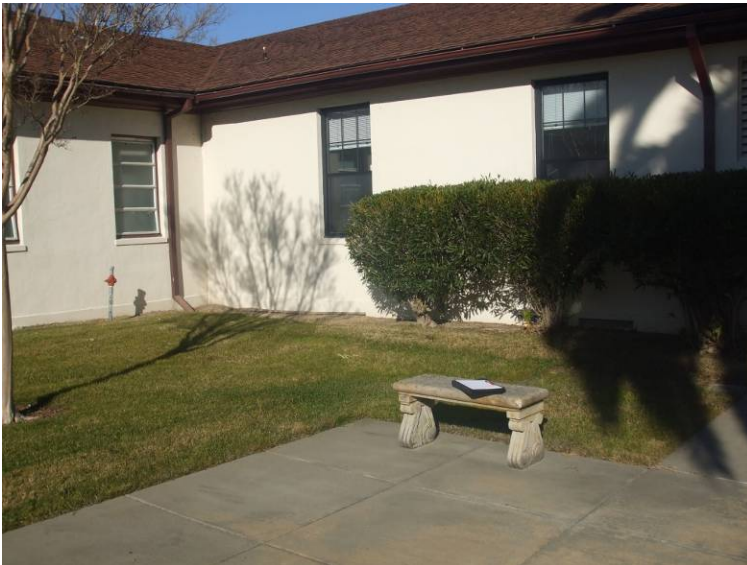
Photograph No. 61

View of another subfloor vent showing deterioration on surrounding stucco.

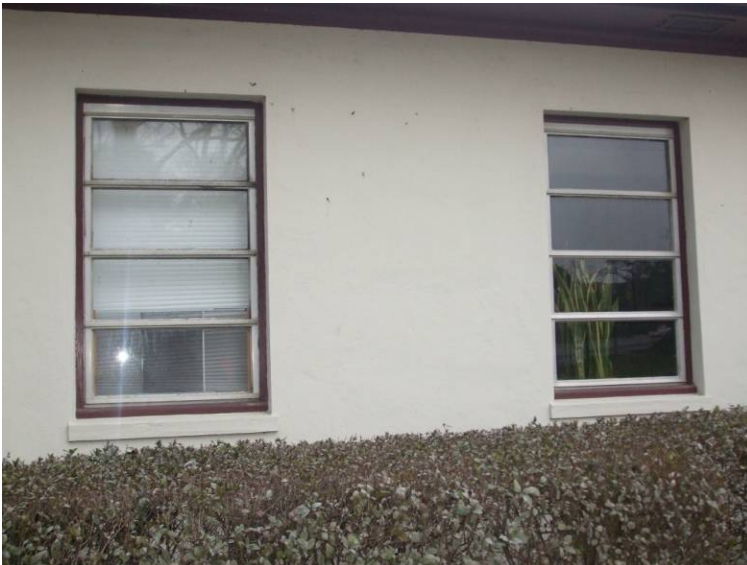
Photograph No. 64

View of cracking around window on the 789 building.

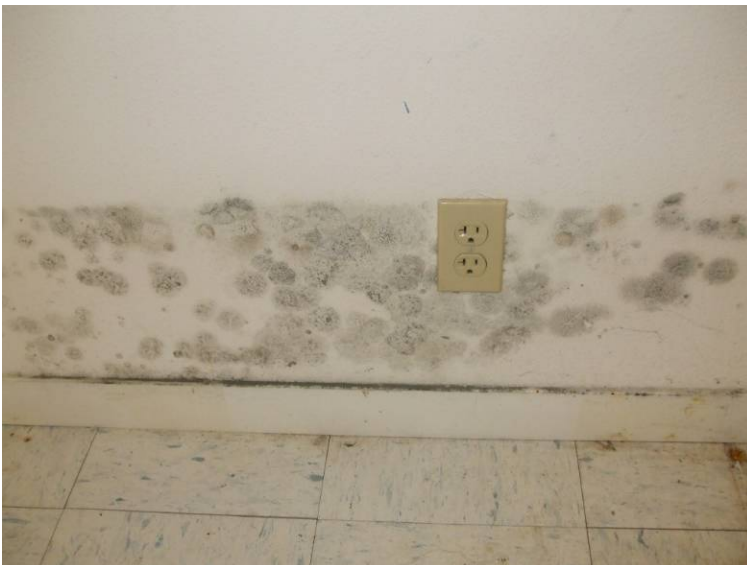
Photograph No. 80

View of deterioration to interior wall finish located in the corridor of the 789 building.

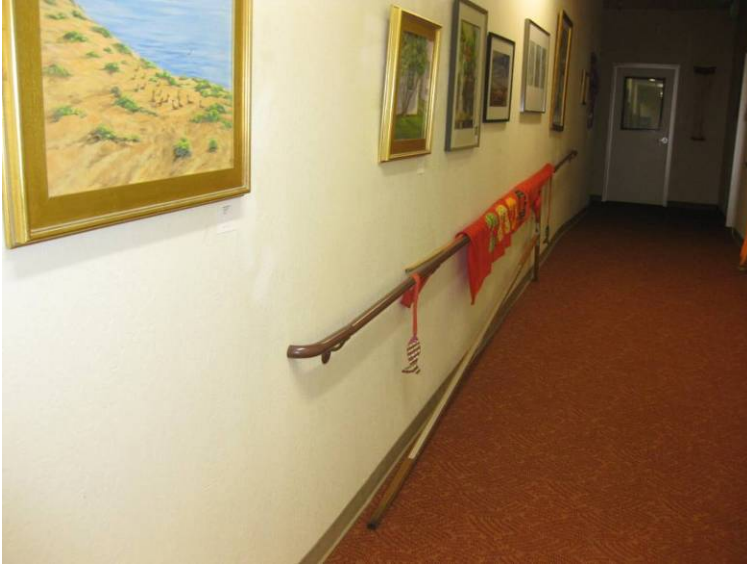
Photograph No. 81

View of staining on wall finish in the 789 building.

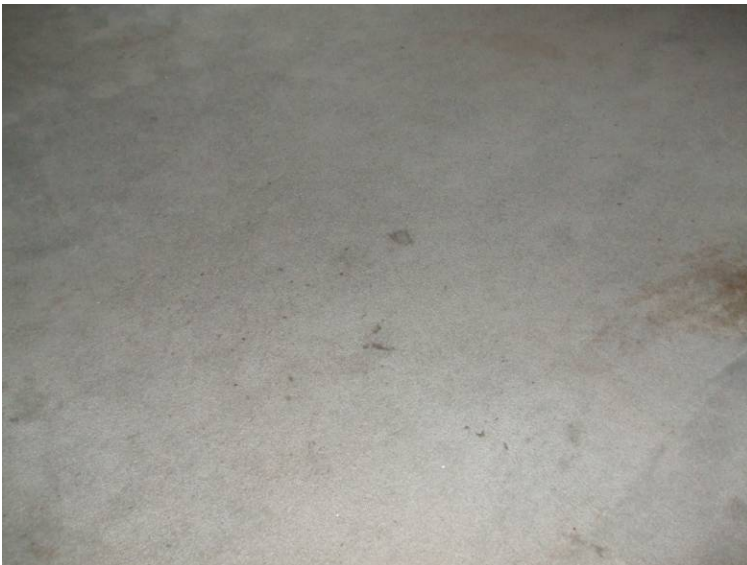
Photograph No. 83

View of worn VCT floor in kitchen in the 789 building.

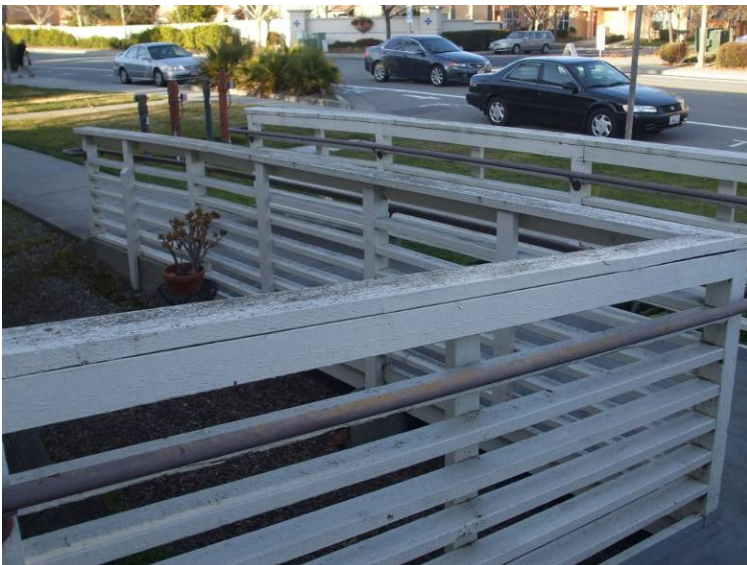
Photograph No. 113

View of deteriorated post on exterior steps.

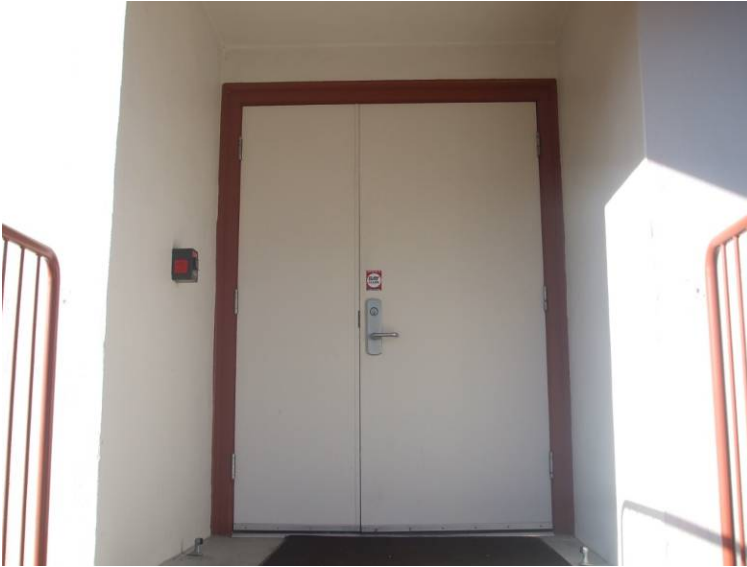
Photograph No. 157

Signs of deterioration to the wood subframe.
