Citywide  
Facility Condition Assessment

Report of  
Facility Condition Assessment

For  
City of Novato  
Hamilton Community Center  
503 South Palm Drive, Novato, CA

*March 4, 2013*

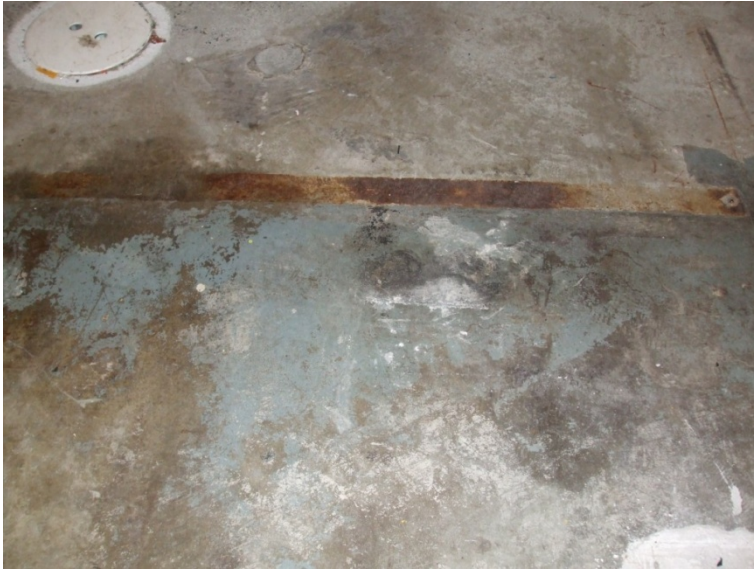
**Photograph No. 1**

The slab-on-grade was observed to be in good condition. While the majority of the slab was not visible there were no signs of undue settling or major cracks noted.

View of the concrete slab-on-grade.

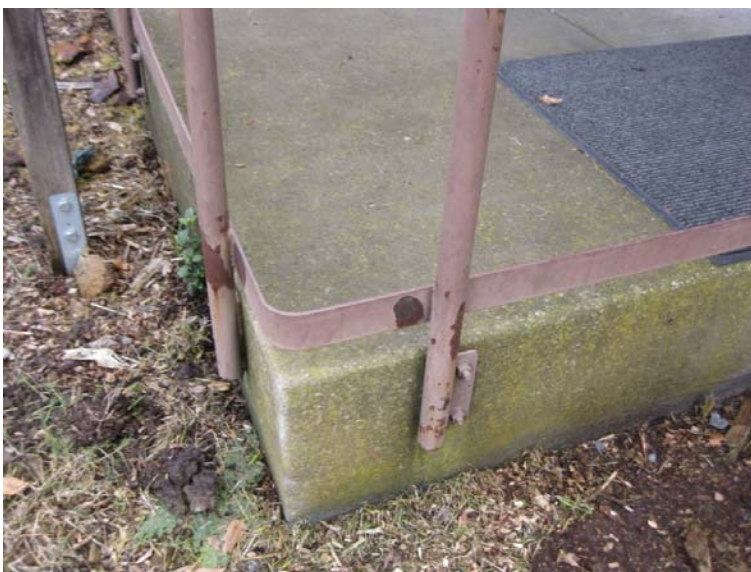
**Photograph No. 3**

View of the deteriorated paintwork on the ramp handrails.

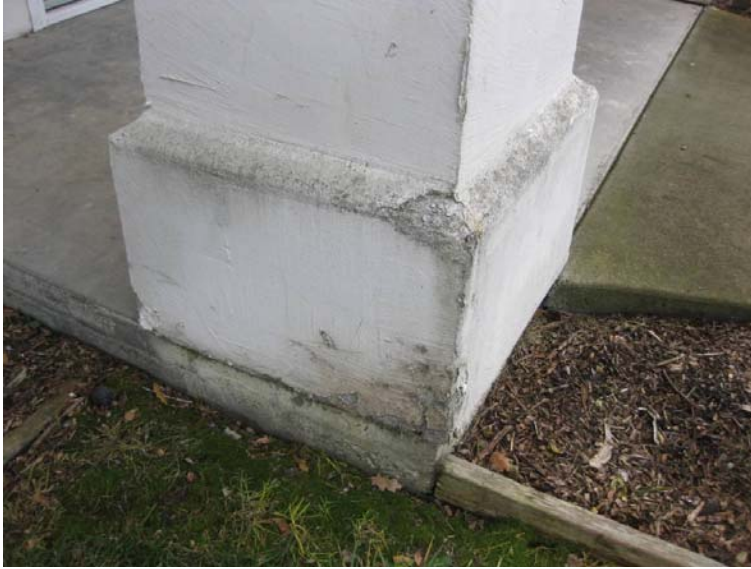
**Photograph No. 7**

View of a column at the main entrance showing signs of wear and needs repainting.

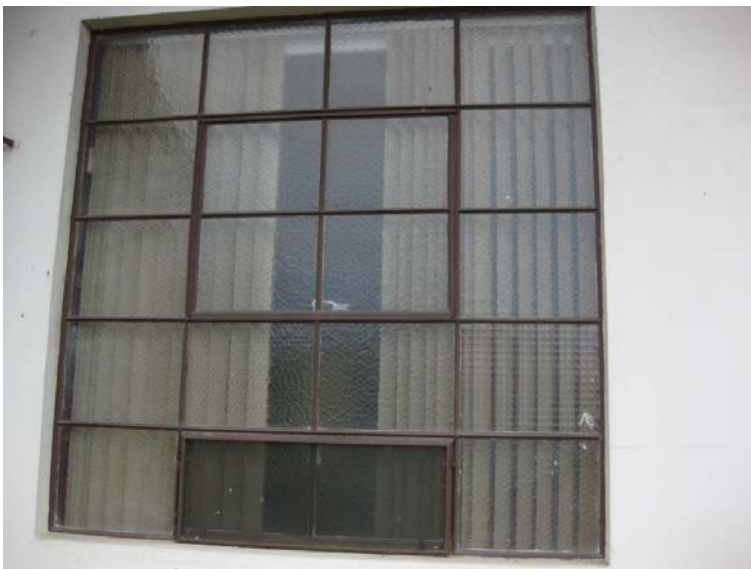
**Photograph No. 9**

The steel framed single pane window units appeared to be in fair to poor condition. The single-pane design of the majority of the window units offers limited thermal insulation. Onsite personnel had mentioned the windows had been an ongoing comfort issue along with having operation problems and their RUL we recommend replacing the units early in the study period to match the newer aluminum framed units. The perimeter sealant was starting to deteriorate with surface cracking present in various locations. Therefore with a typical EUL of fifteen-years for exterior sealant we anticipate replacement will be necessary mid-term in the study period with a suitable polyurethane sealant.

Closer view of the metal framed windows which will soon need replacing.

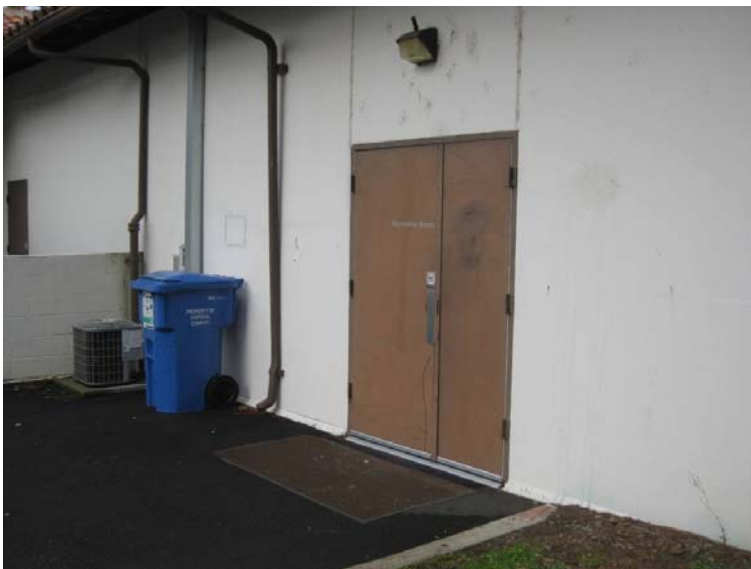
**Photograph No. 12**

The hollow metal doors appeared to be in fair to good condition with no observed issues noted. There is no anticipated requirement for replacement of the doors during the study period. The operation of the swing doors were satisfactory and operated without any difficulty. Repainting along with the exterior elevation repainting works will be necessary to the other previously painted doors.

View of a double hollow metal door. Door is stained and needs repainting. Also shows exterior wall pack light.

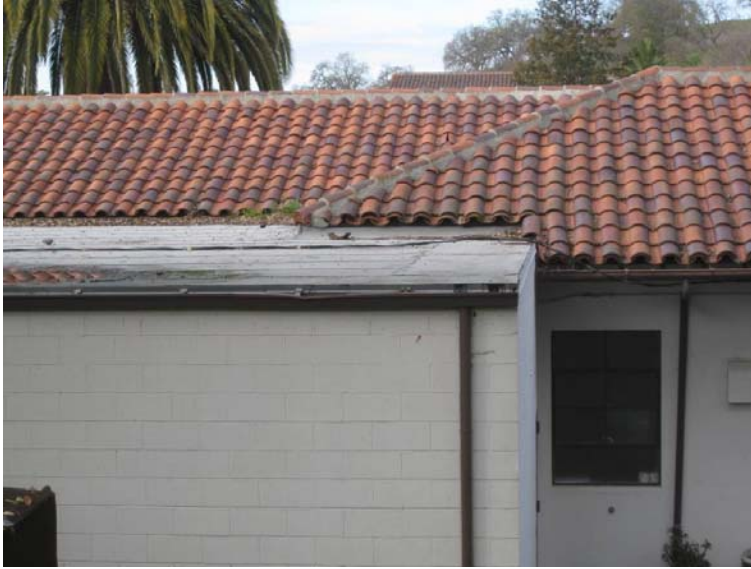
**Photograph No. 13**

The steep-sloped roof area 1(reference Photograph 13 in Appendix B) contained a clay barrel tile roofing system set on a tile battens and waterproof membrane. We are unaware of any insulation present. The low-sloped roof areas 2, 3, and 4 (reference Photograph 13 in Appendix B) contained an asphalt roll roofing system placed directly over the roof deck. The age of the roof covering systems are unknown, however we estimate them to be approximately twenty-years old.

The clay roof tile covering appeared to be in fair to good condition. We understand that the clay roof tile covering is approximately twenty-years old and based on the typical EUL of fifty-years replacement is not anticipated during the cost study period. However we do recommend removing the roof tile and replacing the moisture barrier mid-term in the study period. The asphalt roll roofing appeared to be in fair to good condition. We understand that the asphalt roll roof covering is

approximately twenty-years old and based on the typical EUL of forty-years replacement is anticipated during the final year of the cost study period.

View of both types of roof covering. Asphalt roll on the flat roof and 'Spanish' tiles cover the pitched roof. Also shows gutters and downspouts.

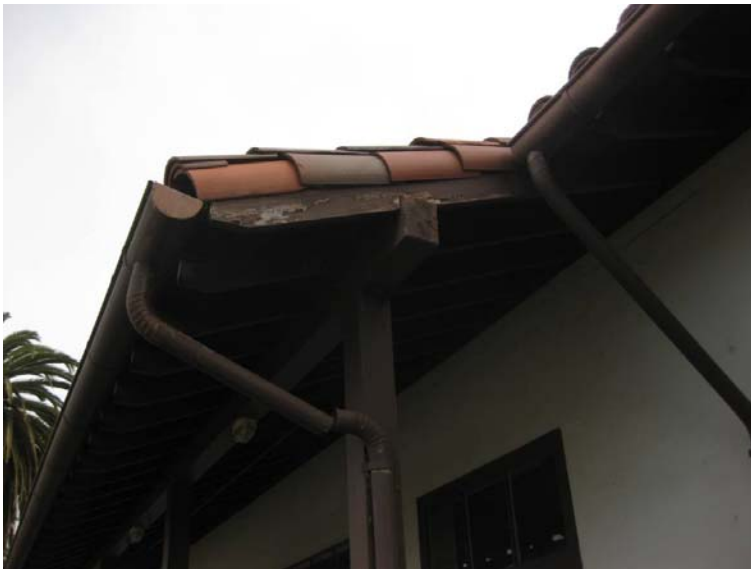
**Photograph No. 14**

The roof appears to drain well with adequate slope at all areas to allow water to run to the drains. The gutters appeared to be free from debris, adequately sized and spaced properly. We did notice that one of the downspouts had become detached from the gutter at the front entrance to the building (reference Photograph 14 in Appendix B). We do not anticipate a full replacement; however recommend the gutters are maintained on a regular basis to ensure they are free from debris and working properly.

View of an unconnected downpipe. Also shows weathered fascia board that needs repainting.

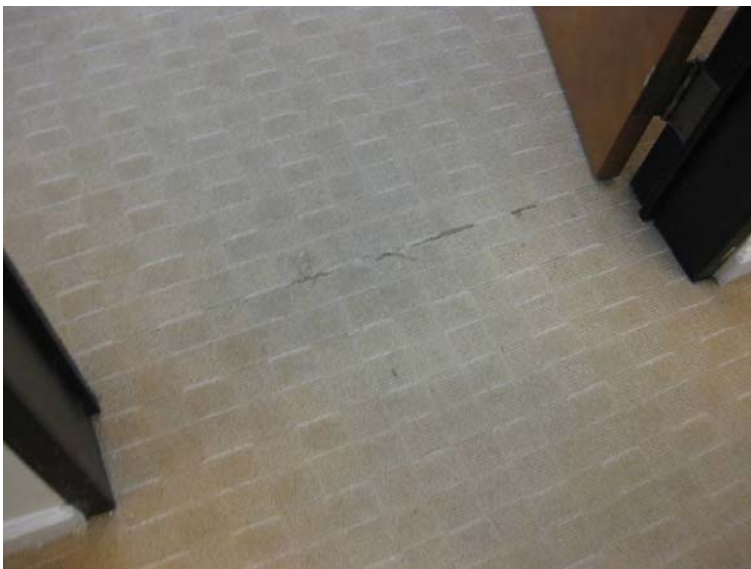
**Photograph No. 24**

We noted sheet carpet generally throughout all areas of the hallways and offices (reference Photograph 24 in Appendix B).

View of the sheet carpet floor finish. Carpet here is becoming detached at the seam.

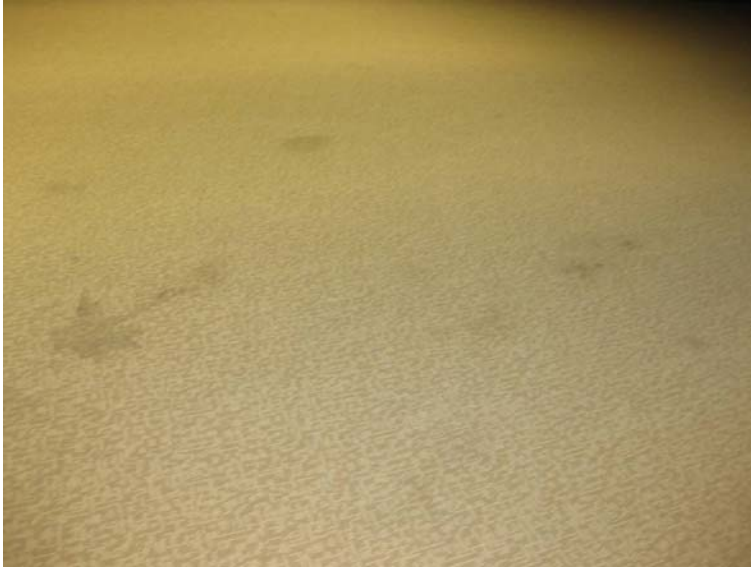
**Photograph No. 25**

View of the stained carpet in the large conference room.

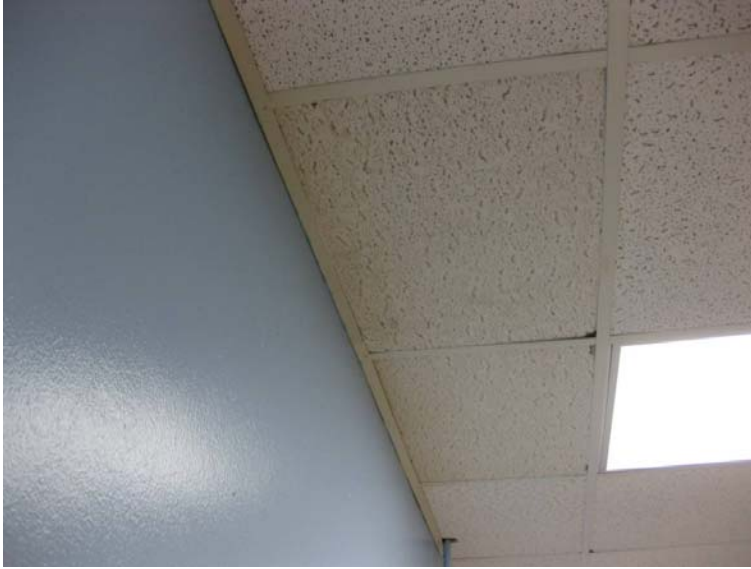
**Photograph No. 28**

View of some stained acoustic ceiling tiles that need replacing.

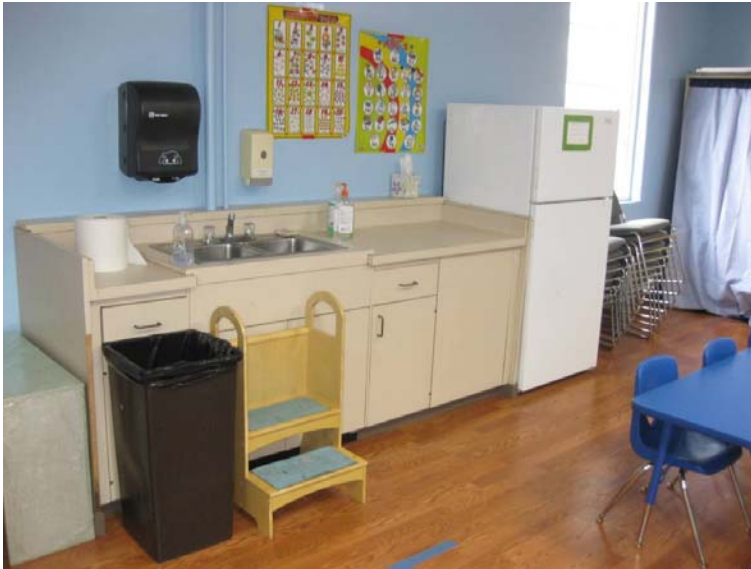
**Photograph No. 47**

View of a dated fixed wooden cabinet which will soon need replacing. Also shows countertop double stainless steel sink.

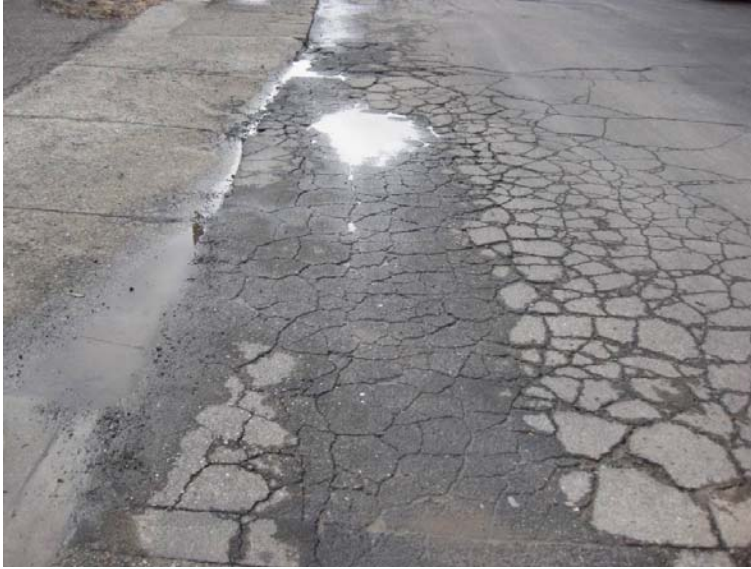
**Photograph No. 50**

View of the deteriorated asphalt.

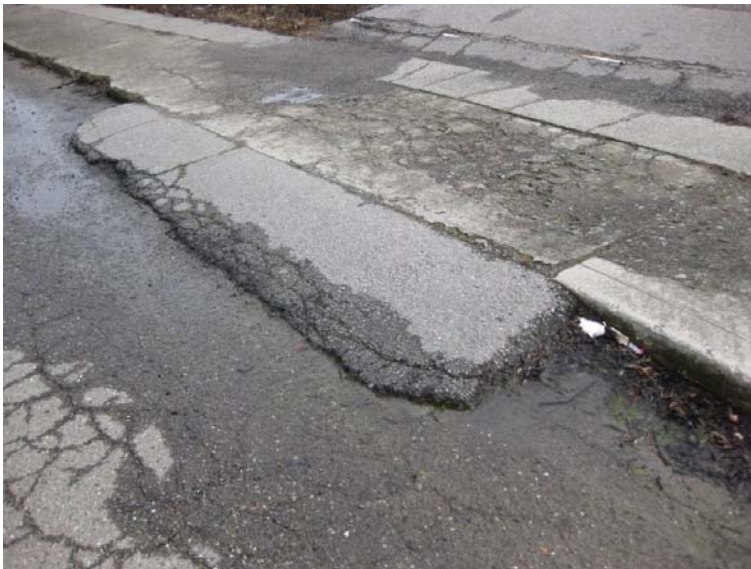
**Photograph No. 51**

A further view of the deteriorated asphalt.
