Citywide
Facility Condition Assessment

Report of
Facility Condition Assessment

For
City of Novato
Hamilton Firehouse
555 Hangar Avenue, Novato, CA

March 4, 2013

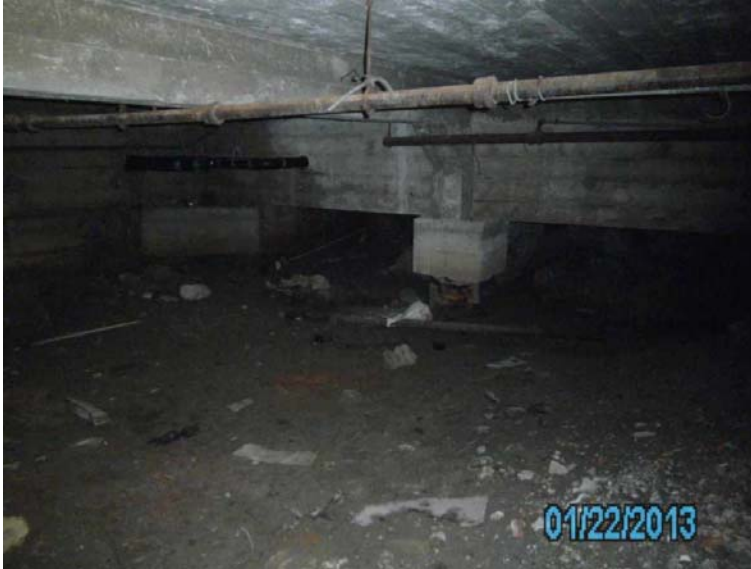
Photograph No. 1

The structure, we noted as cast in place concrete walls which we assume are all supported via the foundation system. Based on the sizing, type and anticipated loads of these wall systems and our visual observation of geotechnical conditions, we anticipate that they are all founded on a series of mild-steel reinforced cast-in-place concrete isolated, wall, and grade beam footings (reference Photograph 1 in Appendix B).

The footings are not visible due to their location below the exterior wall construction. However the foundation systems appeared to be in good condition, with no evidence of overloading or failure noted. We do not anticipate any works within the twenty-year study period.

View of the an isolated concrete footing and grade beam supporting the floor construction.

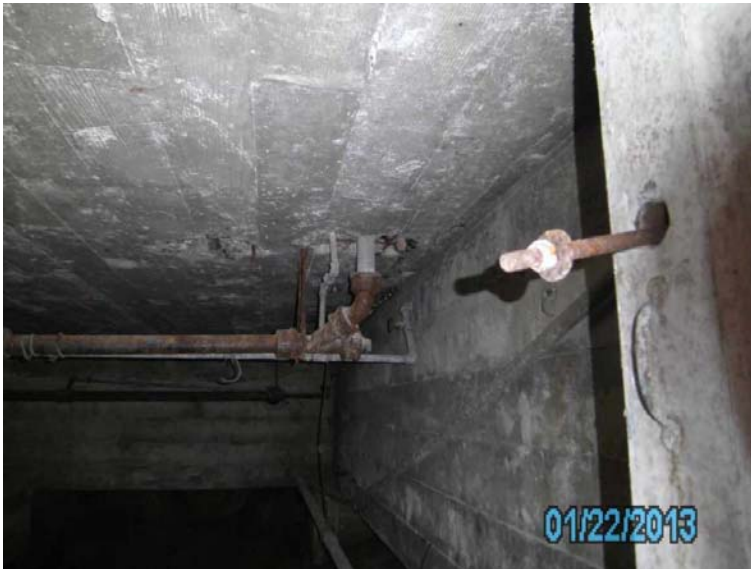
Photograph No. 2

The floor slab appeared to be in poor to fair condition. We noted uneven areas within the concrete floor slab in the area previously used as the main bay area for the firetrucks. It is unknown whether the slab was intended to be in this configuration to allow for proper drainage when washing the fire trucks, whether the weight of the fire trucks had anything to do with the uneven slab. The inspection was limited due to the existing floor finishes.

View of the concrete floor construction.

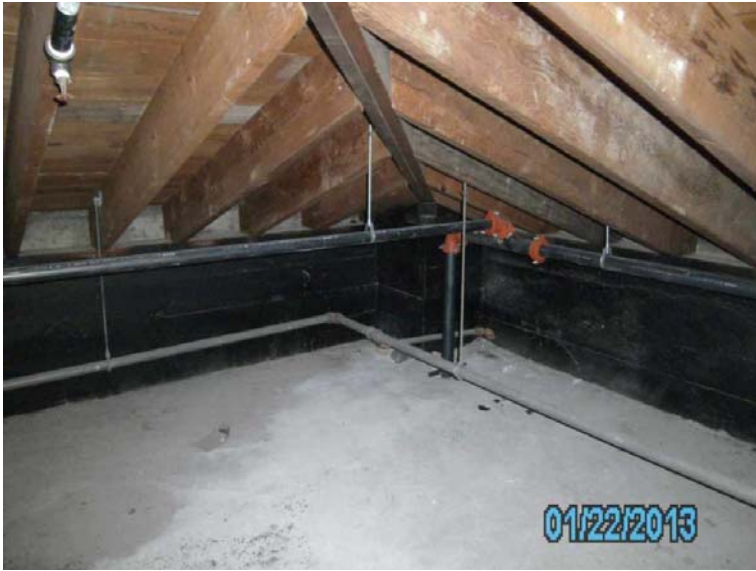
Photograph No. 4

The roof above the majority of the building consisted of pitched roof assembly of wood rafters, joist and purlins, which span various directions (reference Photograph 4 in Appendix B). The roof construction is supported via the exterior wall, various sizes of wood framing and posts providing mid-frame support. The wood deck was replaced in the year 2000.

The pitched roof construction appeared to be in fair condition. There were no visible signs of failure noted. We do not anticipate any expenditure during the cost study period.

View of the timber roof construction and pendant sprinkler head system which is present throughout the building.

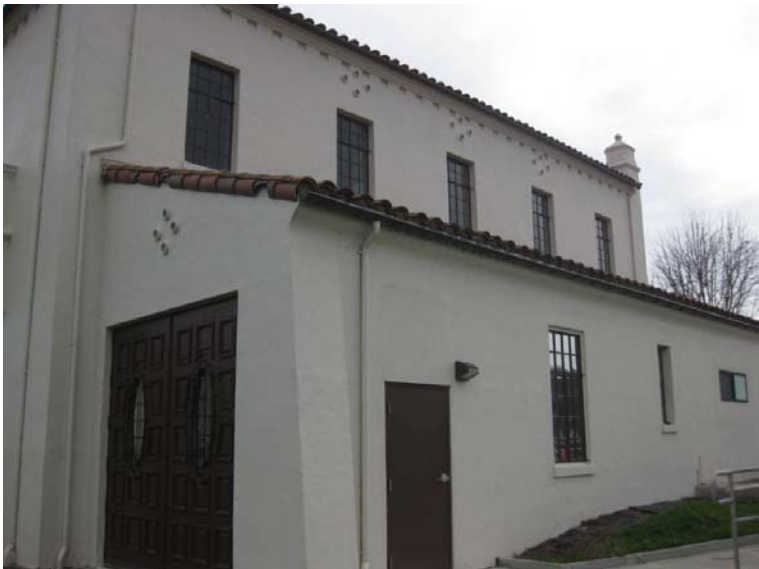
Photograph No. 6

The structure of the building was noted to be of a cast-in-place reinforced concrete structural frame (reference Photograph 6 in Appendix B).

The firehouse building was enclosed with an approximately 12" thick cast in place concrete walls which contained a smooth finished stucco surface (reference Photograph 6 in Appendix B). At high level we noted a decorative indented detail just below the fascia as well as circular attic ventilation.

The building contained single and double hollow metal doors and frames at the perimeter (reference Photograph 6 in Appendix B), mainly at the east and west elevations. Door hardware consisted of lever handles, with emergency push bars at the interior as well as self closing devices. The east elevation contained 4 double hung decorative wooden doors (reference Photograph 12 in Appendix B) that were recently installed to match the previous firehouse doors. The building manager noted that they were constructed in Mexico at a cost of \$5,000 per door.

The exterior wall system construction and stucco surface appeared to be in fair to good condition. We understand that the stucco walls were last painted two-years ago and therefore based on their current observed condition and the typical EUL of eight-years repainting of the painted surfaces are recommended early in the study period and then every eight-years after to maintain the exterior appearance of the building.

View of the exterior cast-in-place concrete walls forming the structural frame. The walls have a stucco finish. Also shows single painted hollow metal door and double wood carved door.

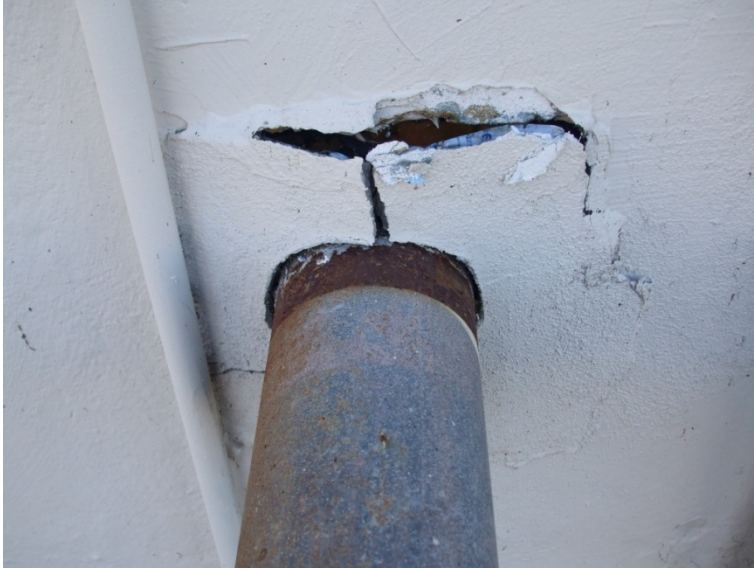
Photograph No. 7

We noted sections of the exterior walls on the west side that were reconfigured which the in-fill had contracted causing an uneven surface and cracking and also around a fire sprinkler supply line located at the south east corner of the building (reference Photograph 7 in Appendix B). We suggest that the cracks and stucco texture be repaired before starting repainting repair work.

View of a cracked section of stucco surrounding the pipe.

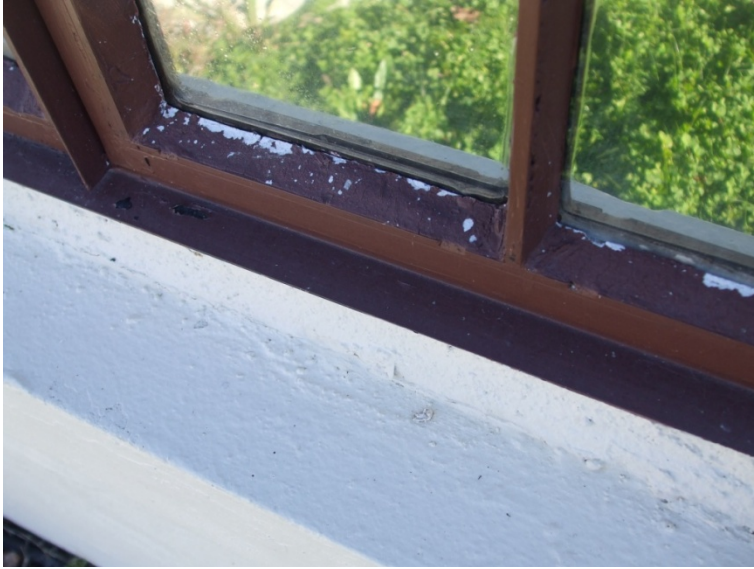
Photograph No. 11

The exterior window units appeared to be in fair condition. We assume they are part of the original construction and date back to 1930's. Metal windows have a typical EUL of fifty-years; therefore replacement would fall within the twenty-year study period. However being that this building has historic value we do not recommend full replacement during the twenty-year study period. We noted that the caulking is in fair to poor condition. We estimate that the sealant will reach its EUL in seven-years and will need to be replaced with a suitable polyurethane sealant. Typically painting the windows would coincide with the exterior painting, however the window frames are currently deteriorated and require re-painting to maintain the exterior appearance of the building (reference Photograph 11 in Appendix B).

View of the painted metal framed window unit and deteriorated putty.

| Element No. | Building Element | Recommendation | Qty | Unit | Rate | Cost | Year | Priority Code |
|---|---|--|---|---|---|---|---|---|
| B2021 | Windows | Replace sealant at perimeter of window panes | 828 | LF | \$11.25 | \$9,315 | 2013 | 3 |

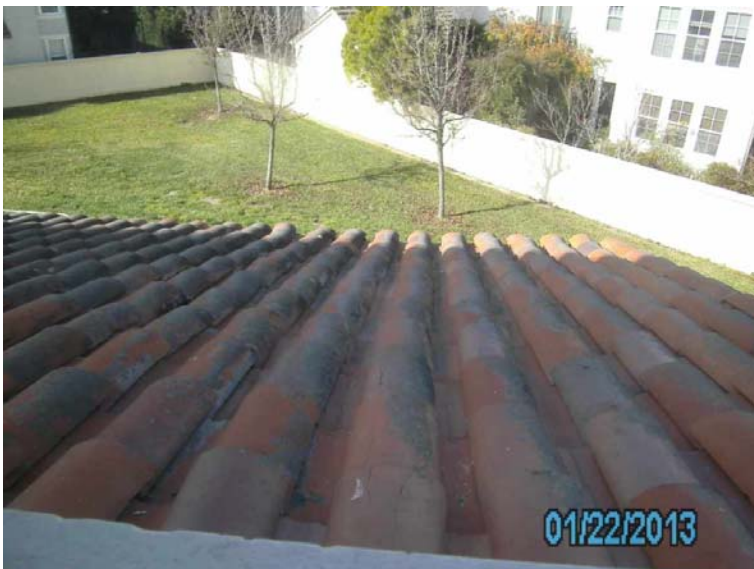
Photograph No. 13

The steep-sloped roof areas 1 through 3 contained a tapered, semicylindrical roofing tile laid convex side up to overlap flanking, similar tiles laid concave side up (reference Photographs 6, 13 and 14 in Appendix B). The age of the roof covering systems are unknown, however we estimate them to be over fifty-years old.

View of the double lap clay tile roof covering.

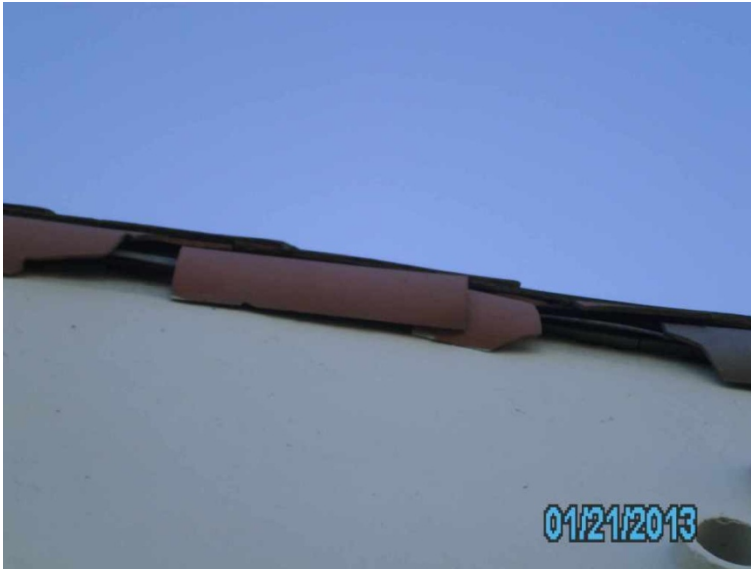
Photograph No. 14

The clay tile roof covering appeared to be in fair condition at each of the roof areas, with no roof leaks reported. We understand that the clay roof tile covering is approximately fifty-years. The roof tiles however were removed in the year 2000 to install a new water proof membrane and then reinstalled. We do not expect any expenditure to the roof covering during the twenty year study period.

View of cracked/missing roof tiles.

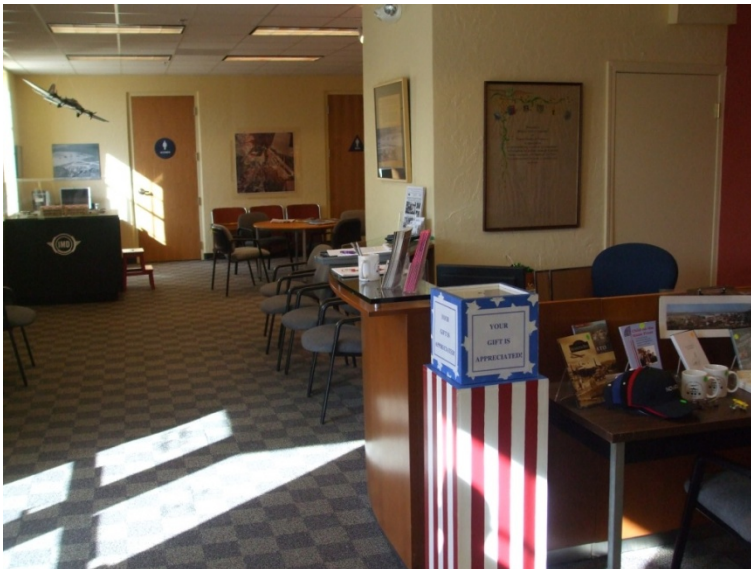
Photograph No. 15

We noted 3' X 3' unbonded carpet squares throughout the lobby as well as the main museum display areas (reference Photograph 15 in Appendix B).

The carpet floor coverings appeared to be in good condition. We understand that the carpet which is present generally throughout the lobby and museum building is two-years old and therefore with a typical EUL of ten-years replacement is recommended mid and late term in the study period.

View of the lobby. Shows carpet tile floor and stud walls with rough plaster finish.

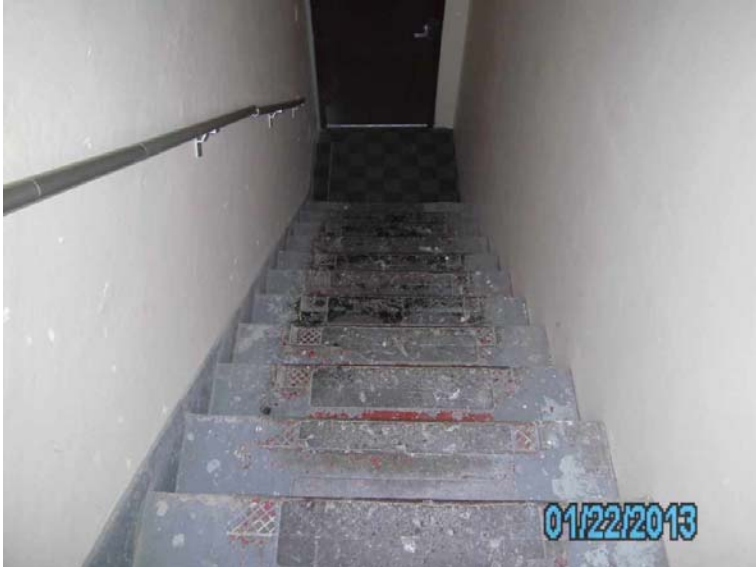
Photograph No. 17

The staircases appeared to be in a fair condition with no issues reported or identified. We do not anticipate any actions in association with the staircases during the study period.

View of the interior concrete staircase leading to upper level.

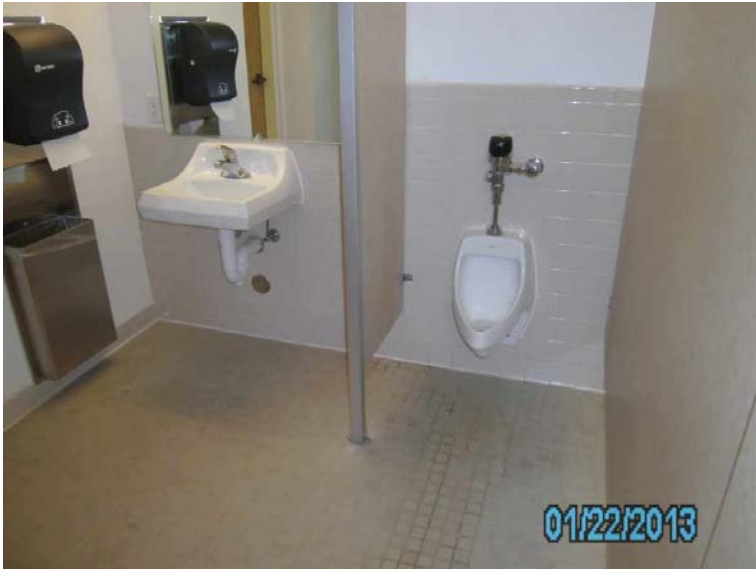
Photograph No. 18

The ceramic wall tiles and grout appeared to be in good condition with no issues noted. We anticipate that the ceramic wall tiles will last beyond the study period however we do recommend re-grouting the ceramic wall tile along with the ceramic floor tile later in the study period to maintain its appearance.

The ceramic tile flooring appeared to be in good condition. Ceramic tile flooring has a typical EUL of thirty-years and therefore based on the EUL and observed conditions the ceramic tile flooring will last beyond the study period without replacement necessary. However we do recommend re-grouting the ceramic floor tile late in the study period to maintain its appearance.

View of the ceramic floor and wall tile finishes in the men's restroom. Also shows the vitreous china wall mounted urinal and lavatory.

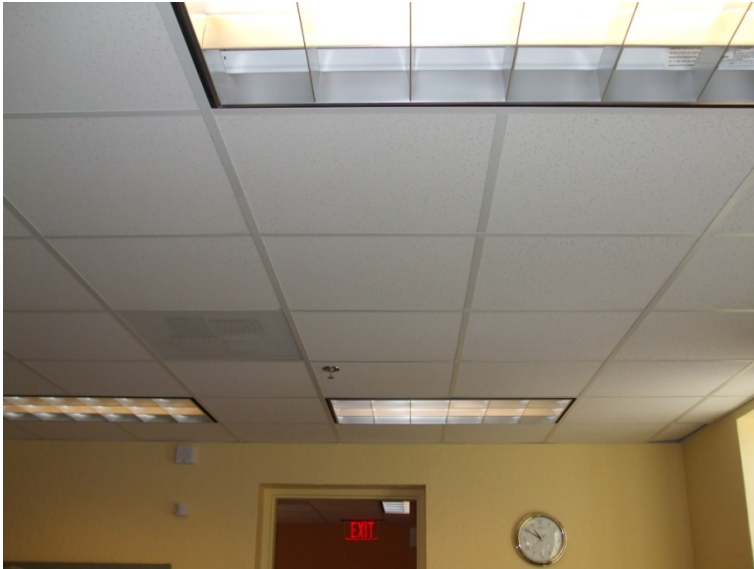
Photograph No. 20

The suspended ceiling systems appeared to be in fair to good condition overall. We do not anticipate a requirement for its replacement during the study period.

View of the 2' x 2' suspended ceiling system. Also shows 2' x 4' recessed light fixtures.
