Citywide
Facility Condition Assessment

Report of
Facility Condition Assessment

For
City of Novato
Hamilton Gym & Bowling Alley
115 San Pablo Avenue, Novato, CA

March 4, 2013

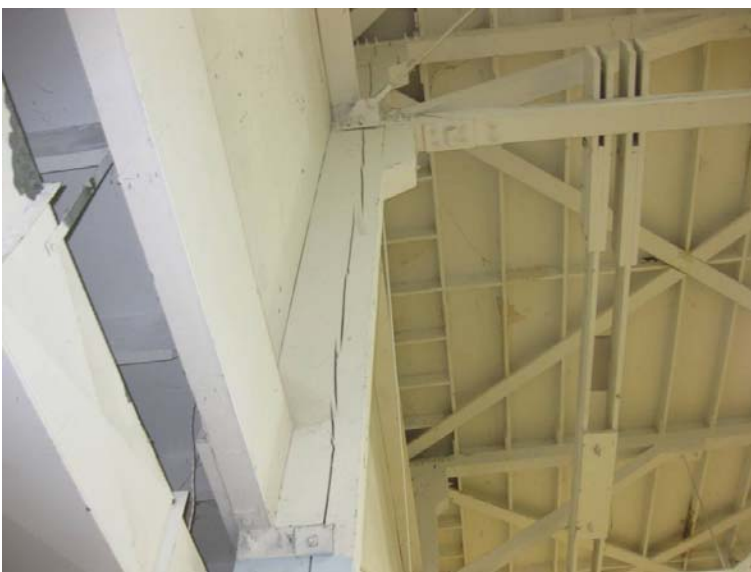
Photograph No. 6

The wood framed structure appeared to be in fair to poor condition. We noted multiple columns in the basketball court area that had splits and cracks running nearly the entire length of the columns (reference Photographs 6 and 7 in Appendix B). We recommend appointing a qualified structural engineer to undertake a structural review of the issues noted to

establish the likely cause of the cracking to the wood columns. We have not allowed for any repair work in association to this as we don't know the extent of the problem. However we have included for the likely cost of appointing a structural engineer.

View of a large vertical crack in wood column.

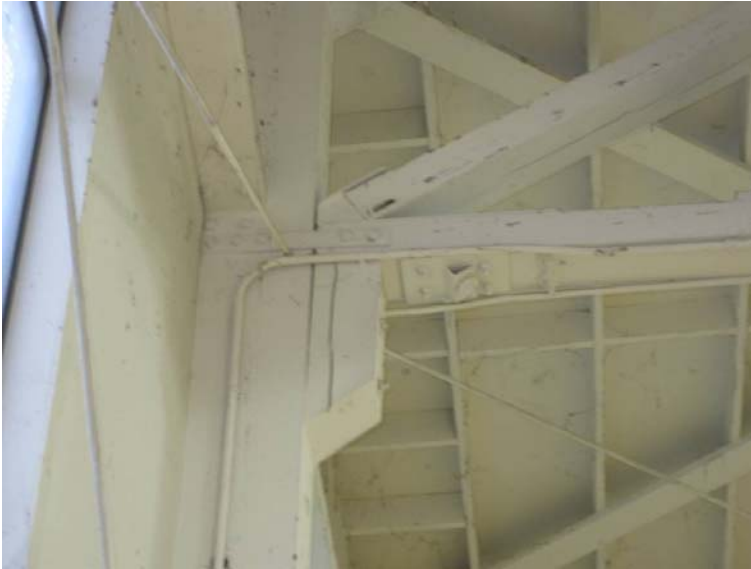
Photograph No. 7

View of another crack in a wood column.

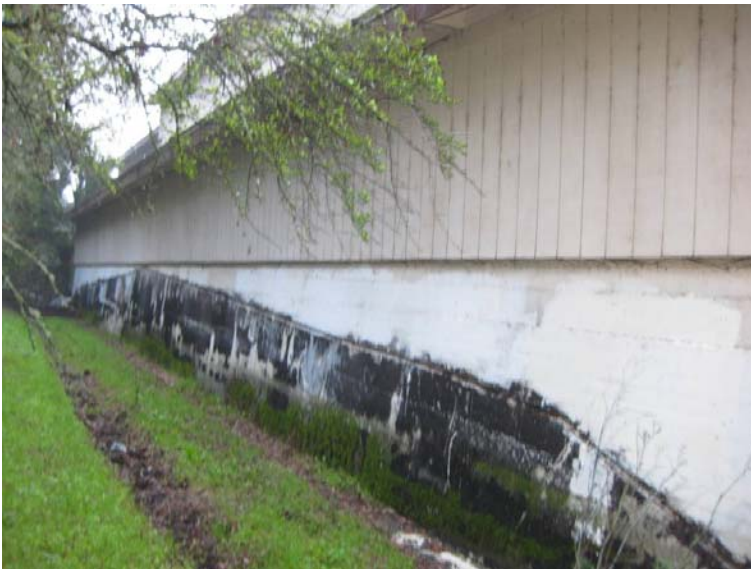
Photograph No. 8

View of the build up of vegetation on lower part of wall.

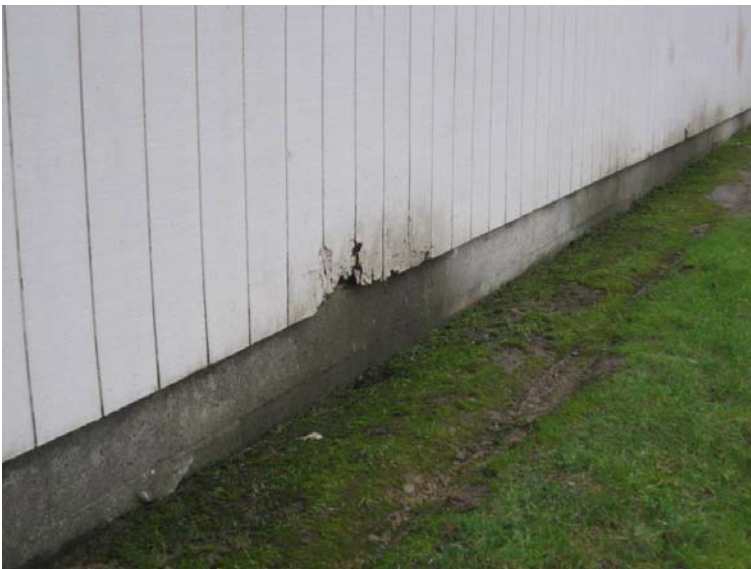
Photograph No. 9

The exterior wall system construction and wood surface appeared to be in fair condition. With a typical EUL of twenty-years for wood panel exterior walls we believe that these panels have exceeded their useful life. We do not anticipate a full replacement however we do recommend replacing the section at the lower areas of the wall that has been damaged by water or other elements early in the study period (reference Photograph 9 in Appendix B

Shows deteriorated parts of the wood siding.

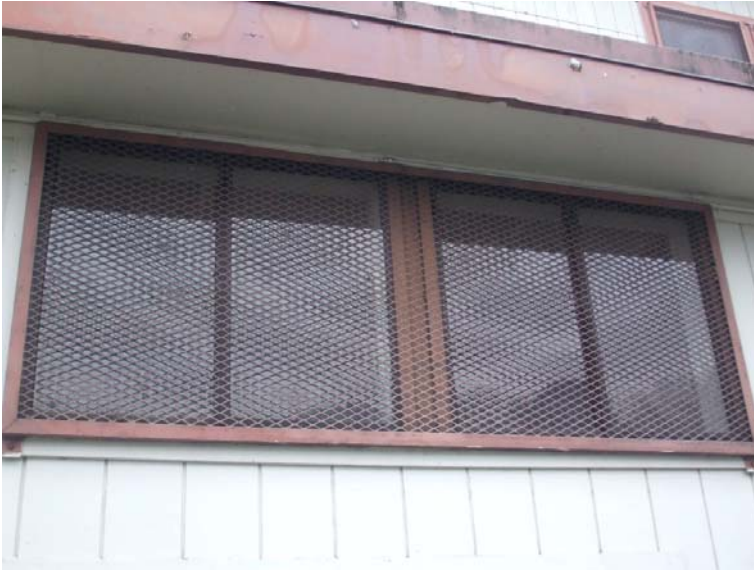
Photograph No. 10

At the north elevations there were fixed steel windows with single pane glazing (reference Photograph 10 in Appendix B). The windows had steel mesh on the exterior believed to be used for security measures. We noted some newer aluminum framed windows at the west side of the building which appears to be the main entrance to the bowling alley (reference Photograph 11 in Appendix C).

The exterior window units appeared to be in fair to poor condition. The window units appeared to be original to the building which would put them beyond their useful life. Replacement is recommended for the single pane window units based on observed condition and industry standards early in the study period. At the time when the window units are scheduled to be replaced, we recommend they are replaced with more efficient dual pane windows in aluminum frames.

View of a painted metal framed window with mesh surround.

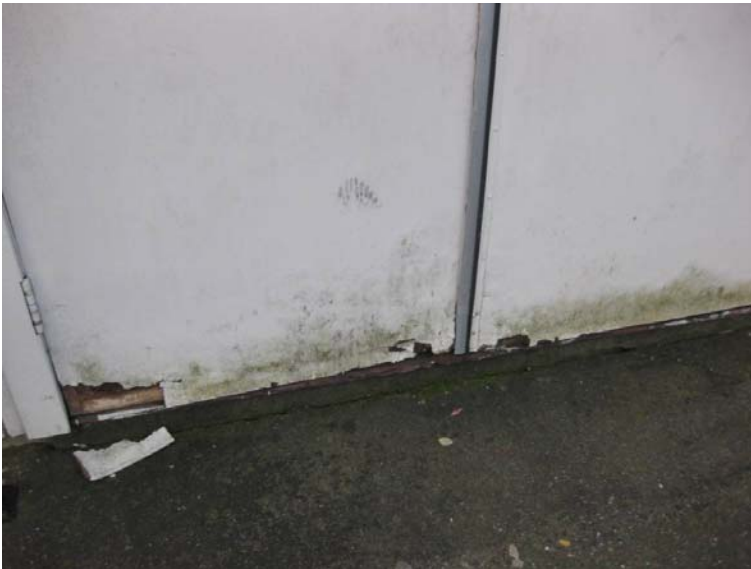
Photograph No. 14

The solid wood doors appeared to be in poor condition. We observed areas of deterioration and rot along the bottom portions of the doors (reference Photograph 14 in Appendix B). We anticipated a requirement for full replacement during the study period. At the time of replacement we recommend that these doors be painted to ensure all sides are sealed from the elements.

View of deterioration on the door.

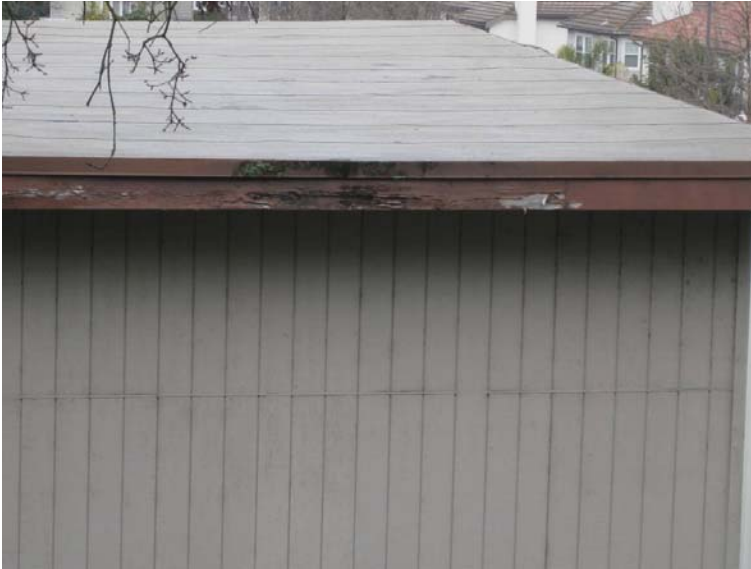
Photograph No. 16

We noted sections of the fascia at all elevations have started to deteriorate with peeling and blistering paint (reference Photographs 16 and 17 in Appendix B). We recommend repainting during the first year of the study period and at a cyclical basis every eight years after that.

View of the wood shingle roof covering. Also shows worn fascia board.

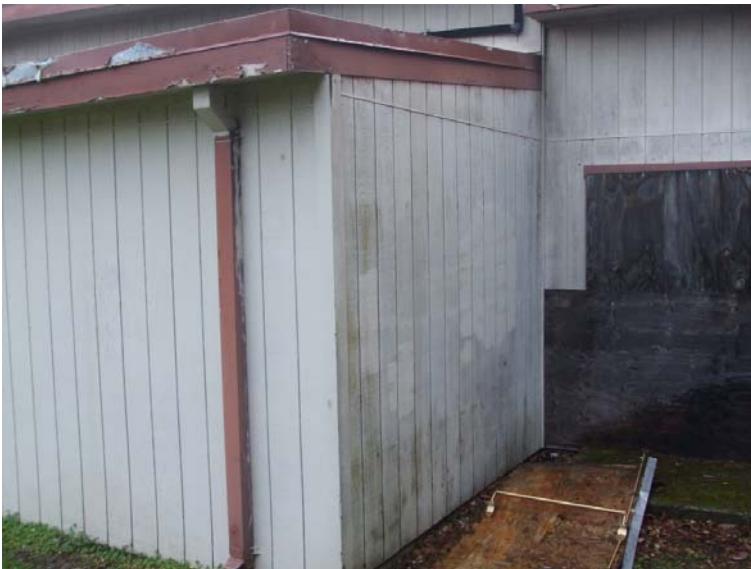
Photograph No. 17

Further view of deterioration to the fascia board and vertical board siding.

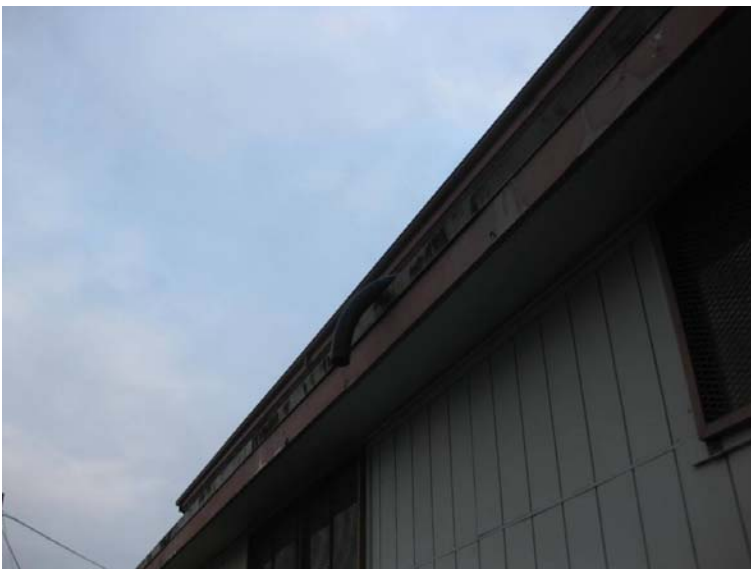
Photograph No. 18

The roof levels each drain to perimeter gutters which either drain over the edge to the lower roof level, or to the ground. This building does not have any downspouts, only flexible tubing which is hung over the perimeter edges (reference Photograph 18 in Appendix B).

View of a loose drainage pipe on the lower section of the flat roof.

The roof appears to drain well with adequate slope at all areas to allow water to run to the perimeter gutters. We recommend however installing downspouts that will lead all the way down to the ground level and away from the building to reduce further erosion from the buildings foundation.

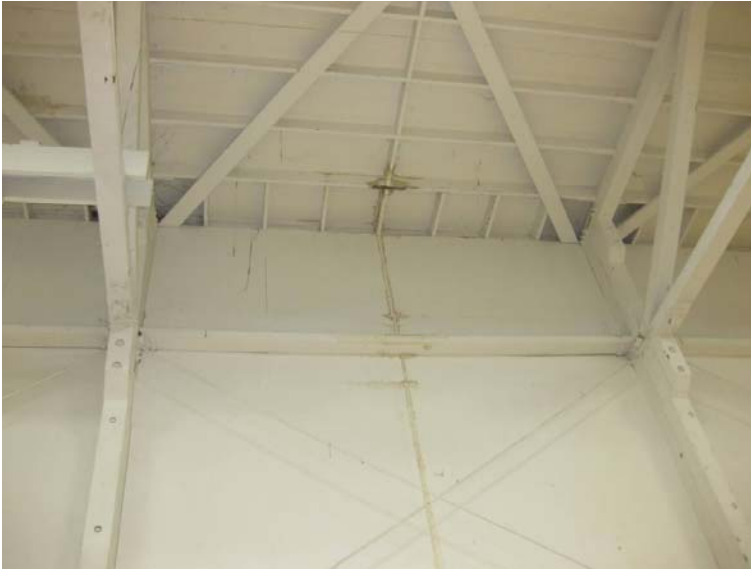
Photograph No. 19

The asphalt roof covering appeared to be in poor condition at each of the roof areas, with roof leaks reported and evidence of water intrusion on the interior of the building (reference Photograph 19 in Appendix B). We were instructed not to get on the roof by our escort however we did obtain a visual inspection by hiking up the hill neighboring the building. We understand that the asphalt covering is approximately twenty-years old and based on the typical EUL of twenty-years and as the roof covering has now started to show deficiencies and repairs are now more regularly necessary, we recommend replacement early in the study period.

View of evidence of a small amount of water ingress through the roof in the main hall.

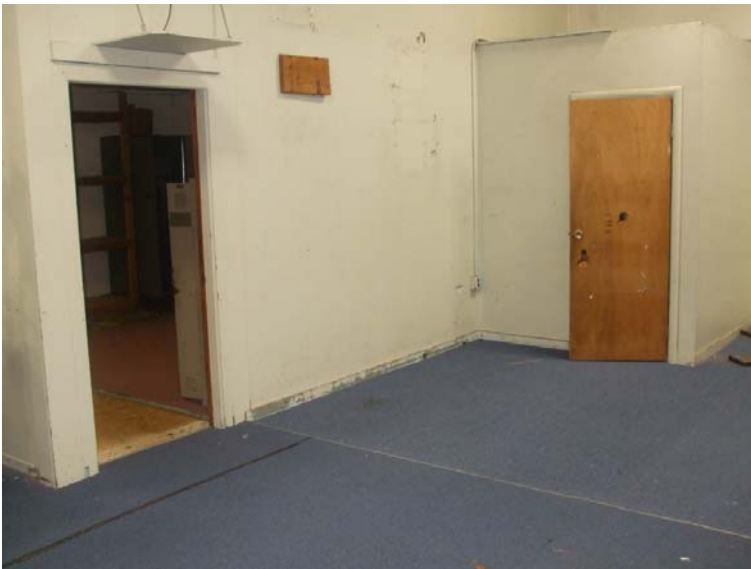
Photograph No. 20

View of fixed gypsum board on stud wall partitions. Also shows carpet which is worn and needs replacing.

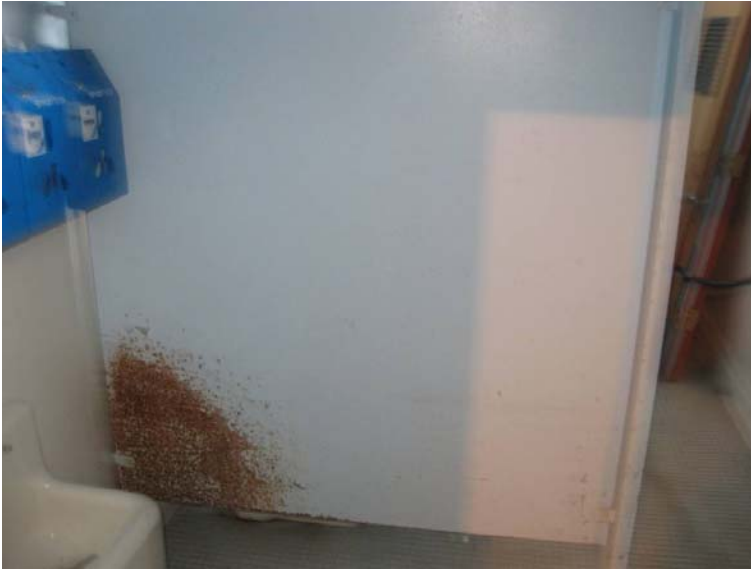
Photograph No. 22

View of a stained and deteriorated toilet partition.

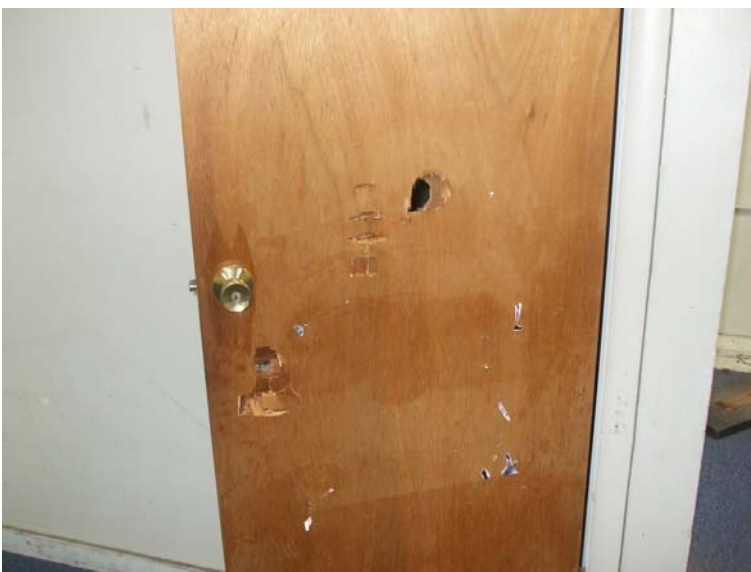
Photograph No. 24

View of another single wood door that is deteriorated and needs replacing. Also shows painted gypsum board wall finish.

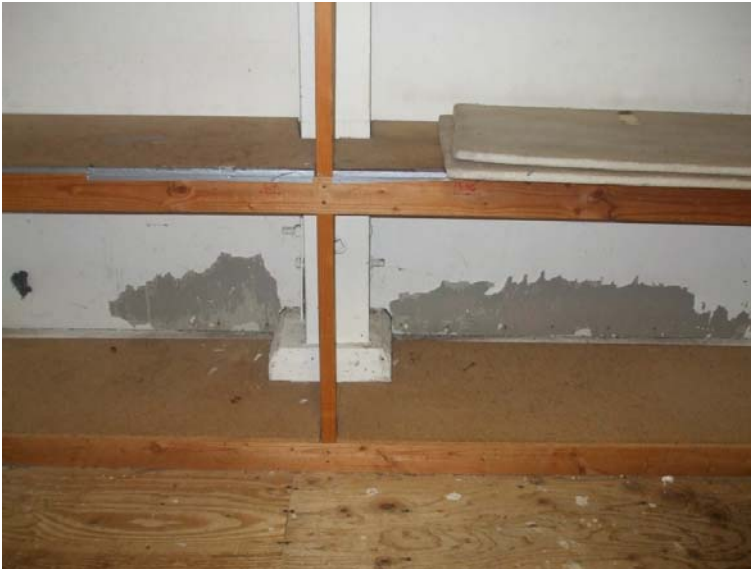
Photograph No. 26

View of deteriorated paintwork in weight room.

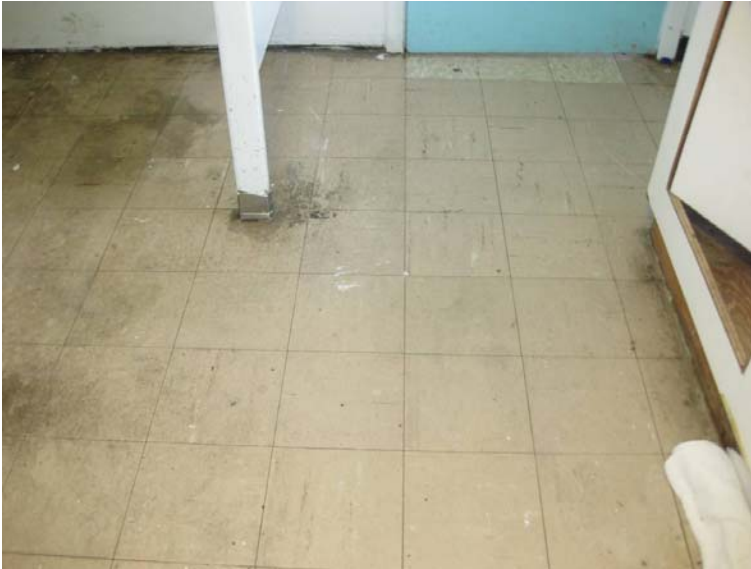
Photograph No. 28

View of deteriorated VCT floor in men's restroom.

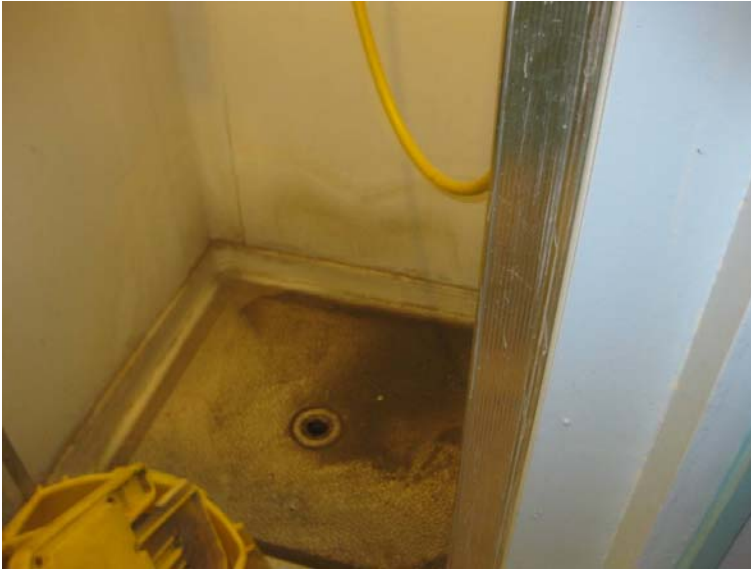
Photograph No. 34

View of a stained shower unit.

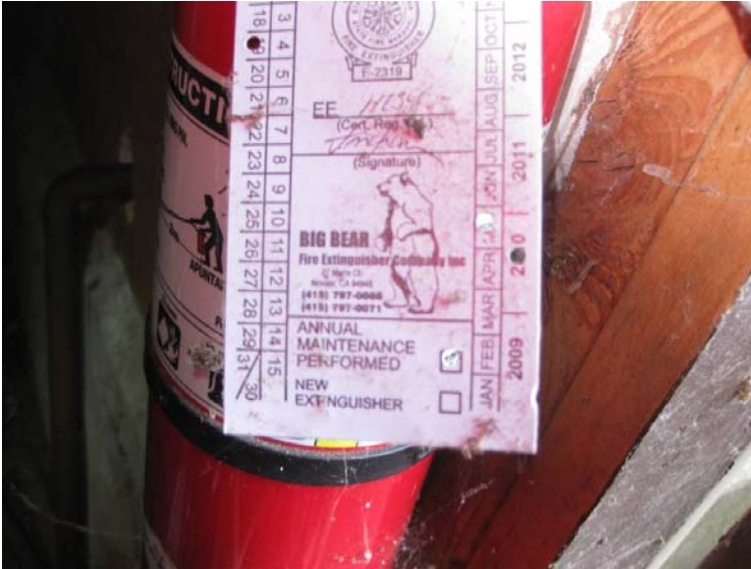
Photograph No. 40

View of a fire extinguisher in mechanical room, inspection tag is out of date.

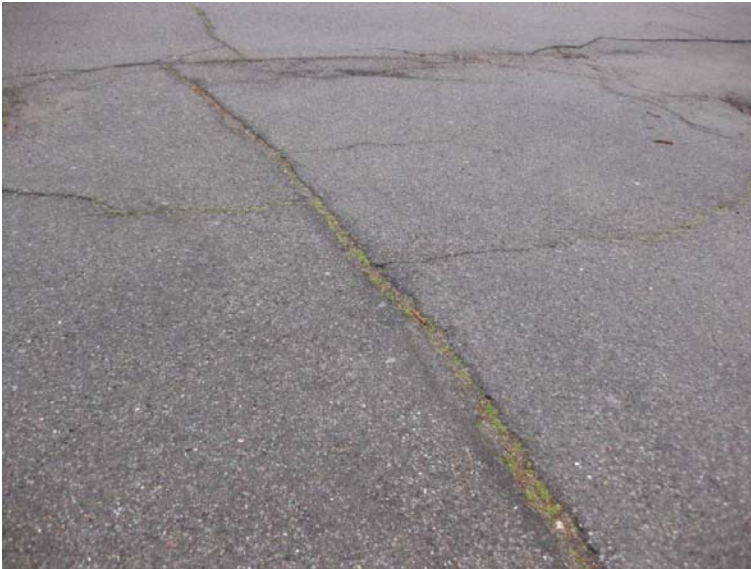
Photograph No. 50

View of cracking in asphalt.
