Citywide  
Facility Condition Assessment

Report of  
Facility Condition Assessment

For  
City of Novato  
Hamilton Pool & Bath House and Pool Pump Building  
203 El Bonito Drive, Novato, CA

*March 4, 2013*

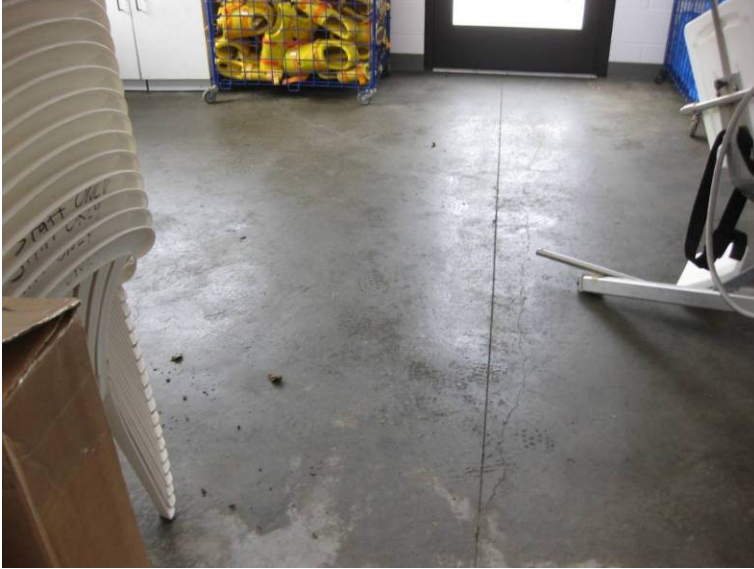
#### Photograph No. 1

Both buildings consisted of cast-in-place concrete slab-on-grade, (reference Photographs 1 and 26 in Appendix B) reinforced with welded wire fabric and supported via concrete strip foundations. The floor slabs were placed over a vapor retarder and compacted gravel fill, with the thickness of the slabs being approximately 4" thick.

View of the concrete slab-on-grade with expansion joint.

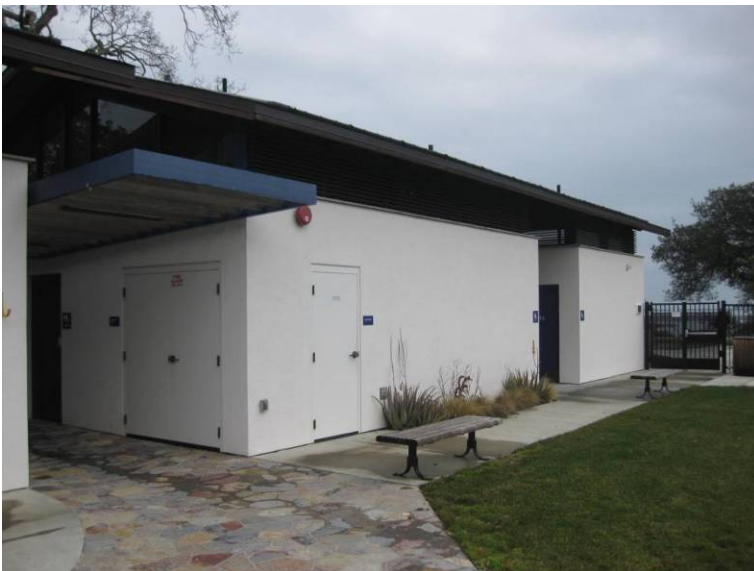
#### Photograph No. 3

The steep-sloped roof areas 1, through 4 contain asphalt shingles on a wood decking (reference Photographs 3 and 33 in Appendix B). There is no specific storm water drainage present at any of the roof levels; rain water is discharged over the edge to the ground below.

View of the steel and wood wall mounted canopy. Also shows exterior CMU wall construction with stucco finish and exterior hollow metal prefinished door surfaces. Also shows the asphalt shingle roof covering.

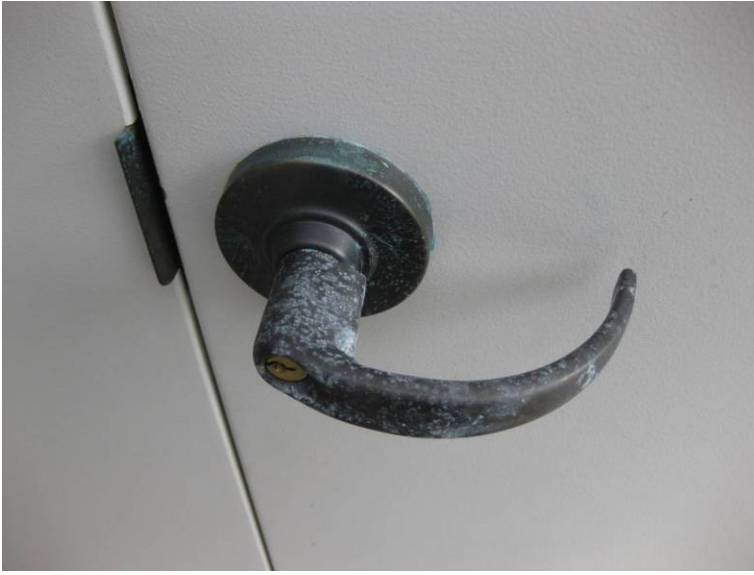
**Photograph No. 7**

View of the corroded door hardware on hollow metal doors.

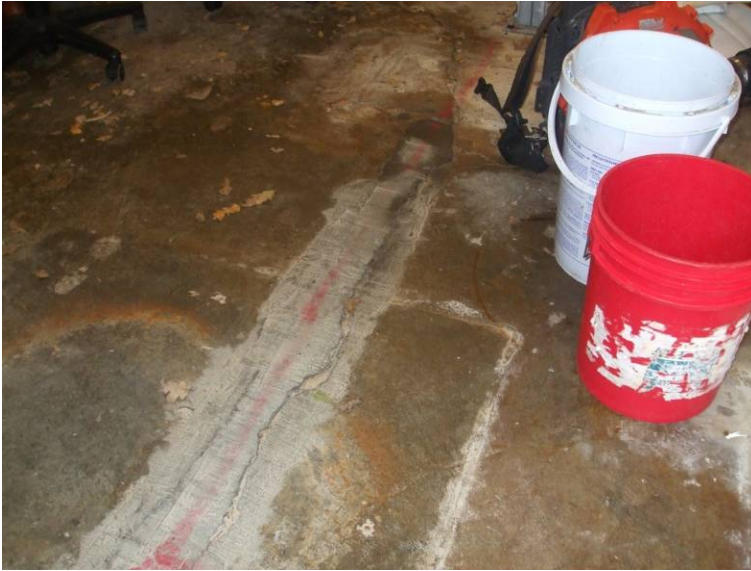
Photograph No. 26

View of the concrete slab-on-grade floor.

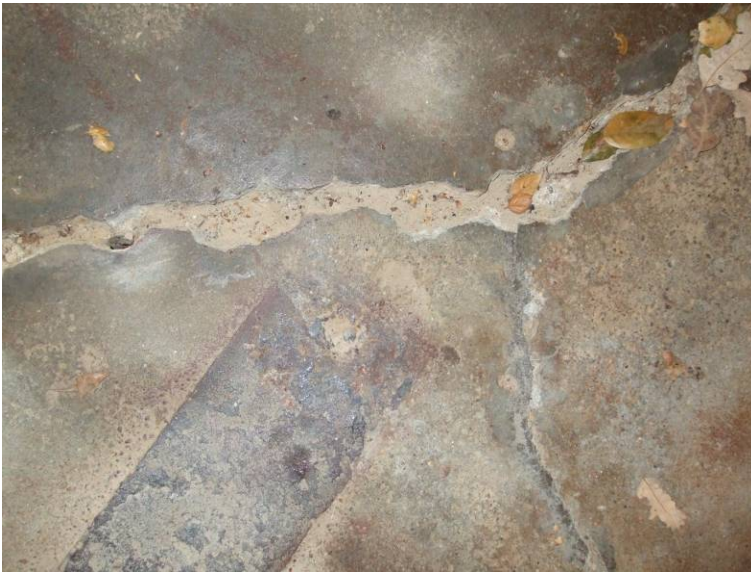
Photograph No. 27

The cast-in-place concrete slabs appeared to be in fair to good condition. We do not anticipate any expenditure during the cost study period, which relates to its replacement. However the Pool Pump Buildings slab contained cracks running throughout the slab which appear to have been previously ground down (reference Photograph 27 in Appendix B). We do not anticipate a full concrete slab replacement; however we do recommend repairing the concrete with suitable epoxy repair system. The cost of this work falls below the threshold level and therefore has not been included in the expenditures for the study period.

View of the cracking in concrete floor slab.

A Substructure: Repairing the concrete with suitable epoxy repair system at location of cracks

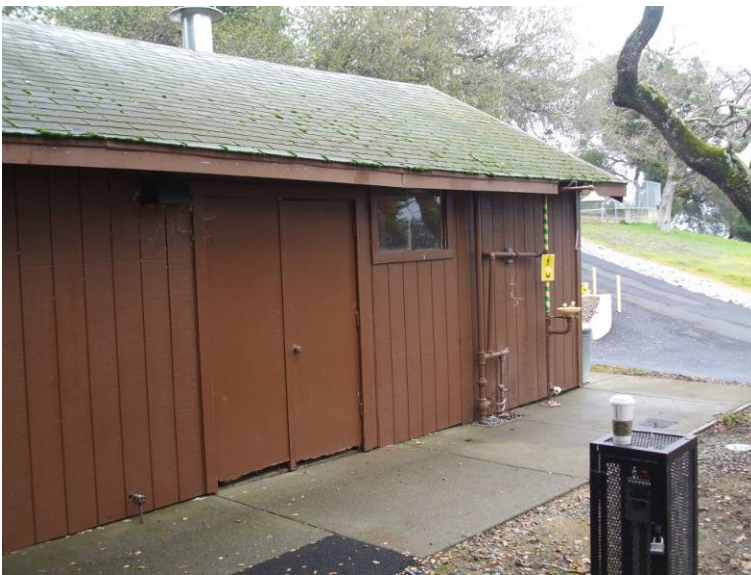
**Photograph No. 33**

View of an exterior double painted wood door. Also shows the asphalt shingle roof covering and the paving around pump house.

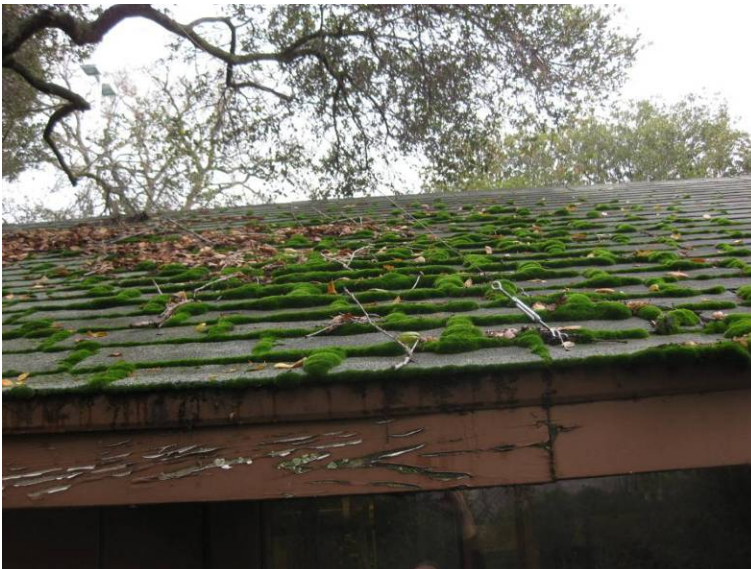
**Photograph No. 34**

View of a weathered fascia board and build up of vegetation on roof covering.

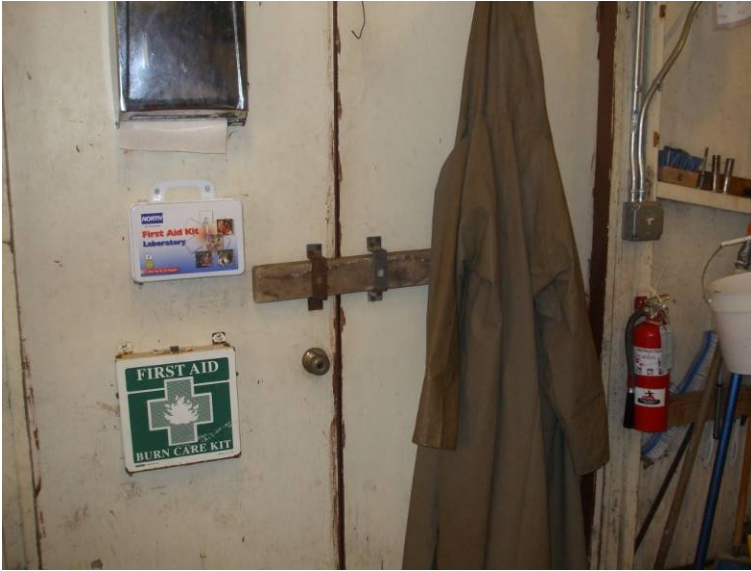
Photograph No. 35

The painted solid wood doors appeared to be in poor condition (reference Photograph 35 in Appendix B). Replacement is anticipated during the beginning portion of the study period. Repainting along with the exterior elevation repainting works will be necessary.

Interior view of the double painted wood door.

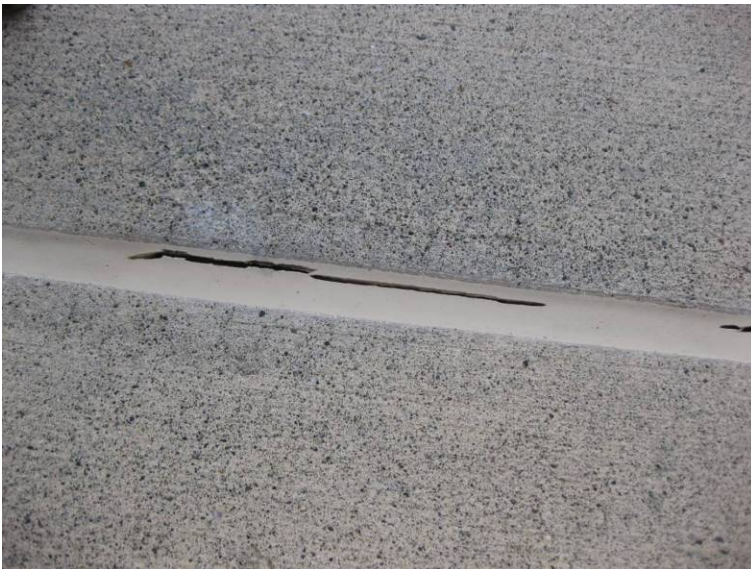
**Photograph No. 46**

View of deteriorated sealant, present between some paving slabs.

G Building Sitework: Replace sealant to paving construction joints at an estimated cost of \$11,374 in year 2025
