**Citywide
Facility Condition Assessment**

**Report of
Facility Condition Assessment**

**For
City of Novato
Lu Sutton Child Care Trailers
1800 Center Road, Novato, CA**

March 4, 2013

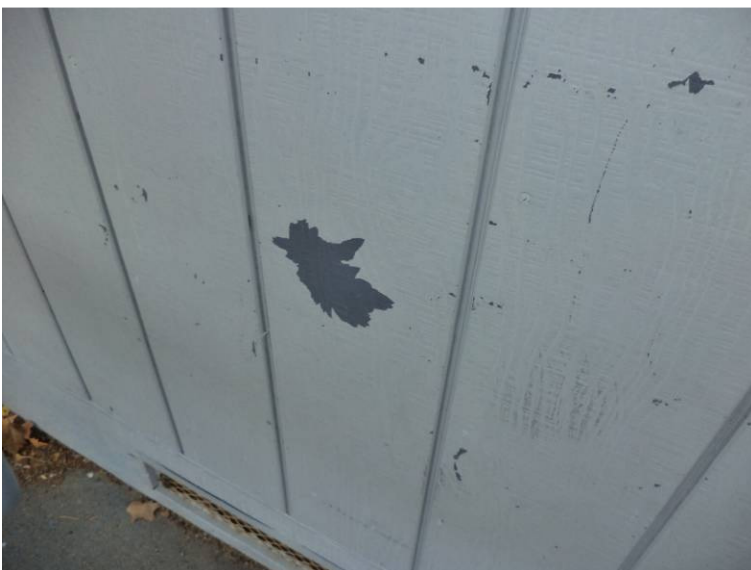
Photograph No. 3

The exterior wall systems at each of the buildings appeared to be in fair to good condition with generally no major signs of deterioration, water ingress or general failure noted. We understand that the painted finish to the vertical wood siding was last painted in year 2010; however we observed an isolated instance at the north elevation of trailer (north); a section where the painted surface has started to blister and peel (reference Photograph 3 in Appendix B). The typical EUL of the exterior paint is eight-years therefore we recommend repainting the exterior elevations at both buildings prior to mid-term and later in the study period based on repainting every eight-years. In relation to the section of blistering we recommend that this is repainted at the start of the study period; the cost of this work is anticipated to fall below the threshold level and therefore has not been included.

View of area that has blistering paint.

B Shell: Repair and repaint blistering and peeling paint at Trailer (North) in year 2013

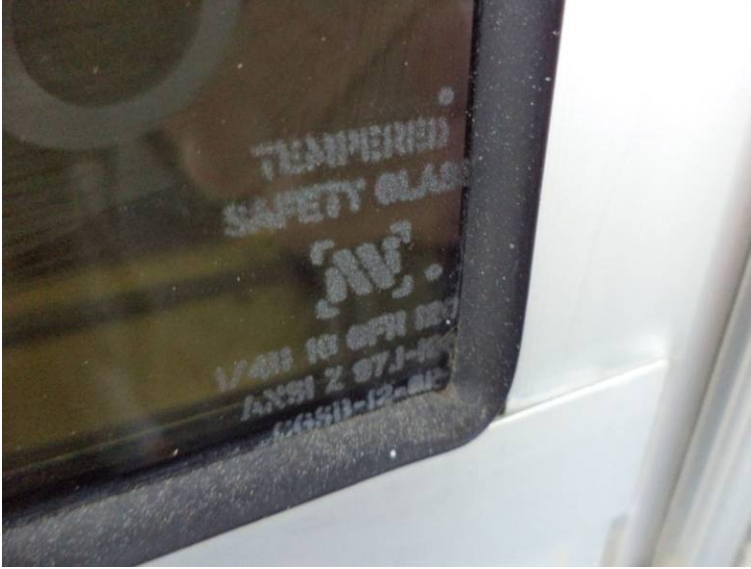
Photograph No. 4

The exterior window units appeared to be in fair condition. Not all of the windows were assessed, however overall we did not find any major deficiencies and no areas of water ingress through the system. We do not anticipate a requirement for full window replacement at this time, however based on a typical EUL of thirty-years, replacement is recommended for the window unit's mid-term, based on industry standards. At the time when the window units are scheduled to be replaced, we recommend they are re-assessed for replacement suitability.

View of the the window units.

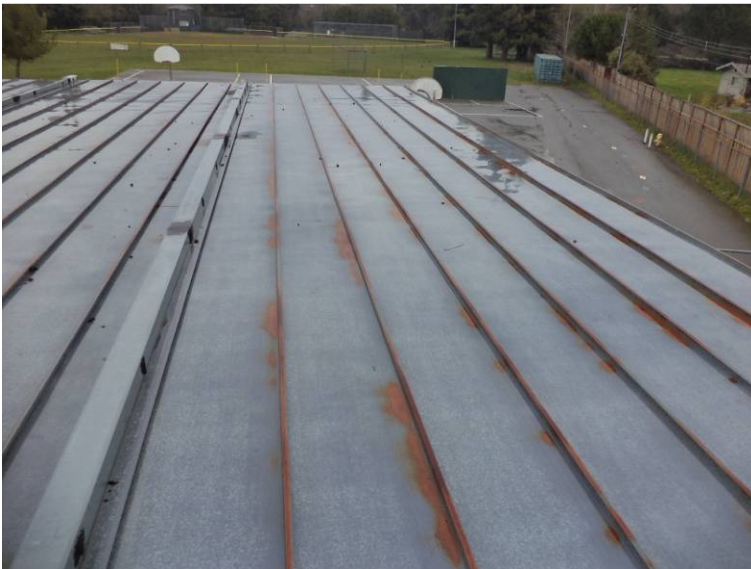
Photograph No. 6

The metal roofing systems appeared to be in fair condition, no issues of moisture penetration was observed at the time of our assessment and none were reported to us. We understand that a recent repair consisting of a new central capping was added following an issue of moisture ingress. Based on a typical EUL of thirty-years for this type of roof covering we recommend replacement is undertaken at both buildings mid-term in the study period as we assume the roof coverings are original and therefore approaching twenty-years old.

View of the roof covering and repair capping strip.

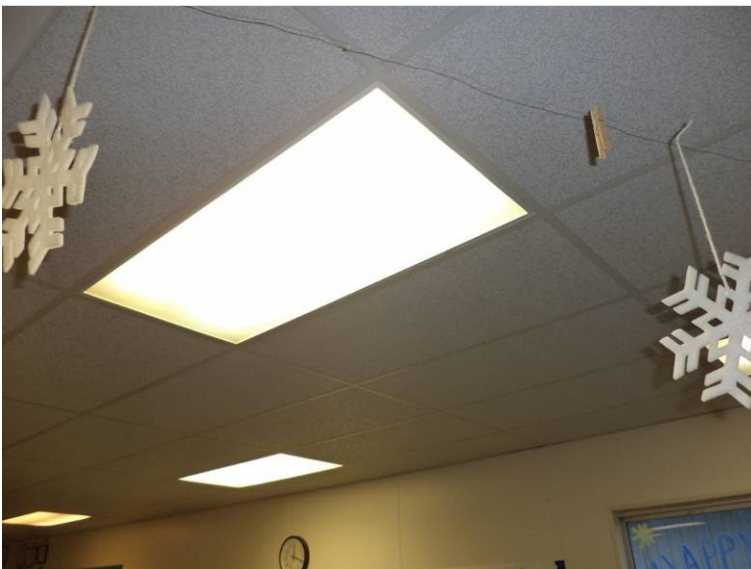
Photograph No. 9

The suspended ceiling systems appeared to be in fair to good condition. The typical EUL of ceiling systems such as this is twenty-years therefore we recommend that the system is replaced mid-term in the study period as we assume it is at least ten-years old. We suggest at that time a review is undertaken to ascertain if there is a need for full replacement or just the replacement of the ceiling tiles. We have included for full replacement.

View of the ceiling system and light fixtures.

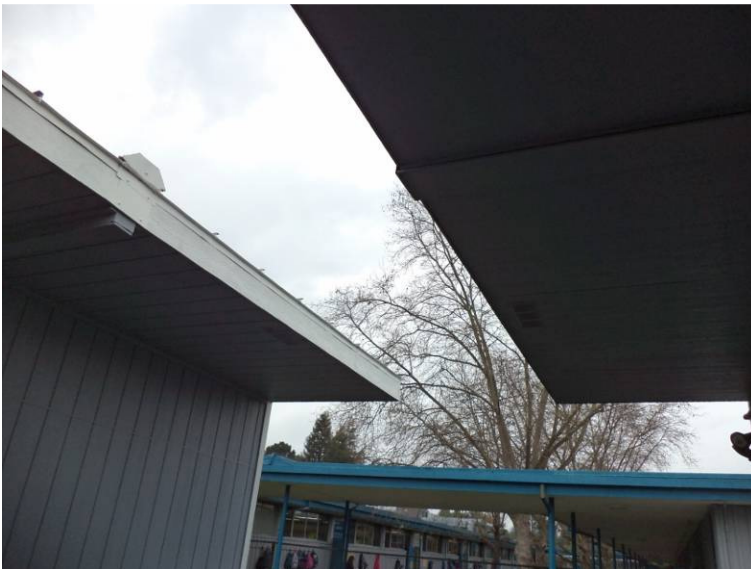
Photograph No. 19

The exterior painted soffits appeared to be in fair to good condition with generally no major signs of deterioration, water ingress or general failure noted. We assume that they were last repainted along with the elevations and therefore we recommend that they are repainted again at the same time as the exterior elevations. The cost of this work has been included in the exterior wall construction repainting works.

View of the overhanging soffits.

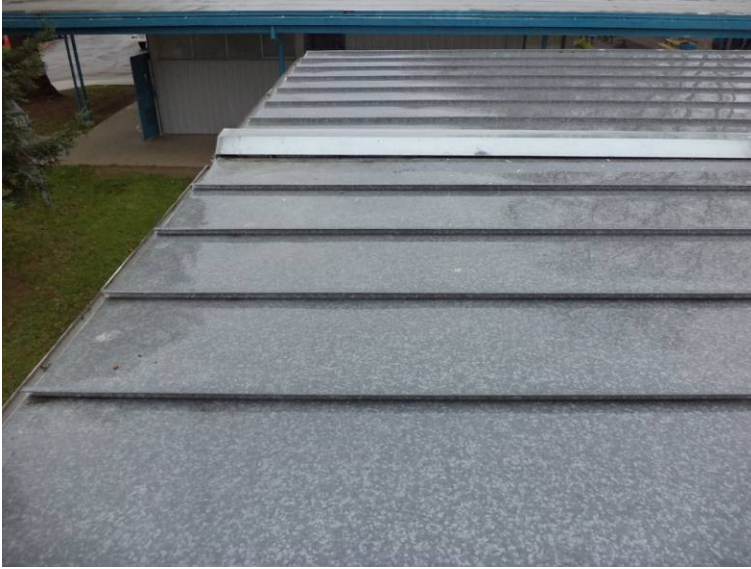
Photograph No. 20

View of the roof covering.

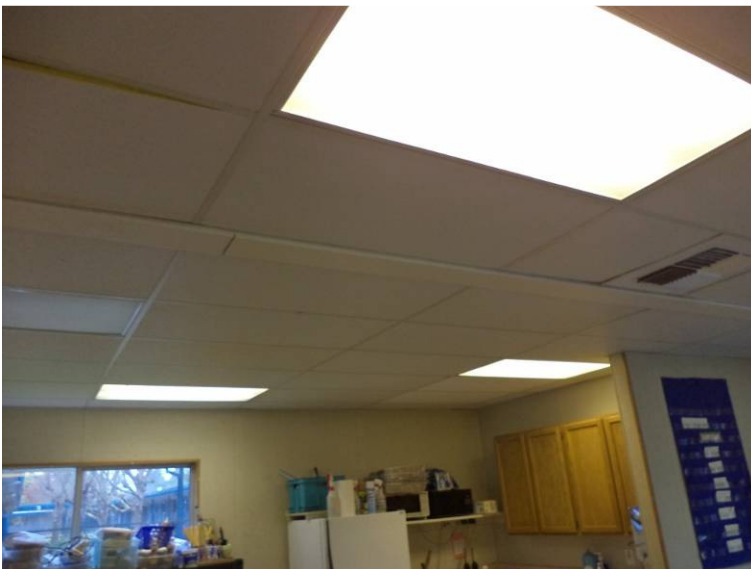
Photograph No. 22

View of ceiling system and light fixture.
