**Citywide  
Facility Condition Assessment**

**Report of  
Facility Condition Assessment**

**For  
City of Novato  
Margaret Todd Senior Center, Community Room & Gymnasium  
1560 Hill Road, Novato, CA**

***March 4, 2013***

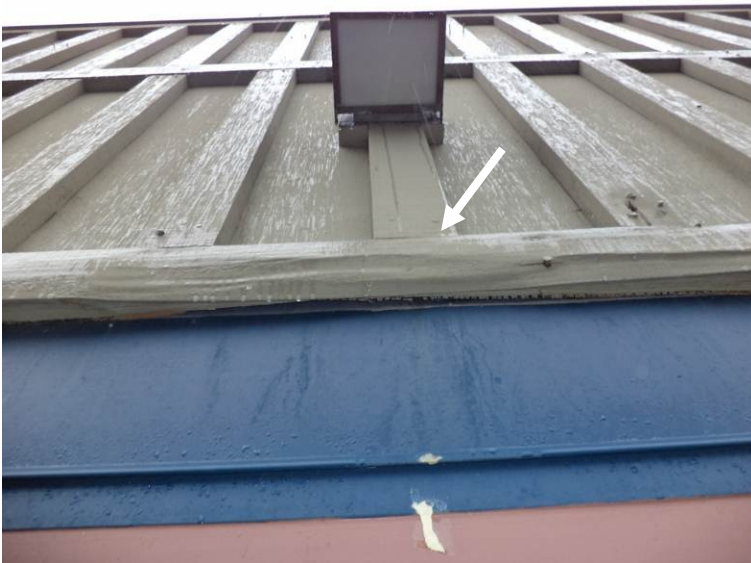
**Photograph No. 4**

The exterior wall construction appeared to be in fair to good condition with only minor signs of deterioration of the wood battens. It appears that the wood battens have rotted due to exposure to moisture in a number of locations (reference Photographs 4 and 5 in Appendix B). We recommend that these areas are repaired at the start of the study period. It was unclear when the plywood wall surfaces were last painted, therefore based on their current observed condition and the typical EUL of eight-years, repainting of the painted surfaces are recommended between near and mid-term in the study period and then every eight-years after to maintain the exterior appearance of the buildings.

View of the plywood and batten wall construction and a section of batten that has deteriorated through moisture penetration (below the light fixture).

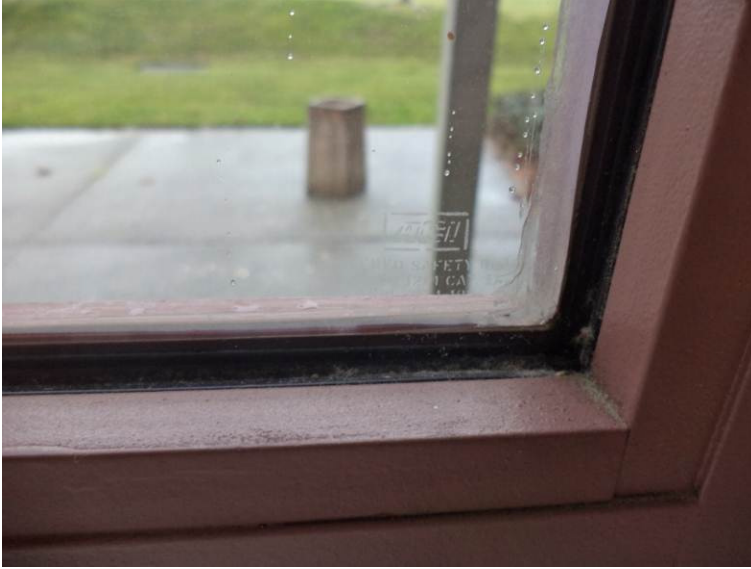
**Photograph No. 6**

The exterior window units appeared to be in fair to good condition, although the single-pane design of the majority of the window units offers limited thermal insulation. Not all of the windows were assessed, however overall we did not find any major deficiencies and no areas of water ingress through the systems. We do not anticipate a requirement for their replacement at this time, however based on a typical EUL of thirty-years, replacement is recommended for the single pane window units based on industry standards later in the study period. At the time when the window units are scheduled to be replaced, we recommend they are re-assessed for replacement suitability.

View of the fixed single pane window units.

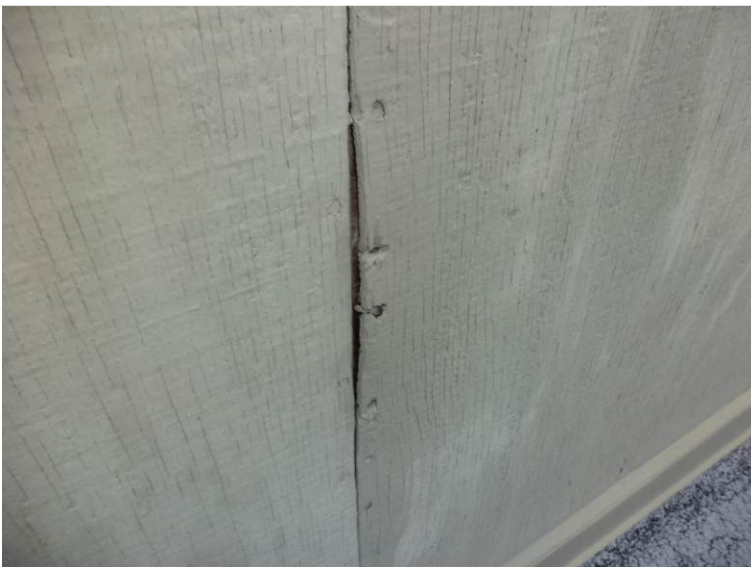
**Photograph No. 14**

View of the plywood boards at the inner side of the parapets that are saturated with moisture.

B Shell: Replace plywood at inner side of parapets with extension of roof covering at an estimated cost of \$39,375 in year 2013
-

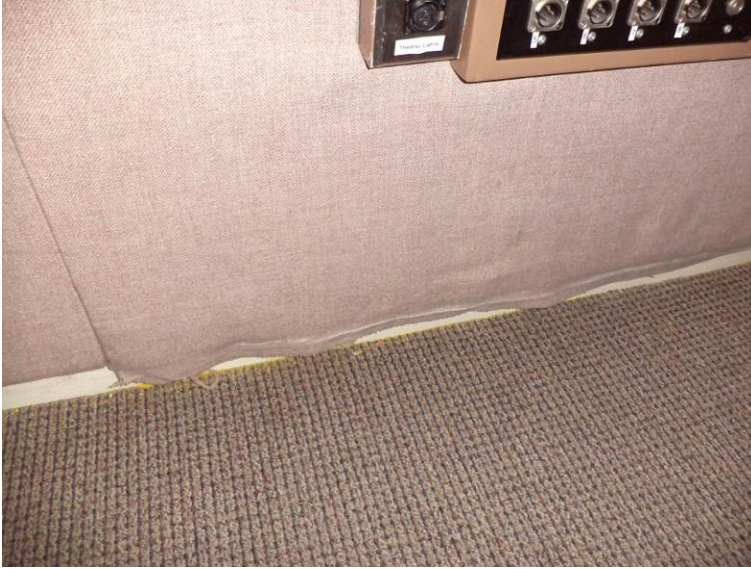
View of the acoustical partitions. Surfaces are heavily marked and aged.
