Citywide
Facility Condition Assessment

Report of
Facility Condition Assessment

For
City of Novato
New Hamilton Gym
530 Nave Drive, Novato, CA

March 4, 2013

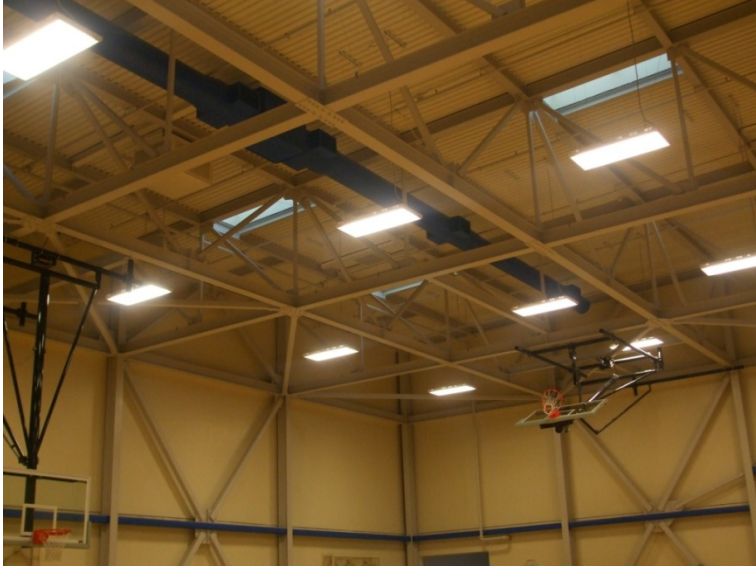
Photograph No. 1

View of the steel roof construction supporting the low flat roof over the main hall. Also shows suspended 2' x 4' T8 lights.

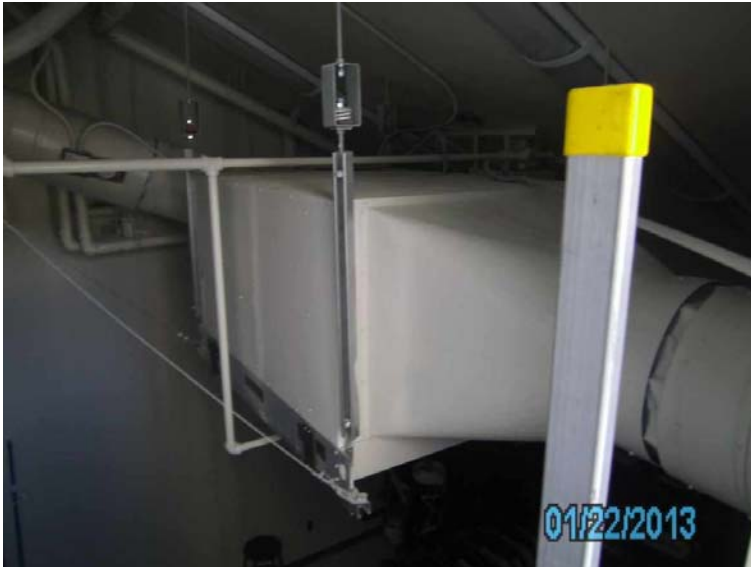
Photograph No. 2

View of some ductwork supplying the building. Also shows the underside of the pitched roof construction in the background.

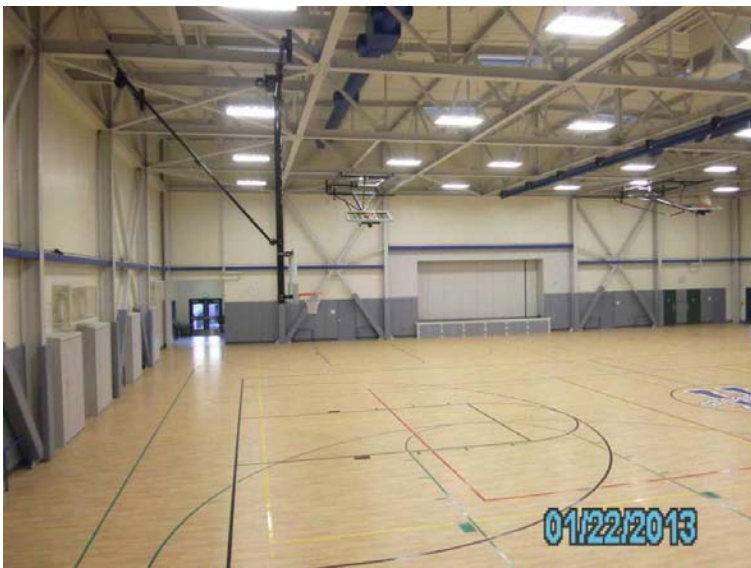
Photograph No. 3

The steel framed structure appeared to be in fair to good condition. We do not anticipate the replacement of such structural elements during the cost study period with exception to re-painting which is included in the interiors section of the report.

View of the exposed steel frame showing both wall and roof members. Also shows the vinyl roll floor for the sports court.

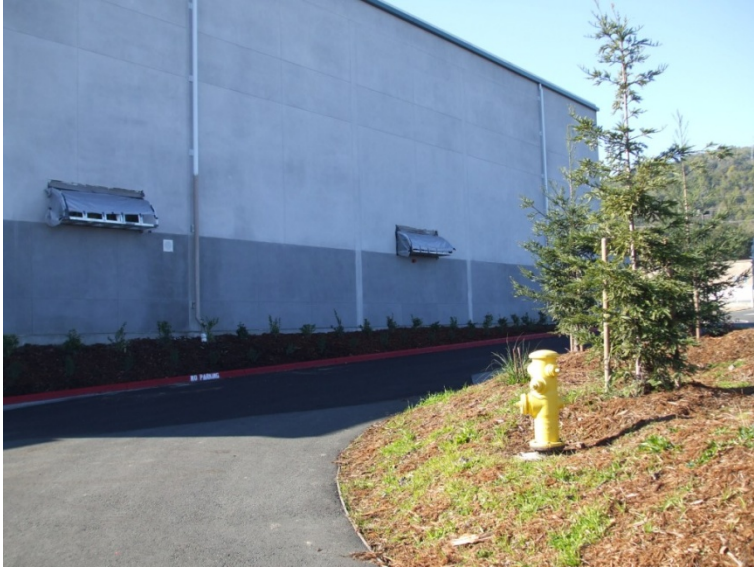
Photograph No. 4

The Hamilton Gym building was enclosed with a non load bearing 2" X 8" steel stud wall with R-19 insulation and a painted Exterior Insulated Finishing System (EIFS). EIFS is a lightweight multi-layered synthetic wall cladding that includes foam plastic insulation and thin synthetic stucco coatings which are colorfast and crack resistant and painted gypsum board to the interior (reference Photograph 4 in Appendix B).

The exterior wall system construction and stucco surface appeared to be in good condition with no signs of deterioration, water ingress or general failure noted. We understand that the stucco walls and surfaces were last painted a year ago and therefore based on the typical EUL of eight-years repainting of the painted surfaces are due at the middle and end portion of the study period.

View of the exterior walls. Non load bearing with a painted exterior insulated finish system.

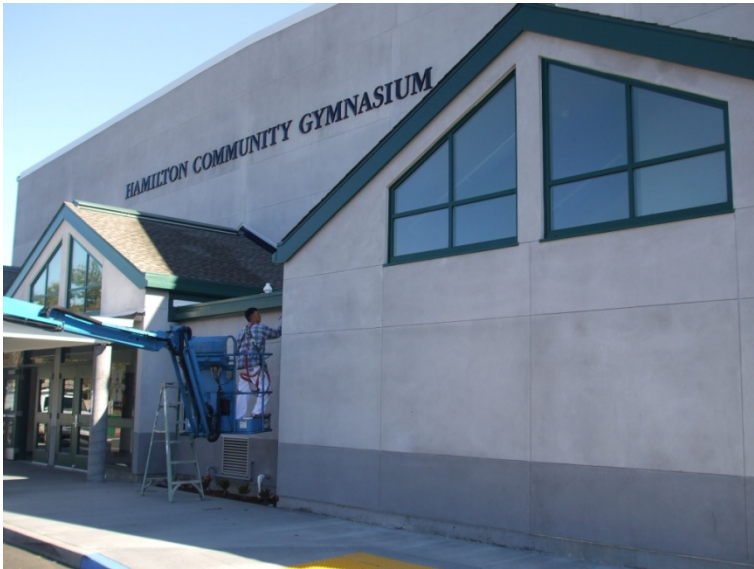
Photograph No. 5

View of a vaulted steel framed window with single pane glazing. Also shows site paving.

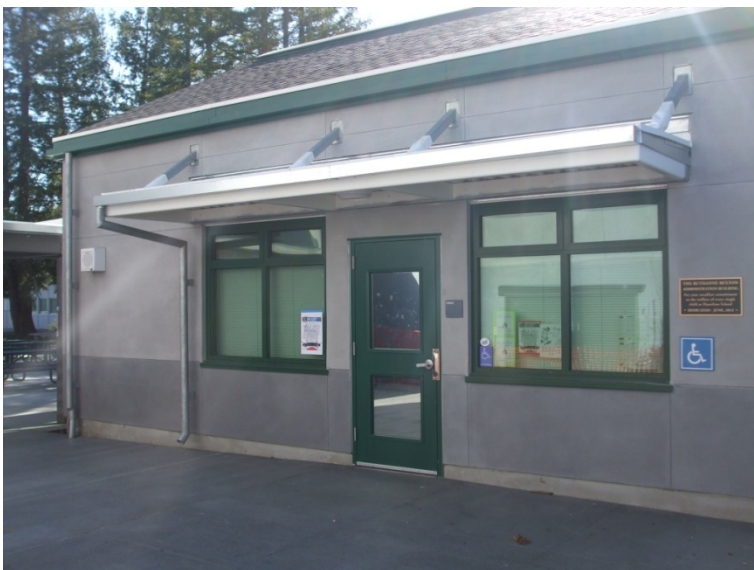
Photograph No. 6

View of two steel framed window units.

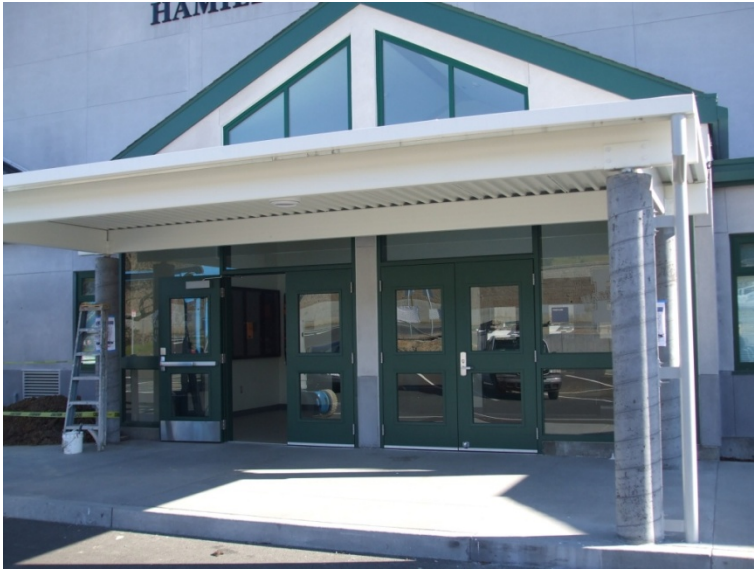
Photograph No. 7

View of the storefront serving as the main building entrance on the west side.

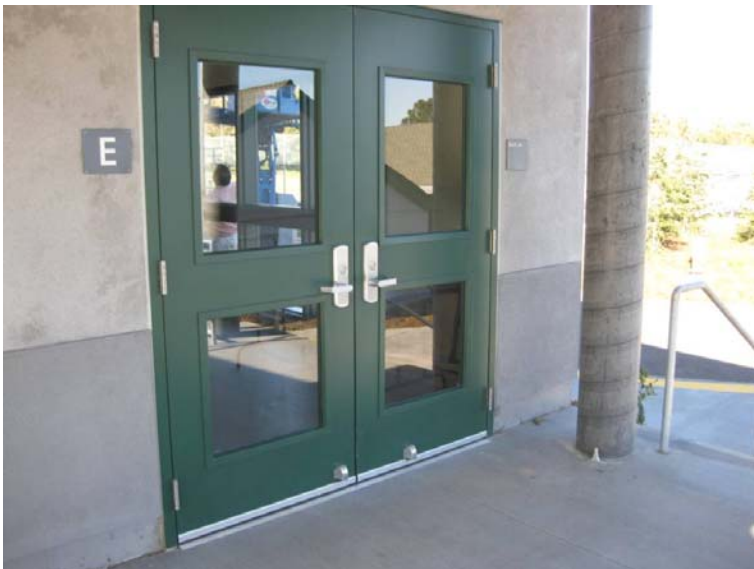
Photograph No. 8

View of a double hollow metal exterior glazed door.

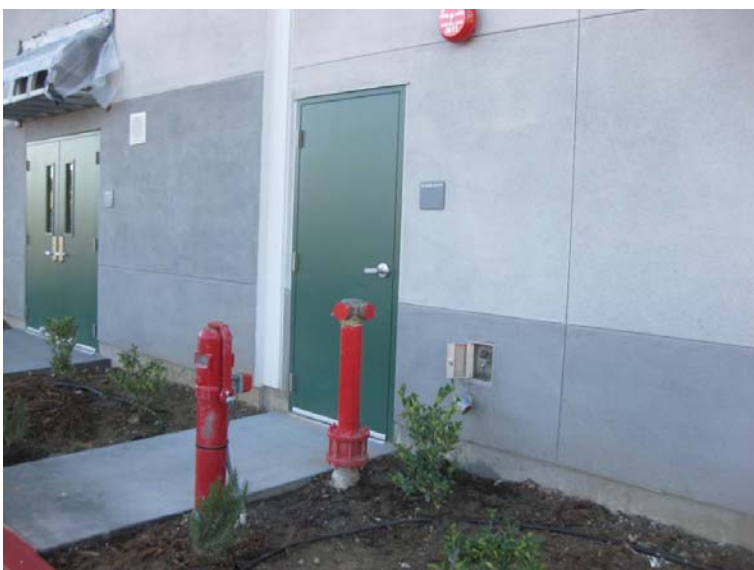
Photograph No. 9

View of a single hollow metal exterior non-glazed door.

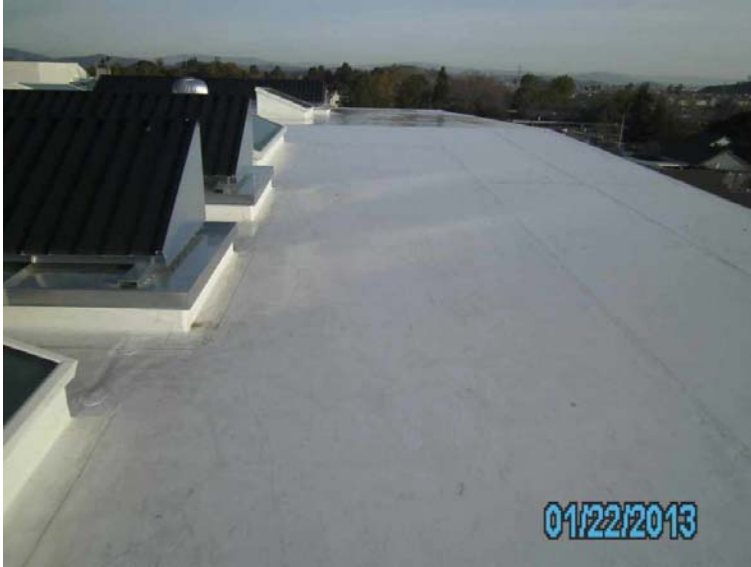
Photograph No. 10

View of the low sloped roof covering consisting of the TPO membrane adhered to metal decking.

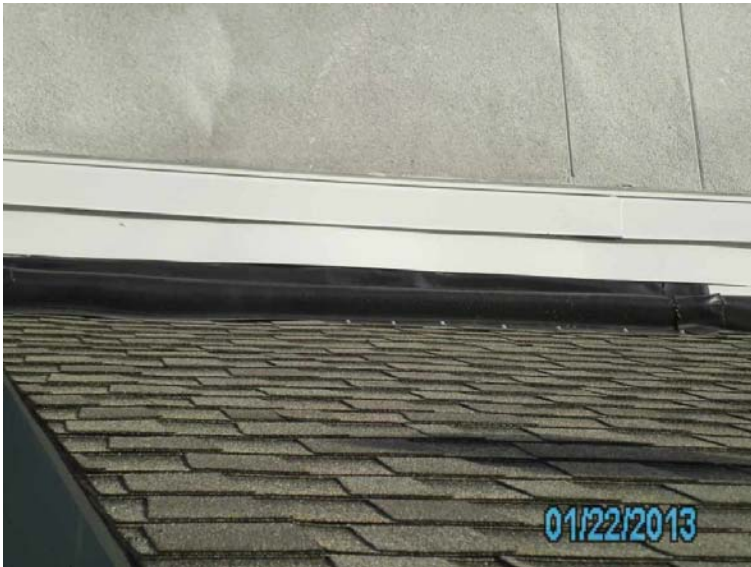
Photograph No. 11

View of the pitched lean to roof with asphalt shingle covering attached over insulation to a plywood deck.

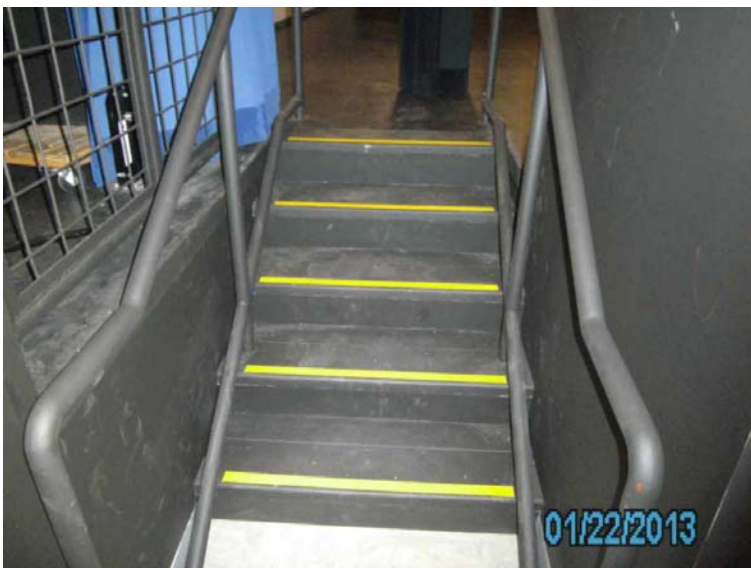
Photograph No. 12

View of the wood staircase with tubular metal handrails.

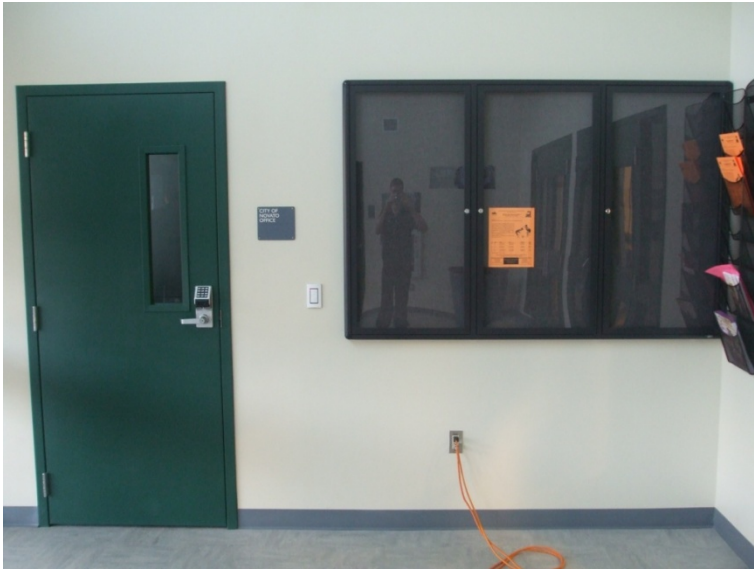
Photograph No. 13

View of an interior single hollow metal door with code access system.

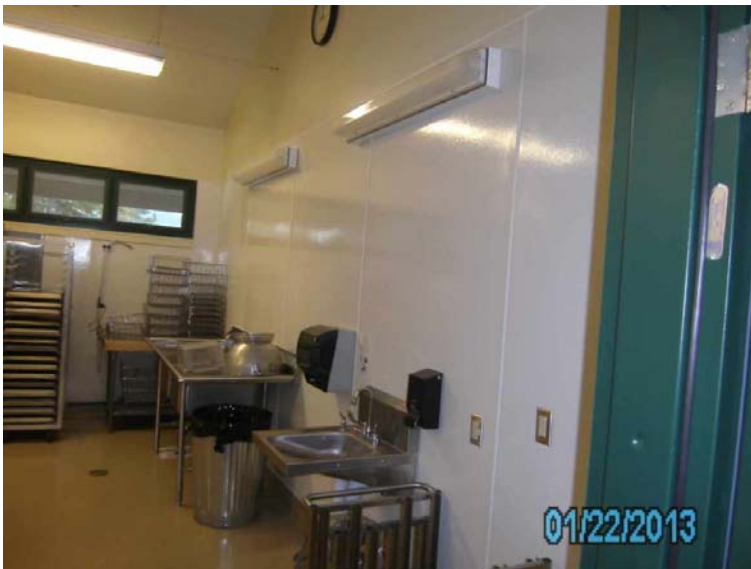
Photograph No. 14

View of the fiberglass reinforced wall panels and wall mounted light fixtures.

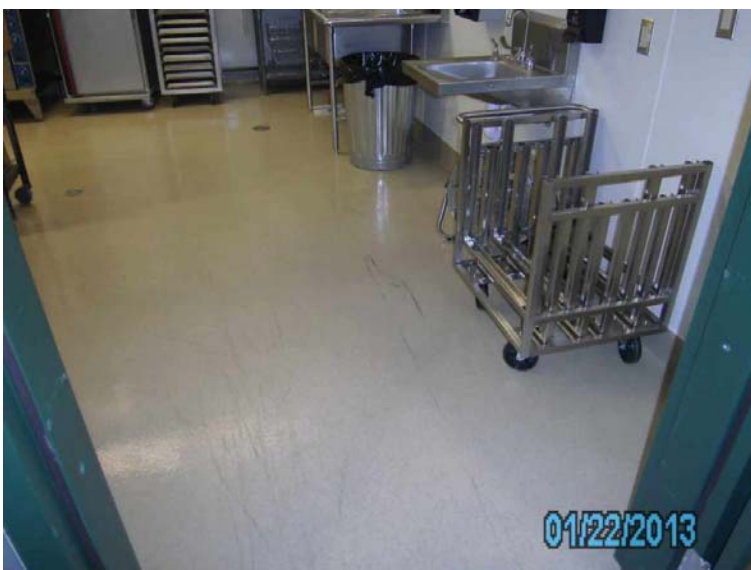
Photograph No. 15

View of the epoxy floor coating in the kitchen.

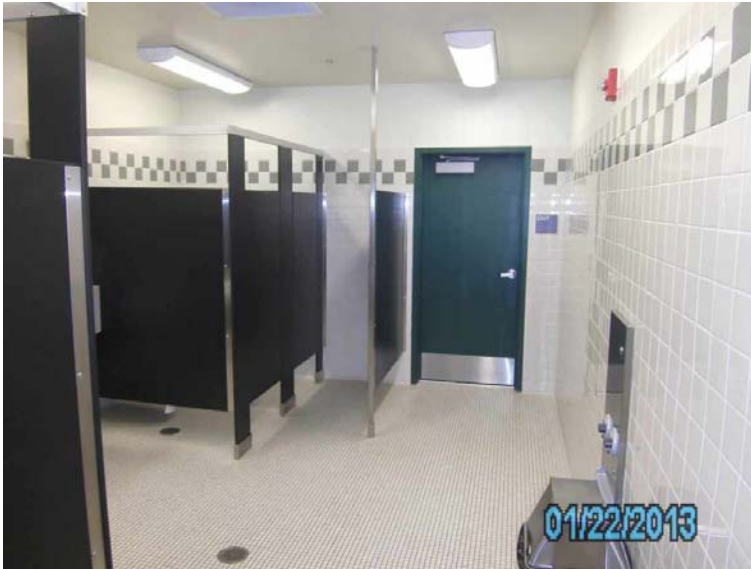
Photograph No. 16

View of the ceramic floor tiles, wall tiles, painted gypsum board ceilings and light fixtures in the women's restroom

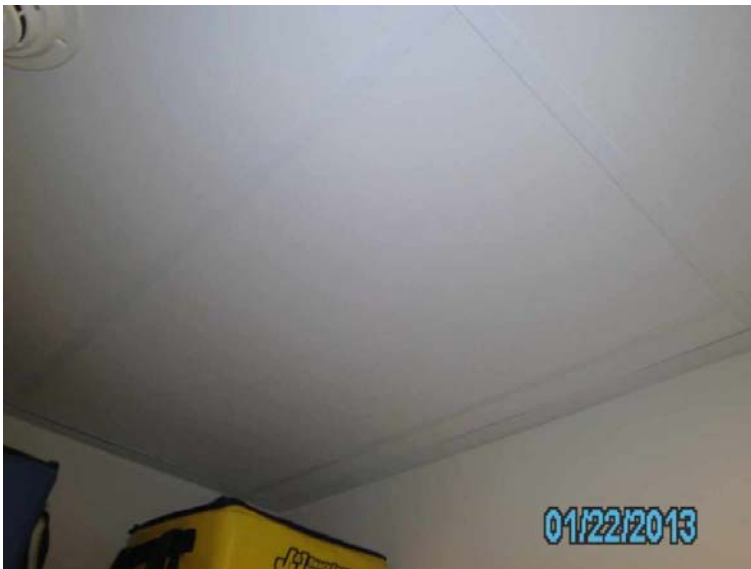
Photograph No. 17

View of the suspended ceiling system with 2'x4' acoustical tile panels.

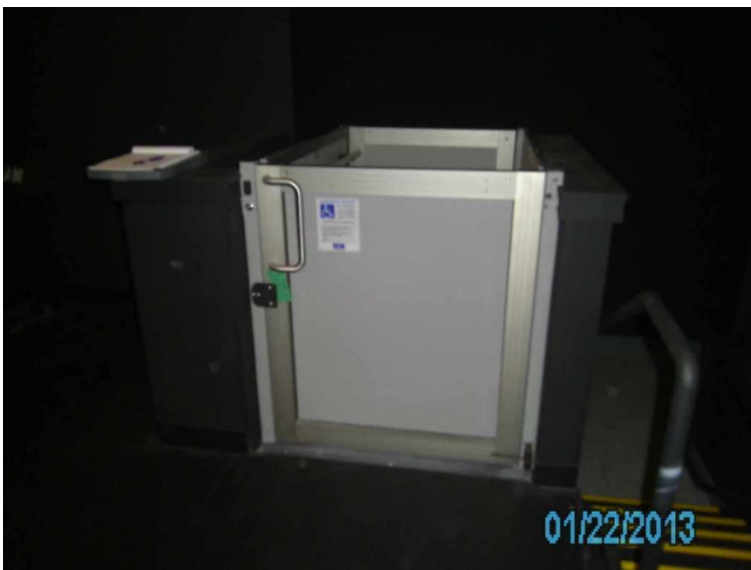
Photograph No. 18

View of the short rise vertical wheelchair elevating system.

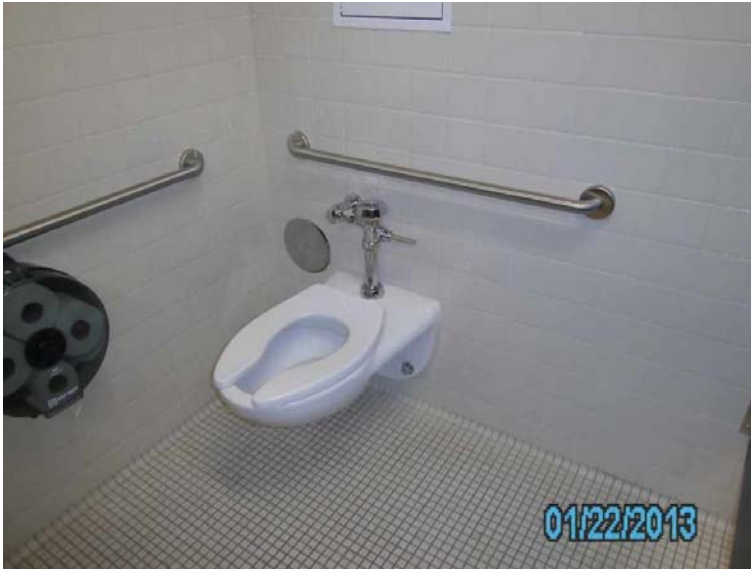
Photograph No. 19

View of the vitreous china ADA compliant water closet.

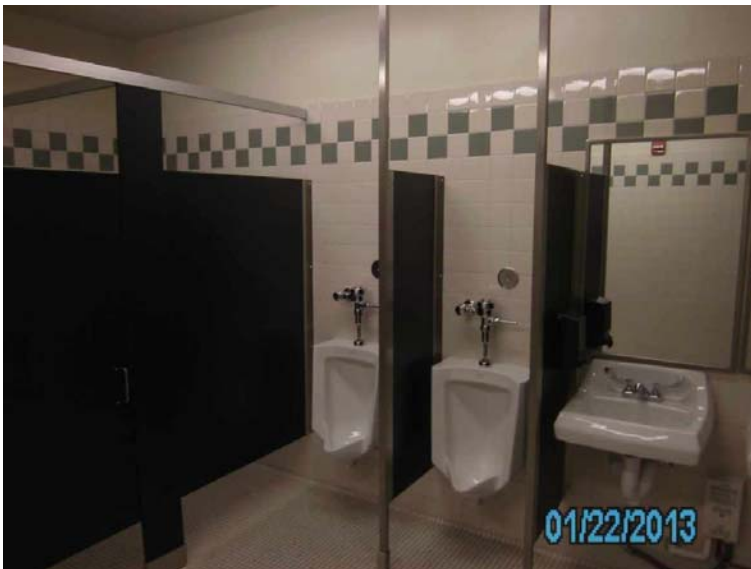
Photograph No. 20

View of the vitreous china urinals and fixed toilet partition within men's restroom.

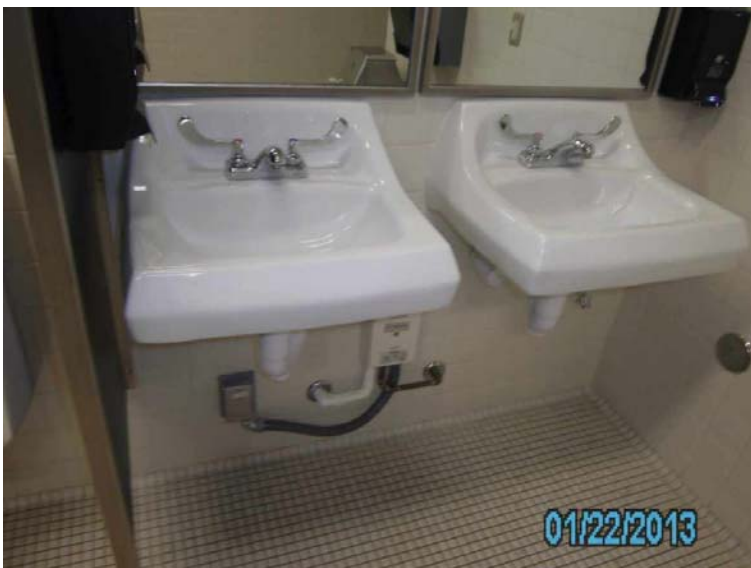
Photograph No. 21

View of the vitreous china lavatories in men's restroom.

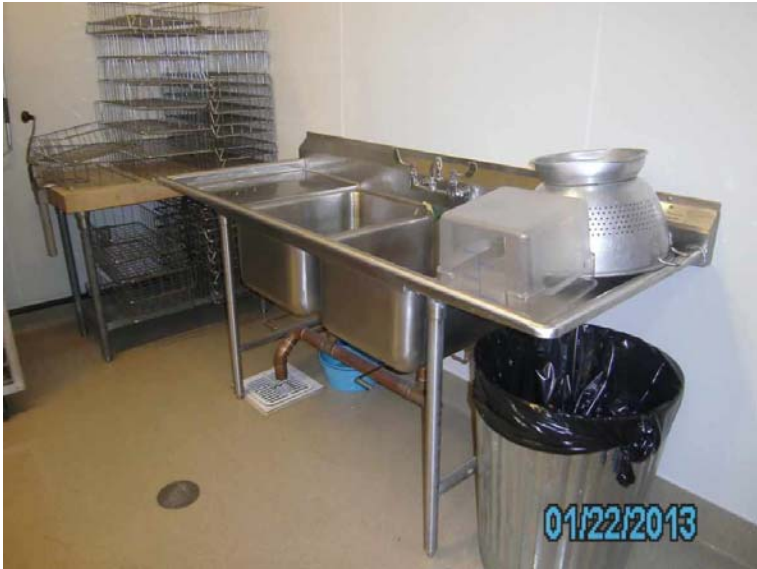
Photograph No. 22

View of one of the three compartment stainless steel sinks in the kitchen.

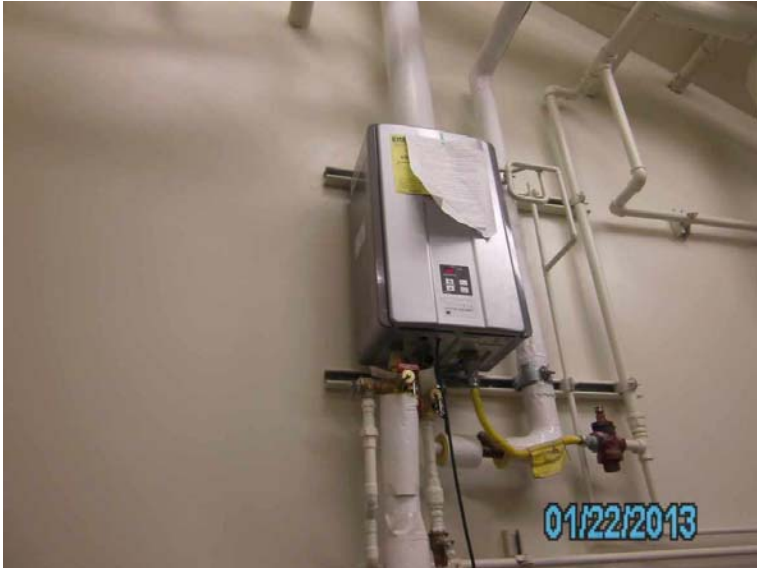
Photograph No. 23

View of the natural gas water heater located in a custodial room.

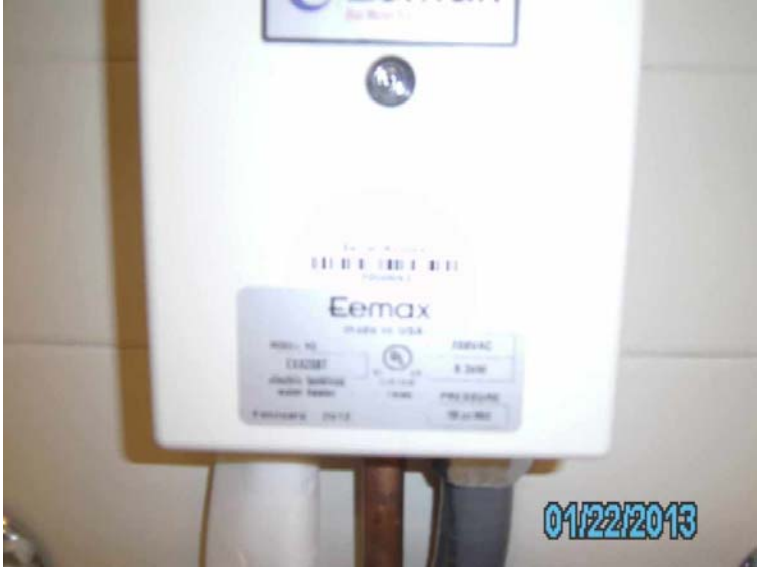
Photograph No. 24

View of an electric water heater serving the restrooms.

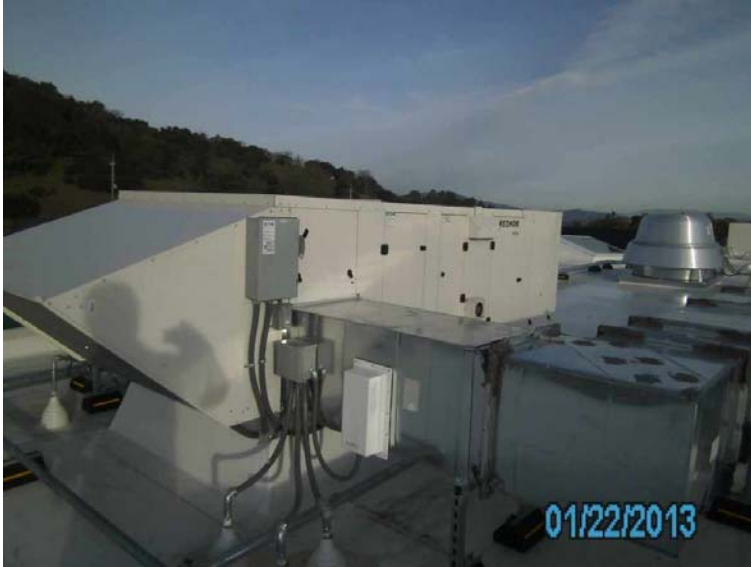
Photograph No. 25

View of one of the rooftop packaged air conditioning units and centrifugal exhaust fan.

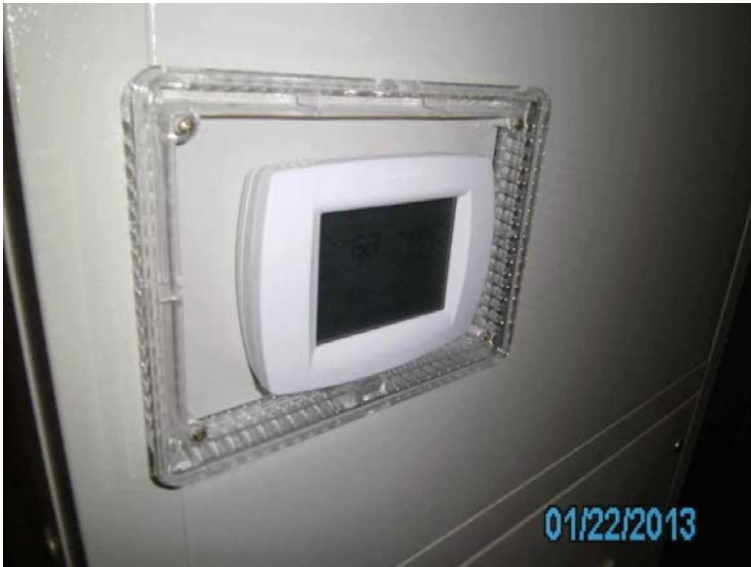
Photograph No. 26

View of a typical electronic thermostat located throughout the building allowing the occupants to adjust the temperature.

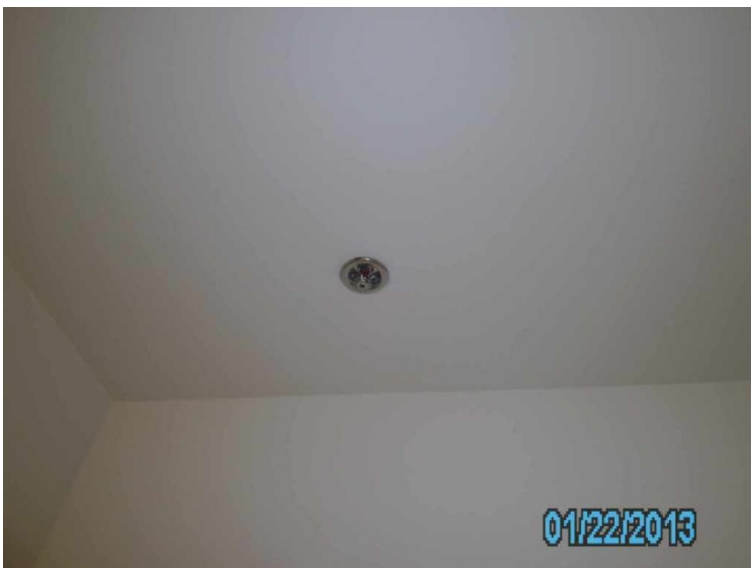
Photograph No. 27

View of a pendant sprinkler head, part of the wet pipe sprinkler system serving the building.

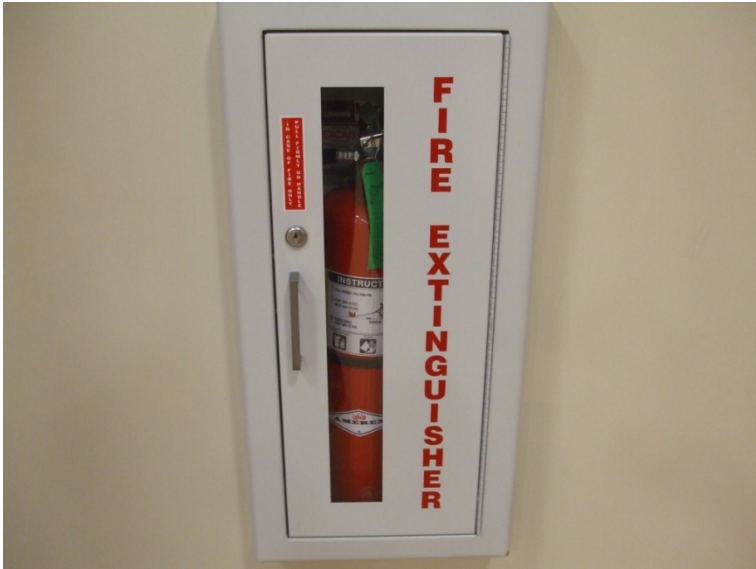
Photograph No. 28

View of a typical fire extinguisher located throughout the building.

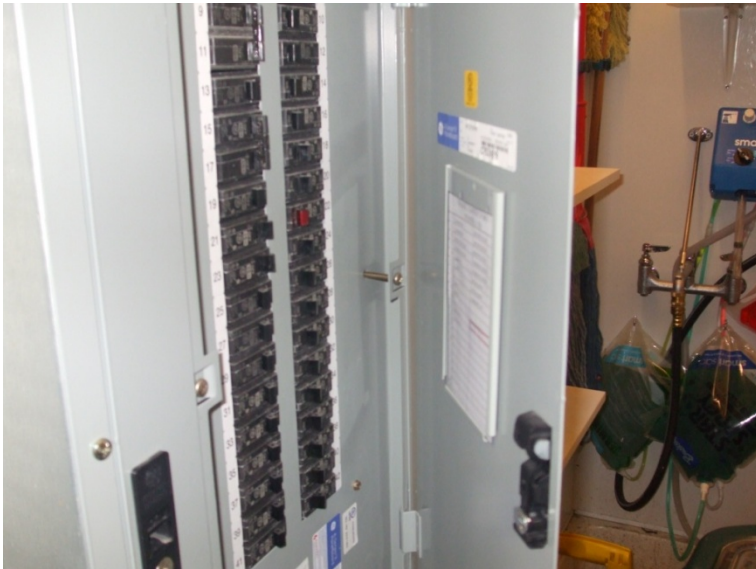
Photograph No. 29

View of a panelboard occupying a custodial space.

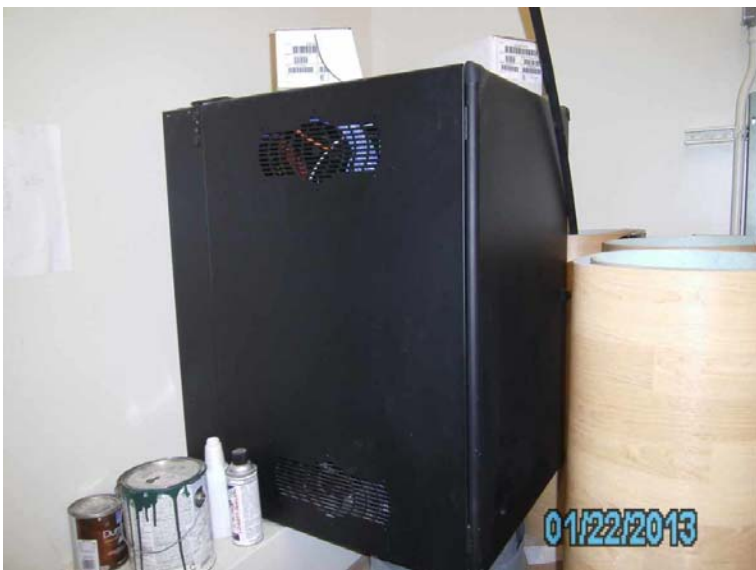
Photograph No. 30

View of the enclosed telephone system located in a custodial room.

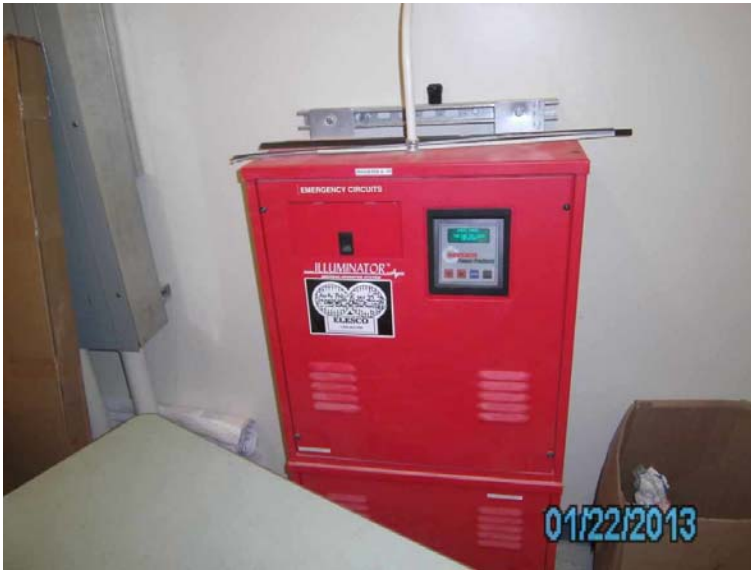
Photograph No. 31

View of the fire alarm control panel.

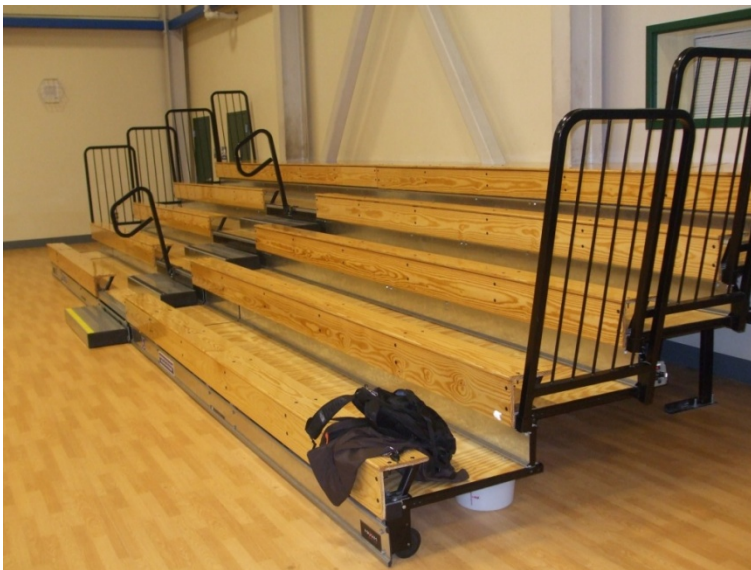
Photograph No. 32

View of one of the multiple seating benches situated in the main hall.

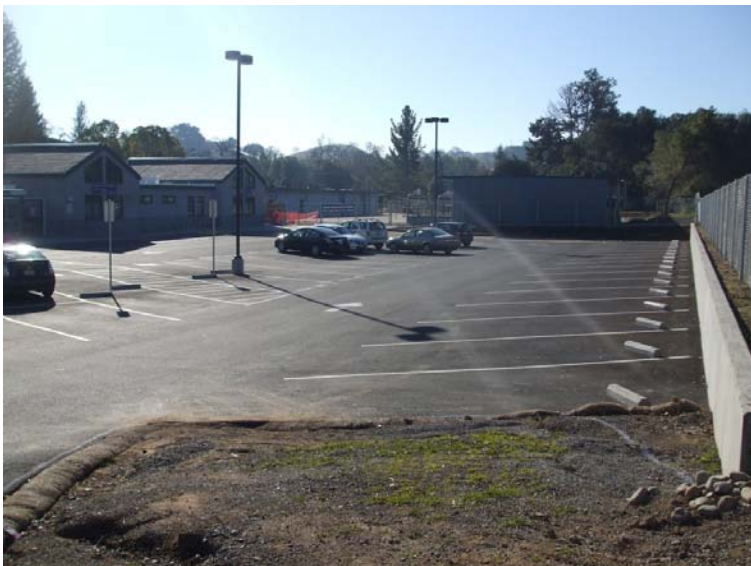
Photograph No. 33

View of the parking lot serving the gymnasium and neighboring school. Also shows pole mounted parking lot lights.

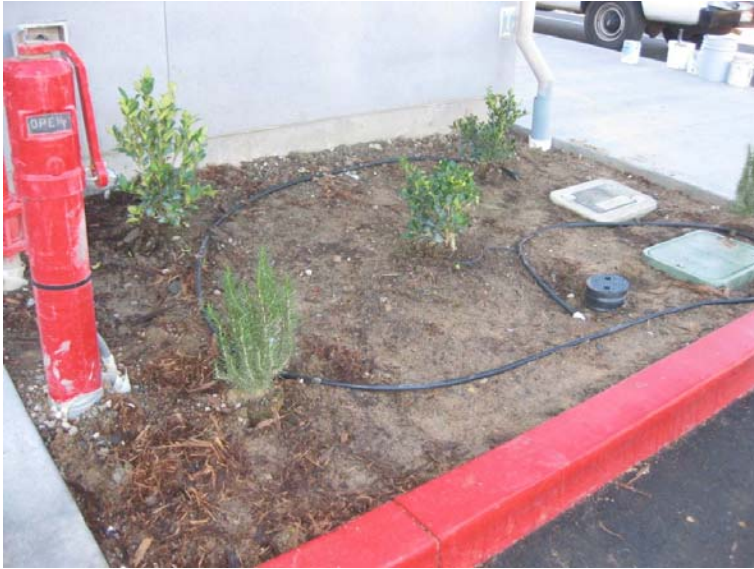
Photograph No. 34

View of a planter along the north side of the building.

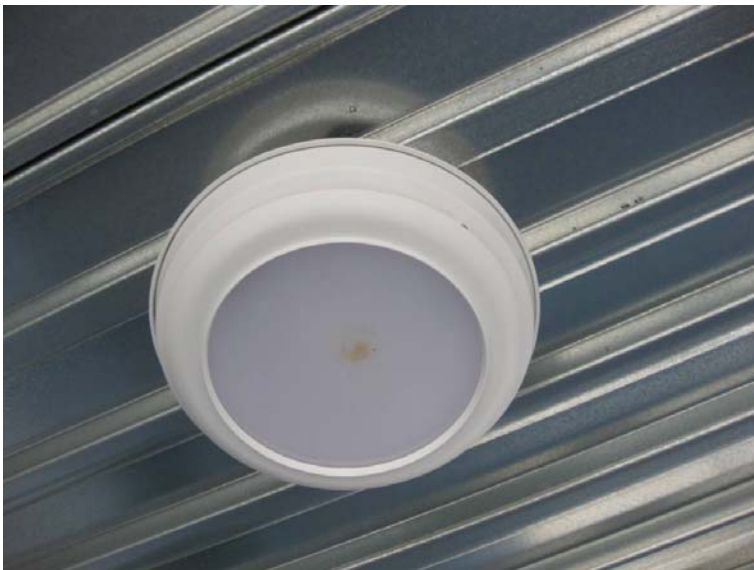
Photograph No. 35

View of an external surface mounted canopy light.

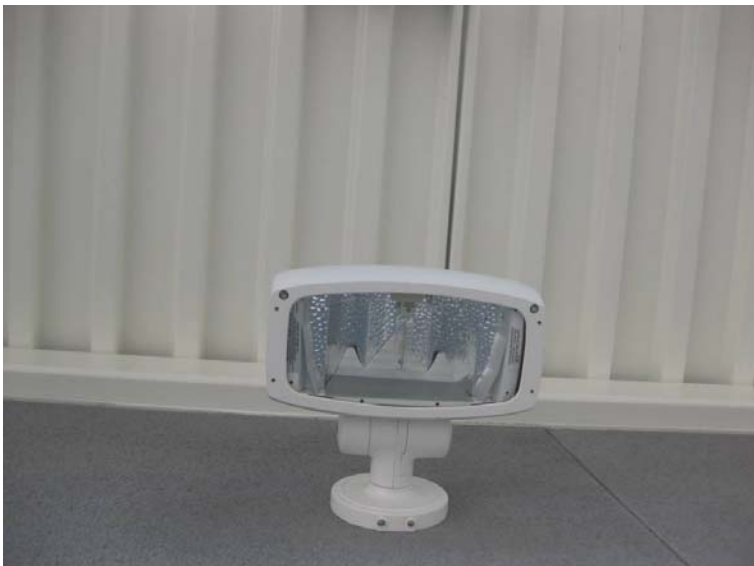
Photograph No. 36

View of an external wall mounted light.
