**Report of
Facility Condition Assessment**

**For
City of Novato
Postmaster's House
815 DeLong Avenue, Novato, CA**

March 4, 2013

Faithful+Gould, Inc.

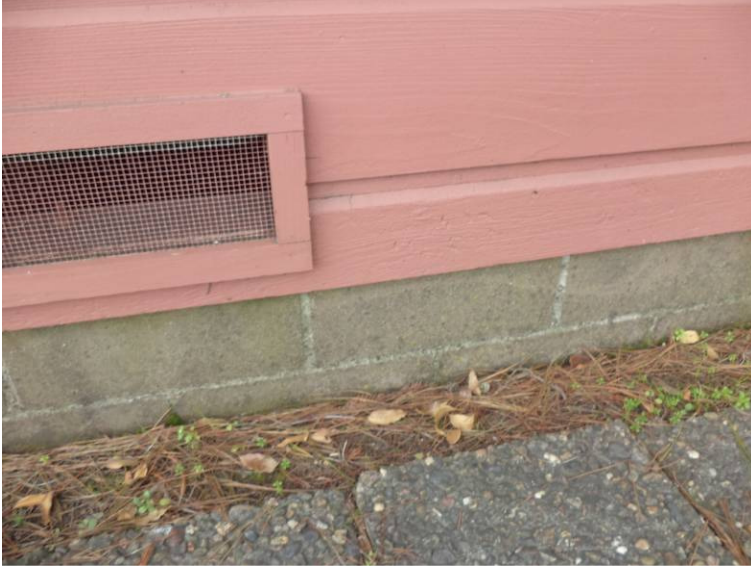
Photograph No. 1

The footings are only visible at the north elevation, the other elevations they are not due to their location below the exterior wall construction. There is no deterioration to the wall constructions that they are supporting, therefore we assume them to be in good condition and free from defects.

View of the footings and crawl space grill.

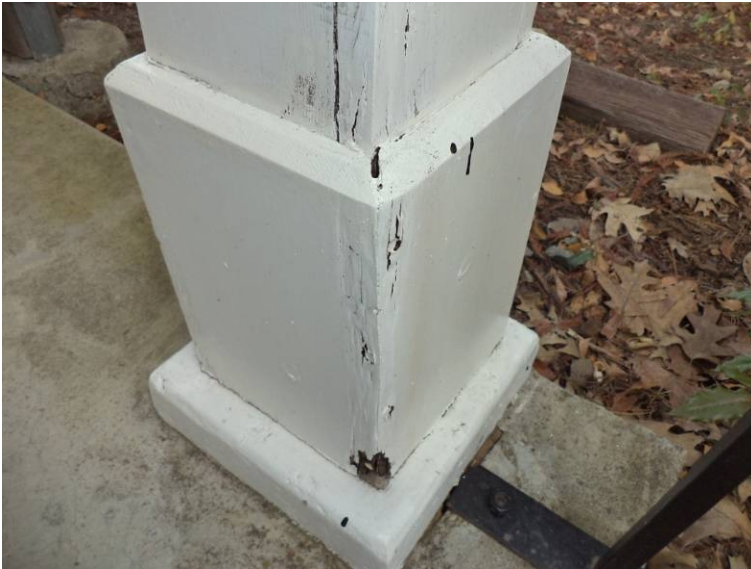
Photograph No. 5

The wood posts supporting the canopy at the east side of the building have started to deteriorate around their base (reference Photograph 5 in Appendix B). We recommend that these are repaired at the start of the study period to prevent further deterioration.

View of the deteriorated post bases.

Element No.	Building Element	Recommendation	Qty	Unit	Rate	Cost	Year	Priority Code
B2011	Exterior Wall Construction	Repair, prepare and repaint base of canopy posts	1	LS	\$500	\$500	2013	4
B2011	Exterior Wall Construction	Repaint all exterior previously painted surfaces	1,800*	SF	\$1.88	\$3,384	2018	4
B2011	Exterior Wall Construction	Repaint all exterior previously painted surfaces	1,800*	SF	\$1.88	\$3,384	2026	4
B3011	Roof Finishes	Replace asphalt shingle roof coverings	1,000*	SF	\$10.00**	\$10,000	2018	3
B3011	Roof Finishes	Replace rolled asphalt roof coverings	1	LS	\$2,500	\$2,500	2018	3
Total Anticipated Expenditure for B Shell						\$19,768

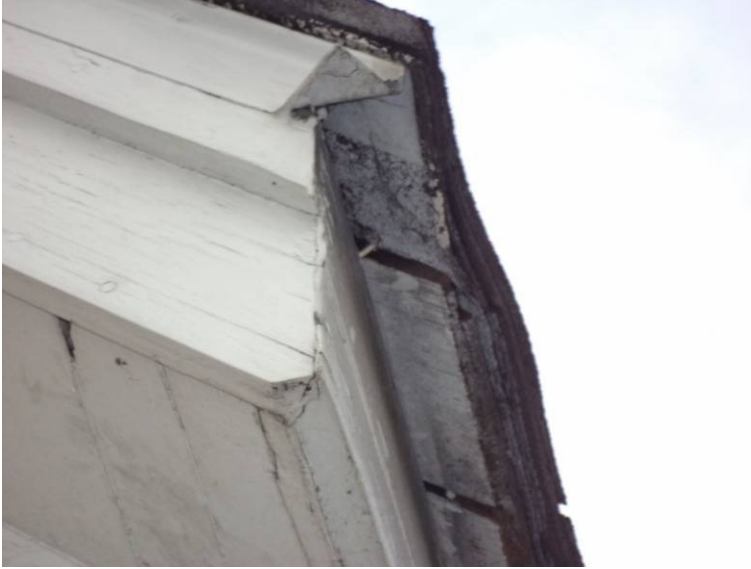
Photograph No. 7

The asphalt roof coverings generally appeared to be in poor to fair condition, we are unaware when the coverings were last installed; we assume them to be more than twenty-years old. This type of roof covering has a typical EUL of forty-years and based on observed conditions and the age of the roof material we anticipate that all of the roof levels will require replacement mid-term in the study period. Furthermore we recommend that each of the previous roof coverings that have been overlaid are removed prior to the new coverings being installed (reference Photographs 7 and 8 in Appendix B). It is never wise to install excessive layers of roof coverings on top of each other, as it can causing constant moisture to seep into the siding, and promoting decay. In addition to this the extra weight from each of the roof coverings adds additional undersigned loads to the structure. Tearing off the old roof shingles should be undertaken prior to installing a new roof covering.

View of the multiple layers of shingles at roof level.

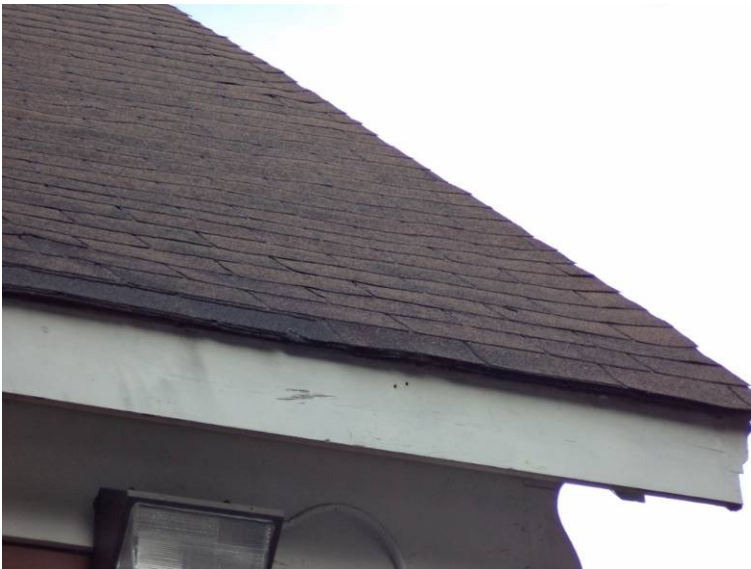
Photograph No. 8

View of the roof covering.

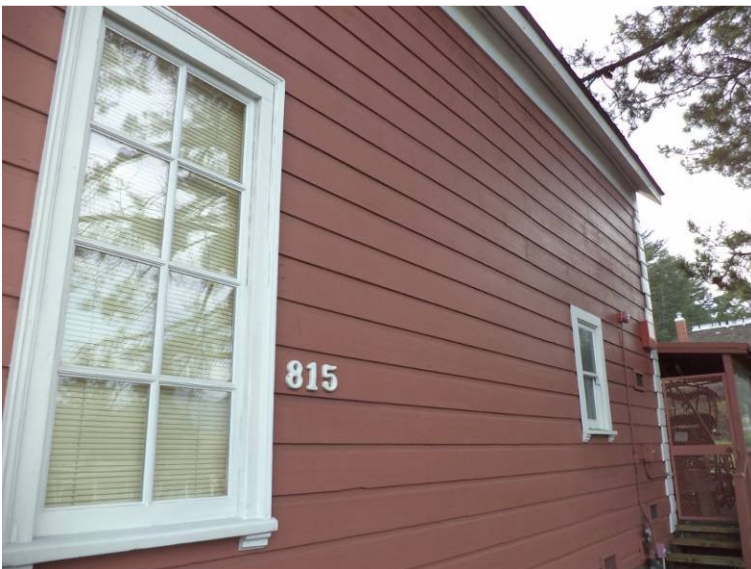
Photograph No. 9

The exterior window units appeared to be in good condition. We are unaware when the window units at each floor level were introduced to the building, however the fixed wood and the aluminum units had no reported or observed issues. We anticipate along with regular maintenance and care at the time of the exterior wall repainting works that they will last beyond the study period without replacement necessary. We recommend that the wood window units are repainted at the same occurrence as the exterior wall repainting works.

View of the first floor wood fixed window units.

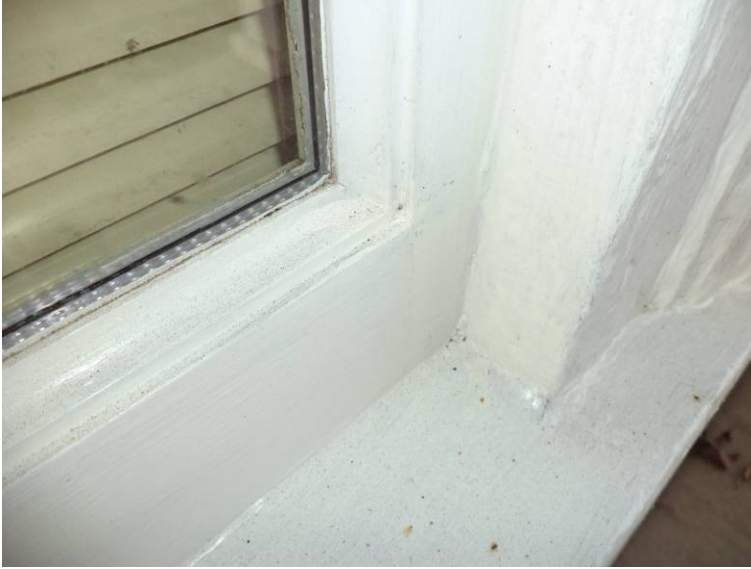
Photograph No. 10

View of the insulated wood windows.

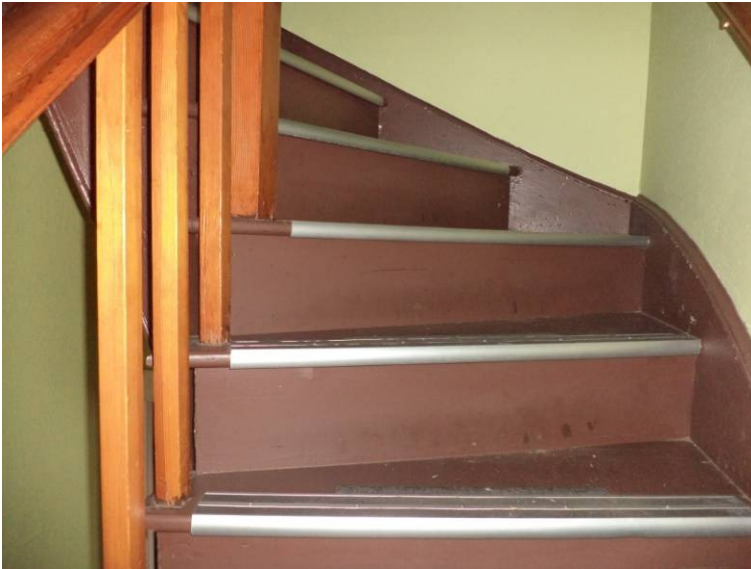
Photograph No. 11

The staircase appeared to be in a good condition with no issues reported or identified. We do not anticipate any actions in association with the staircases during the study period.

View of the wood staircase structure.

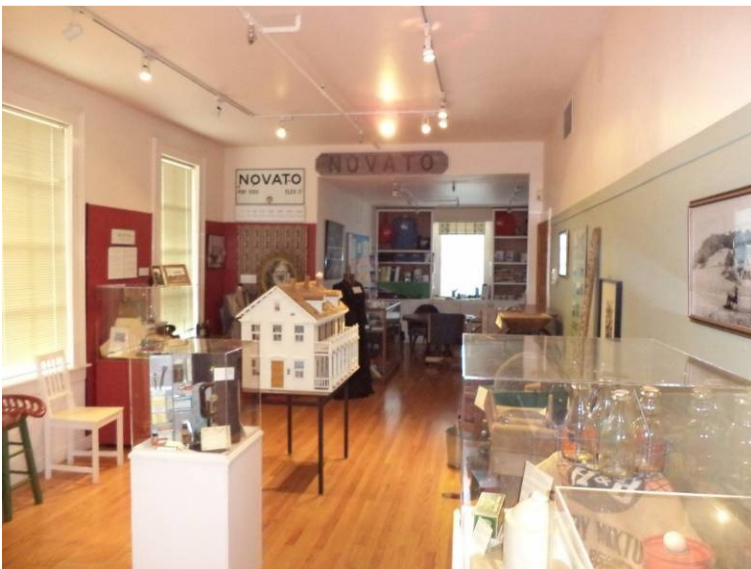
Photograph No. 12

Interior wall finishes appeared to be in good condition generally throughout the building. We are unaware of when the building was last painted, as we understand that it is repainted on an as-needed basis. Based on the typical EUL of eight-years and our observed condition and likely usage of the interior spaces, we recommend repainting prior to mid-term in the study period. The repainting cost also includes for the re-staining of the wood paneling within the restroom.

The floor finishes each appeared to be in good condition. The wood plank floor covering has a typical EUL of forty-years depending on how it's treated. We recommend that the wood plank floor is refinished every ten-years to maintain the appearance of the surface, starting prior to mid-term.

View of the first floor interior finishes.

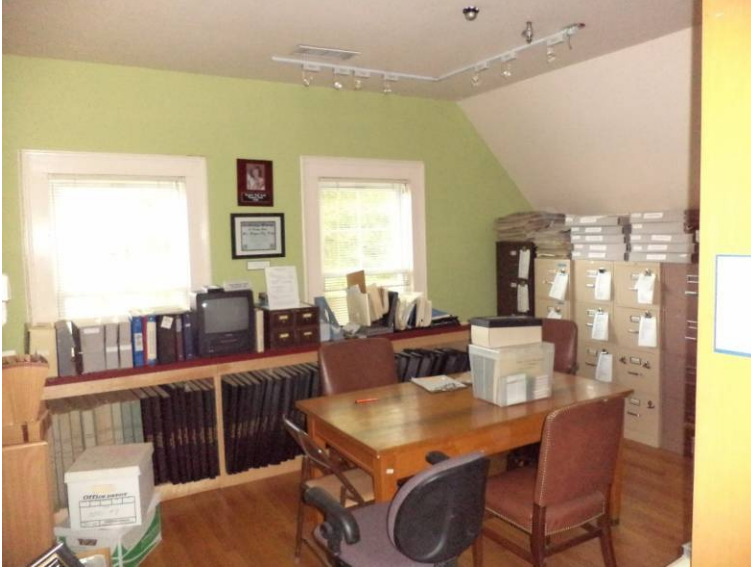
Photograph No. 13

View of the second floor interior finishes.

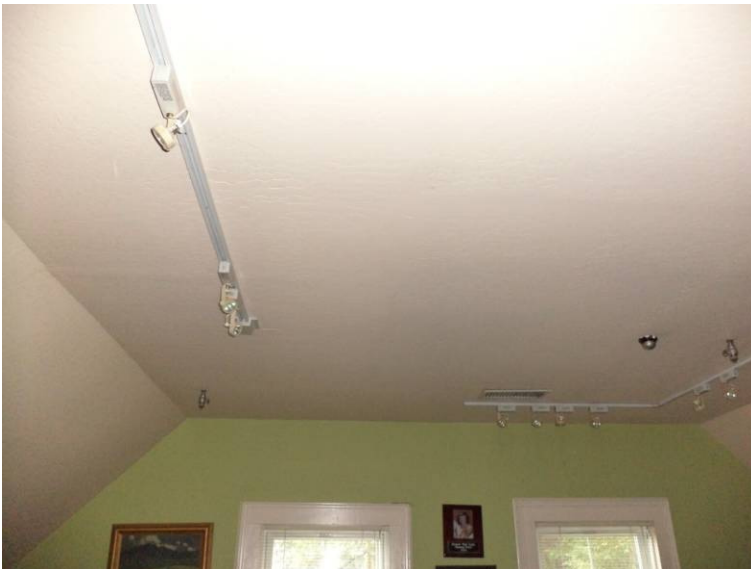
Photograph No. 14

The painted gypsum ceilings appeared to be in good condition. Painted surfaces usually have a typical EUL of eight-years; therefore we recommend that they are repainted at the same time as the wall surfaces.

View of the painted wall and ceiling surfaces.

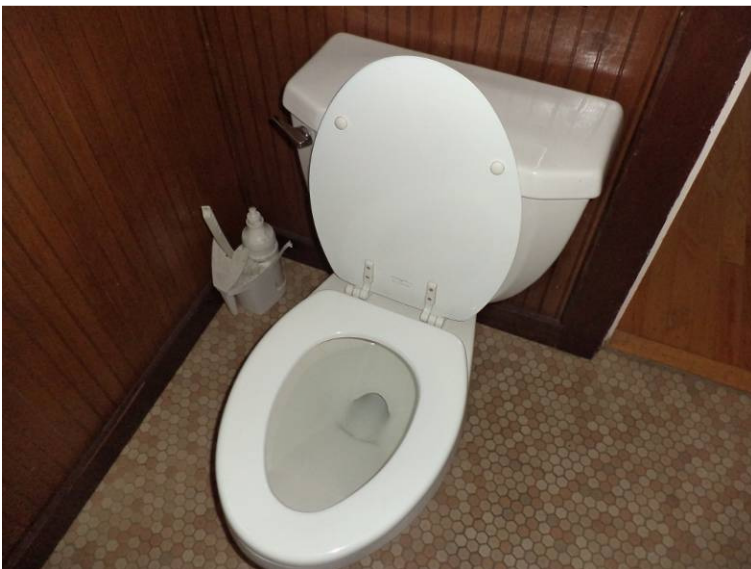
Photograph No. 15

The water closet appeared to be in fair to good condition. The water closet flushed properly and did not have any cracks in the china, therefore based upon observed conditions and with a typical EUL of thirty-five-years, we anticipate that there will be no requirement for its replacement during the study period.

View of the water closet and wood wall panelling.

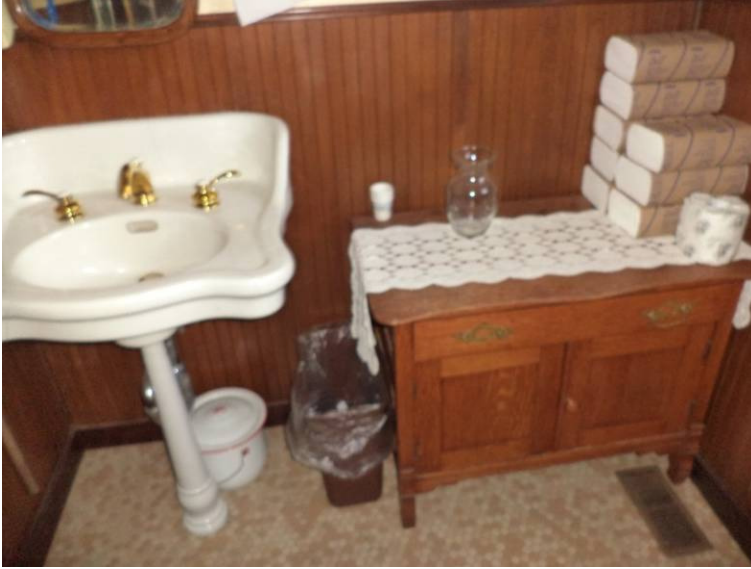
Photograph No. 16

The lavatory and faucet appeared to be in fair to good condition. The sink drained properly and did not have any cracks in the china, therefore based upon observed conditions and with a typical EUL of thirty-five-years, we anticipate that there will be no requirement for its replacement during the study period.

View of the lavatory and wall panelling.

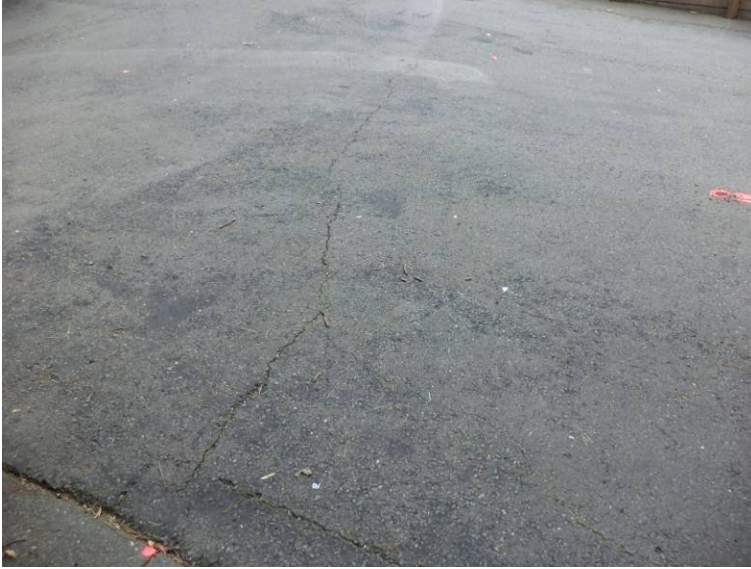
Photograph No. 31

View of the minor cracking in the asphalt surface.
