Citywide
Facility Condition Assessment

Report of
Facility Condition Assessment

For
City of Novato
Maintenance Buildings
(Vehicle Maintenance and Divis & Lockers)
550 Davidson, Novato, CA

March 4, 2013

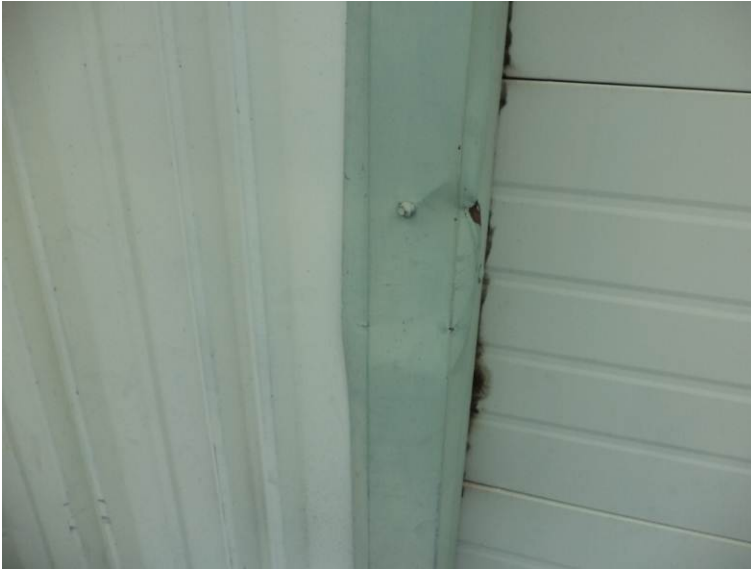
Photograph No. 7

The exterior wall constructions appeared to be in poor to fair condition at Building A and good condition at Buildings B & C. There were no major signs of deterioration, water ingress or general failure noted, however the surface of the metal siding at Building A was marked and deflected which we have assumed has been caused by low impact damage which is minor (reference Photograph 7 in Appendix B). We assume that the metal siding at this building is original and therefore with a typical EUL of twenty-five years replacement is due, however we have not included for its replacement as the condition is considered satisfactory for the type and use of the building. We do however recommend that it is repainted as it appears that it has been painted previously.

View of the exterior metal corrugated siding. Also shows building as "A" and downspout.

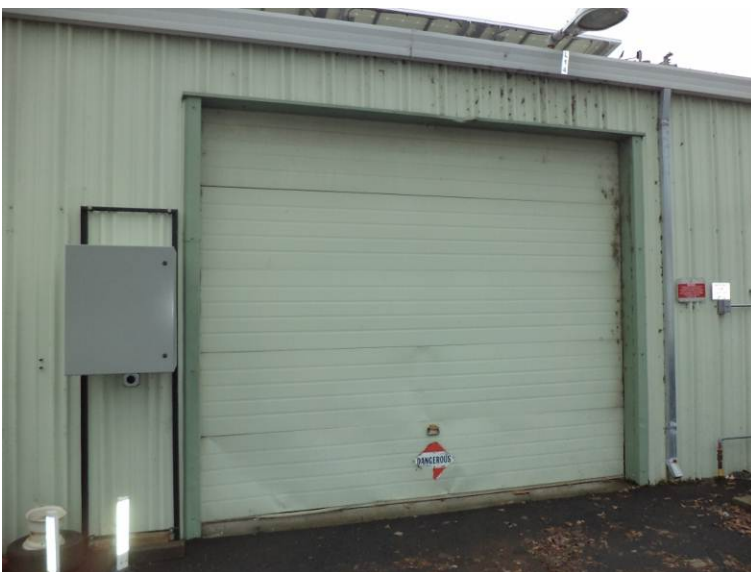
Photograph No. 12

View of one of the original overhead doors at the south elevation.

- ✚ B Shell: Repaint exterior wall surfaces at an estimated cost of \$5,828 in years 2015 and 2023
- ✚ B Shell: Replace two overhead doors at an estimated cost of \$5,600 in year 2013
- ✚ B Shell: Replace metal panel roof covering at an estimated cost of \$151,938 in year 2017
- ✚ D Services: Renovate restroom at an estimated cost of \$8,500 in year 2013
- ✚ D Services: Replace rooftop solar modules at an estimated cost of \$57,750 in year 2031
- ✚ G Building Sitework: Replace emergency generator at an estimated cost of \$5,000 in year 2017

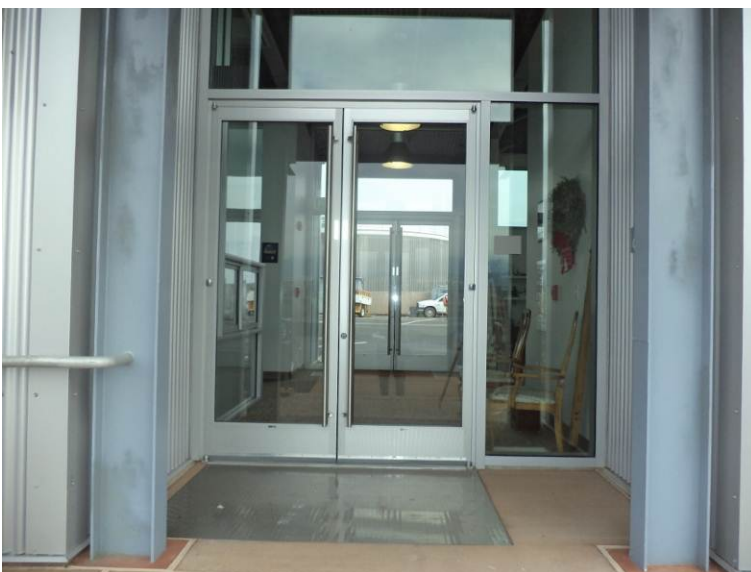
Photograph No. 48

The window units at Building B are newer and therefore based on EUL will last beyond the study period without replacement necessary. Over time the perimeter sealant will eventually start to dry out and shrink, this is typically a result of exposure to moisture, heat and ultraviolet radiation; the sealant will lose its movement capabilities due to loss of plasticizers. The deformed sealant at some point, may allow air and water to enter the building; no signs of moisture penetration at the interior was observed at the time of the assessment. Sealant such as this has a typical EUL of fifteen-years therefore we anticipate it will require replacement with a suitable polyurethane sealant later in the study period to maintain water integrity and prevent any water penetration.

View of the caulking at the window units and reveals of Building B.

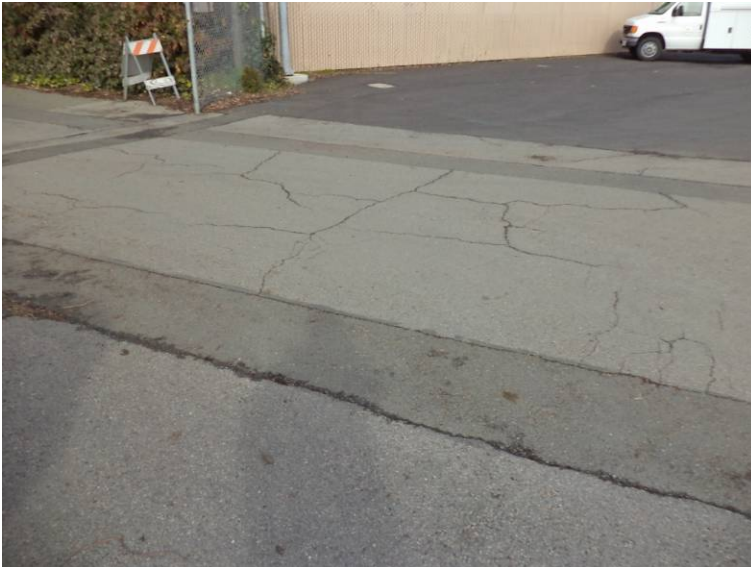
Photograph No. 100

View of the cracking within the asphalt.

- ✚ G Building Sitework: Undertake asphalt mill and overlay to damaged areas only at an estimated cost of \$30,000 in year 2013
- ✚ G Building Sitework: Undertake seal coating to surface of parking lot, yard and roadways at an estimated cost of \$19,200 in years 2018, 2023 and 2028
