FISCAL SUSTAINABILITY – FACILITIES CONDITION & MAINTENANCE

March 19, 2013

Tom Adams, Public Works Department

Faithful+Gould - Consultant

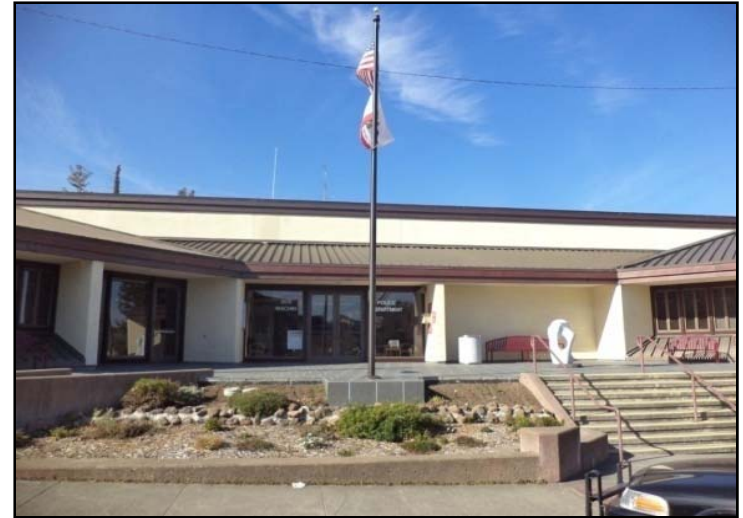
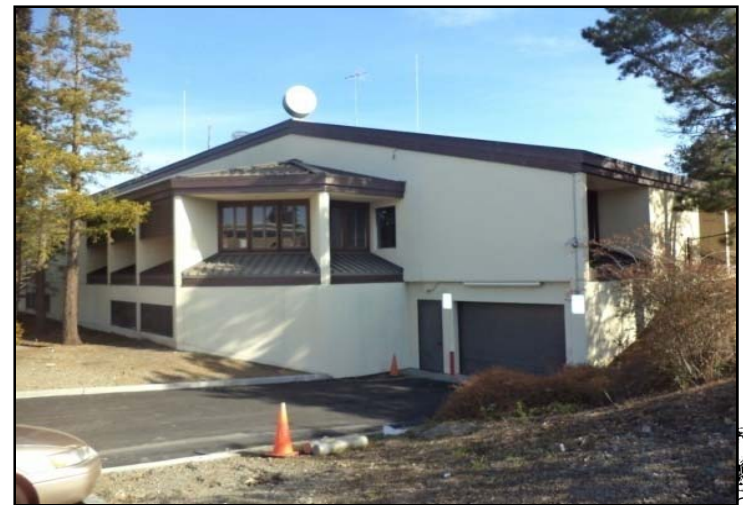
City of Novato Police Department is located at 909 Machin Avenue and was originally built in circa 1979. We understand that there has been minor improvements to the building since construction that include the replacement of the roof coverings, chiller unit, domestic and building heating water boiler, light fixture upgrades and generator replacements.

The building has concrete columns supporting structure and is encapsulated with concrete masonry unit walls at basement level and wood stud walls with a stucco finished surface at the first floor level. The roof covering consists of a low-sloped built-up roof with stone gravel surface and also a steep-sloped standing seam metal panel roof. The floor consisted of a cast-in-place reinforced slab-on-grade concrete floor slab at the basement floor level and a suspended cast-in-place concrete slab at the first floor level. Windows systems consisted of aluminum single pane units. Doors consisted of swing operated glazed entrance doors, hollow metal personnel doors and roll up overhead vehicle doors.

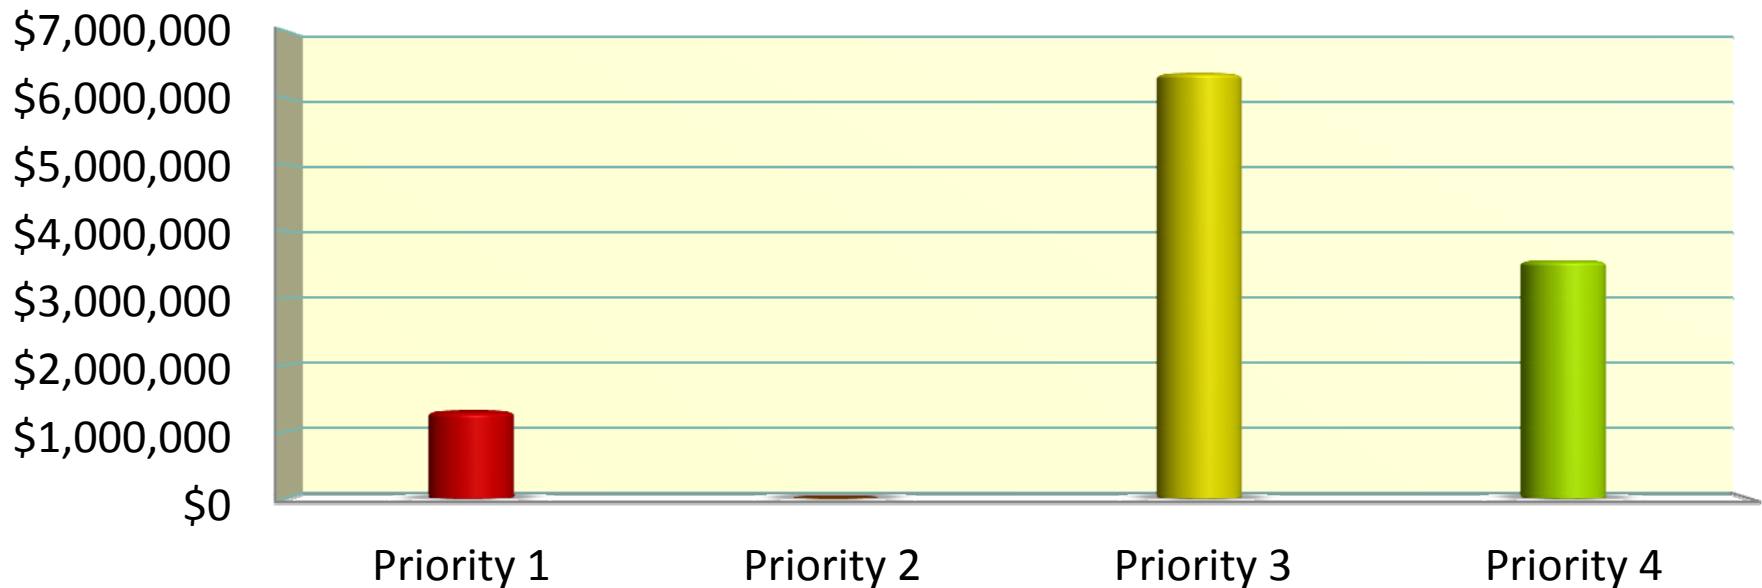
Expenditure by Priority Over 20 Year Period

Priority 1	Priority 2	Priority 3	Priority 4
Expenditures	\$1,297,328	\$500	\$6,375,267	\$3,561,803

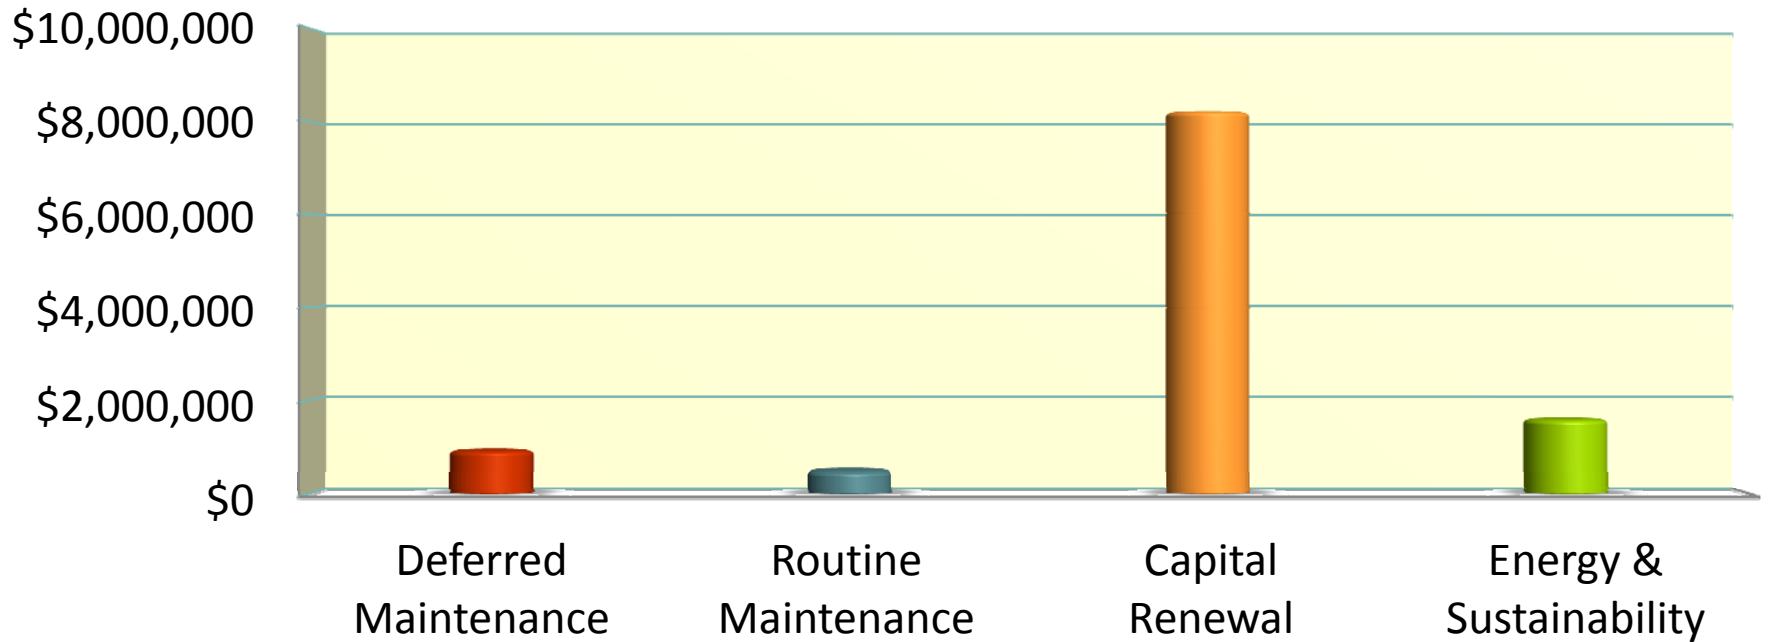
Expenditure by Plan Type over 20 Year Period

Deferred Maintenance	Routine Maintenance	Capital Renewal	Energy & Sustainability
■ Expenditures	\$918,907	\$501,466	\$8,221,792	\$1,592,734
