Facility Condition Assessment and Maintenance Analysis
Executive Summary Report

March 12, 2013

Faithful+Gould, Inc.

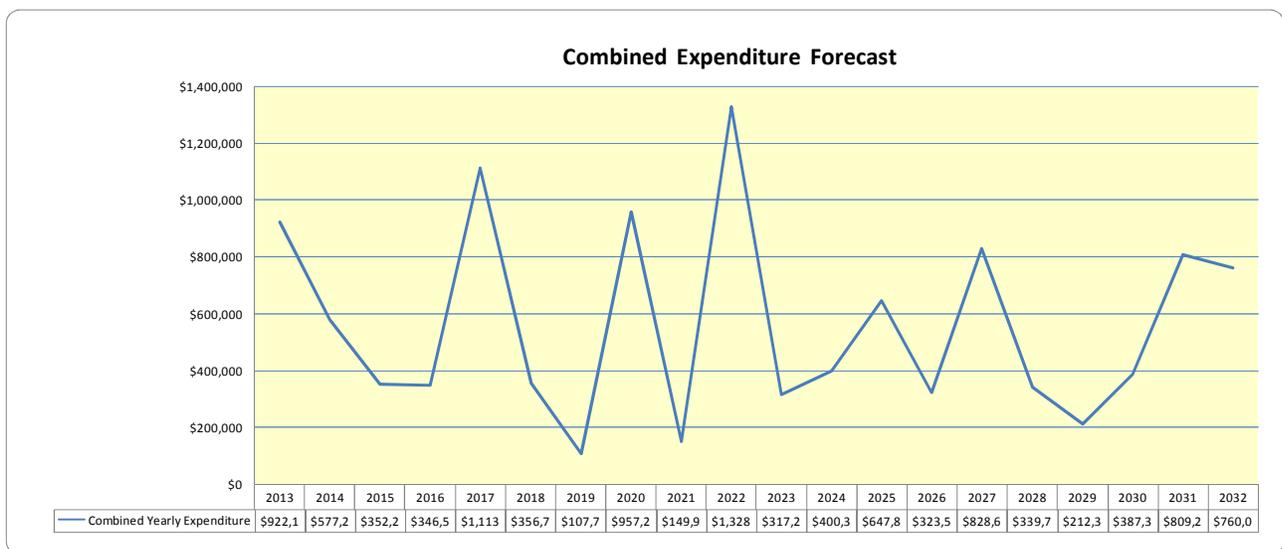
Chart EX-1 Combined Facilities Twenty-Year Expenditure Forecast

Chart EX-1 illustrates a summary of the total twenty-year expenditure forecast for the combined facilities with a total anticipated combined expenditure over the study period of circa \$11,234,898. A more detailed analysis of expenditure is included in the capital expenditure forecast within Appendix A of each report. The chart illustrates the lowest annual expenditure of \$107,754 in 2019 with the highest being \$1,328,723 in 2022.

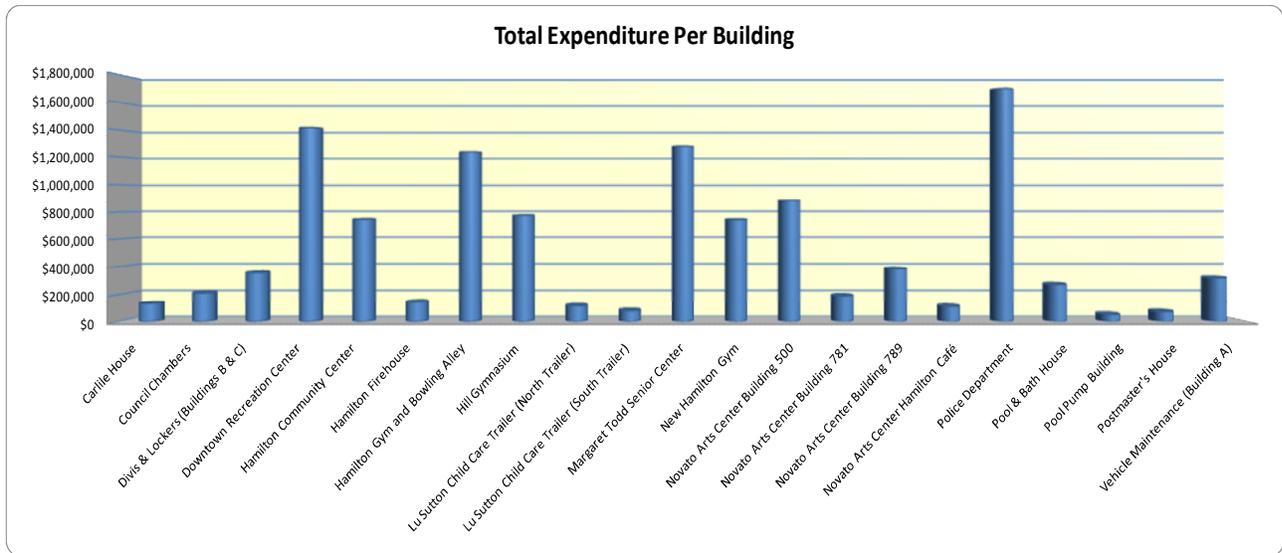
Chart EX-2 Combined Facilities Twenty-Year Expenditure Forecast

Chart EX-2 illustrates a breakdown of expenditures against each facility providing an opportunity to effectively target budget allocation against facilities with the greatest expenditure need. The chart illustrates the Police Department, Downtown Recreation Center, Hamilton Gym and Bowling Alley together with the Margaret Todd Senior Center will require the greatest anticipated expenditure over the next 20-years.

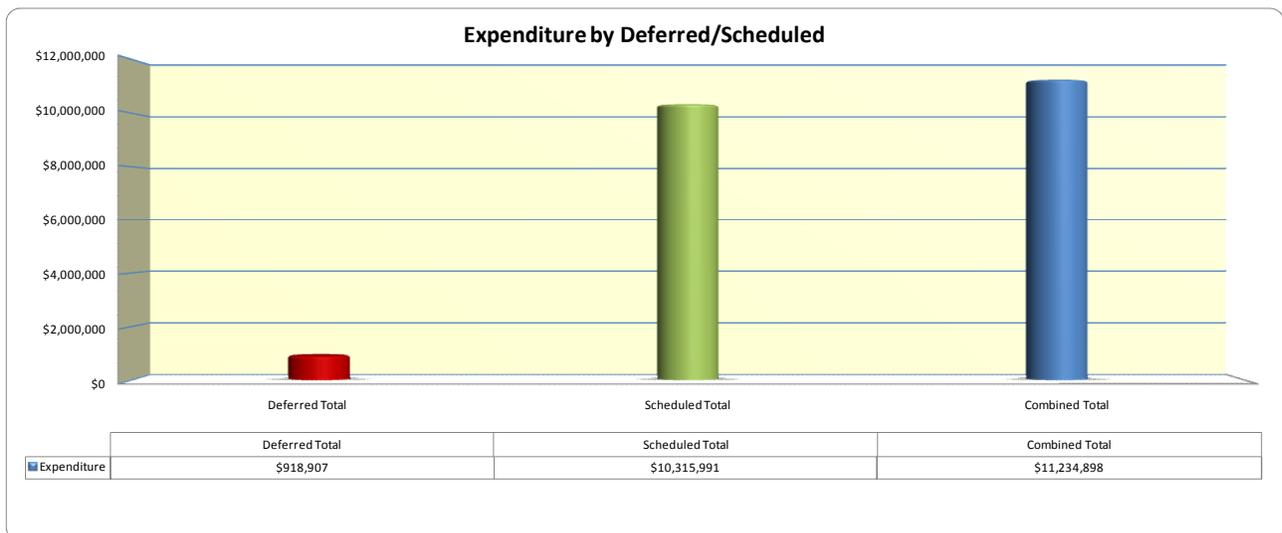
Chart EX-3 Combined Facilities Expenditure by Deferred/Scheduled

Chart EX-3 illustrates a breakdown of expenditures against Deferred and Scheduled providing an opportunity to understand the extent of deferred maintenance. The chart illustrates that deferred maintenance expenditure represents \$918,907 (of which \$672,000 is deferred maintenance at the Hamilton Gym and Bowling Alley), which is just over 8% of the total required funding over the 20-year period.

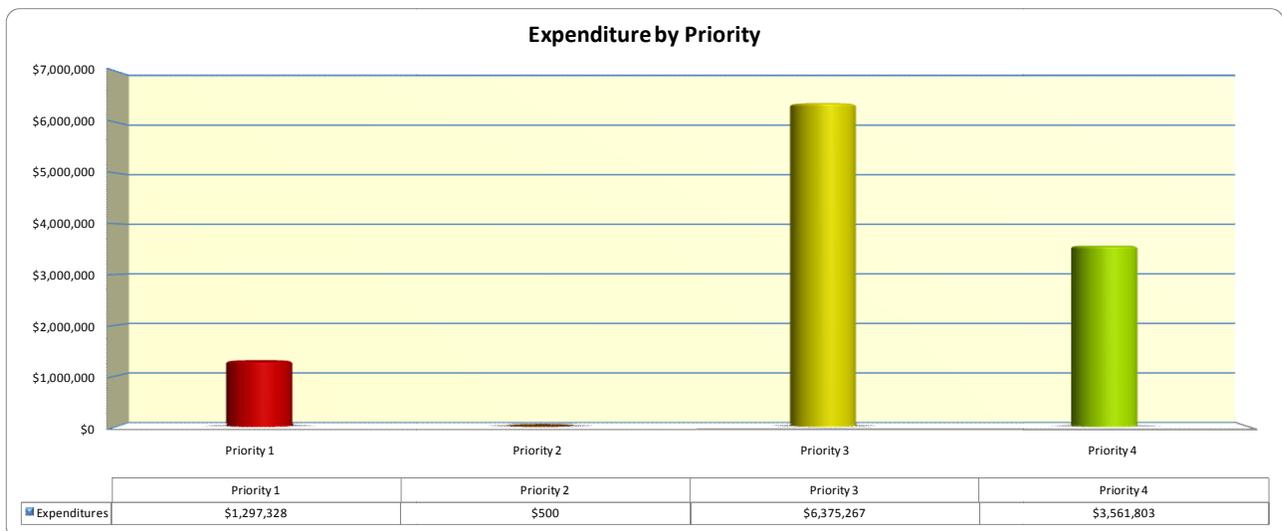
Chart EX-4 Combined Facilities Expenditure by Priority

Chart EX-4 illustrates a breakdown of expenditures by priority providing an opportunity to make informed decisions on funding according to the criticality of the action required. The chart illustrates that Priority 3 – Necessary/Not Critical works require the highest anticipated expenditures of \$6,375,000.

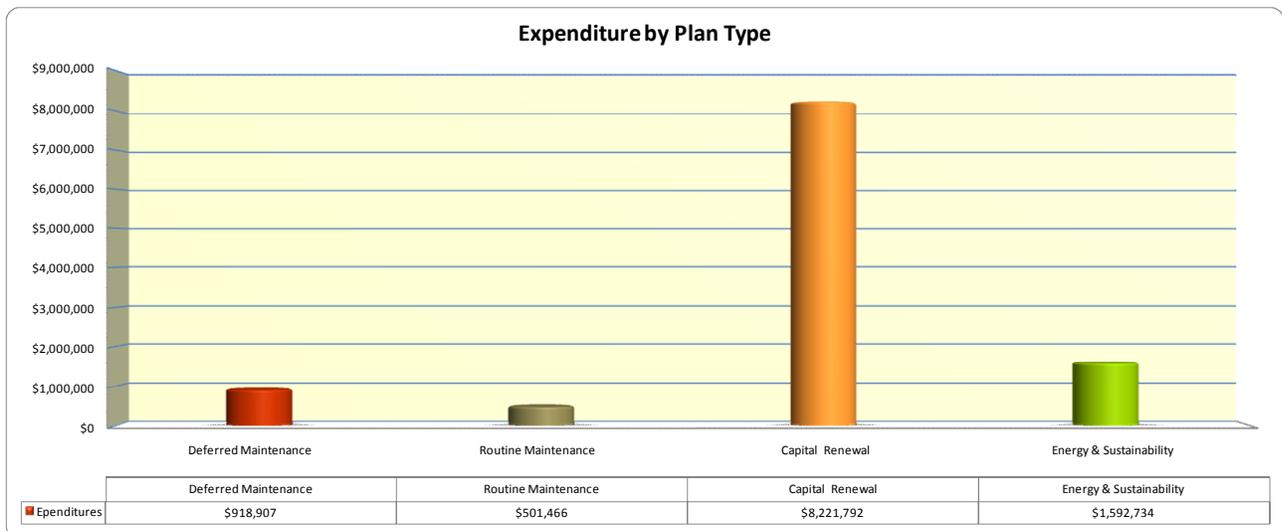
Chart EX-5 Combined Facilities Expenditure by Plan Type

Chart EX-5 illustrates a breakdown of expenditures by plan type providing an opportunity to target funding more effectively against different revenue categories. The chart illustrates that Capital Renewal expenditure of \$8,222,000 represents the greatest amount of required funding over the 20-year period.

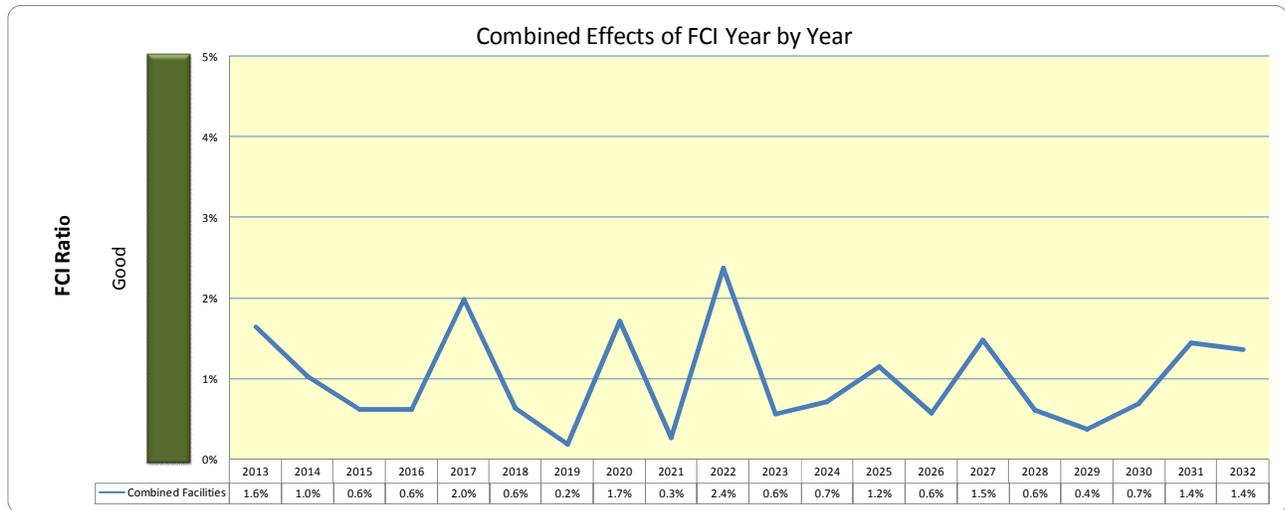
Chart EX-6 Year by Year Effects of FCI over the Study Period

Chart EX-6 indicates the effects of the FCI ratio per year, assuming the required funds and expenditures are made to address the identified works and deferred maintenance each year. The results indicate that the buildings (excluding site systems, as indicated in the individual reports) are all in a GOOD condition at this current time and will remain within GOOD condition based on completion of the identified actions.

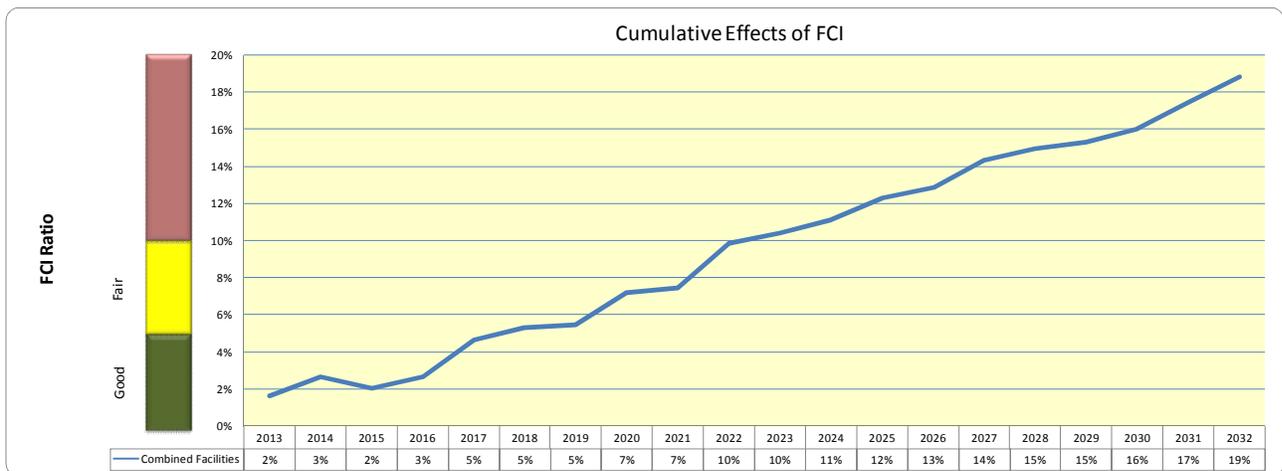
Chart EX-7 Cumulative Effects of FCI over the Study Period

Chart EX-7 indicates the cumulative effects of the FCI ratio over the study period assuming the required funds and expenditures are **NOT** provided to address the identified works and deferred maintenance each year. The results of the study indicate at this current time all of the buildings (with exception to the bowling alley) are well maintained and have a facility condition index rating mainly within the GOOD condition. The condition of the buildings will deteriorate over time and our recommendations are to combat this diminishing trend and keep the buildings from reaching a POOR condition index ratio.
