**Citywide  
Facility Condition Assessment**

**Report of  
Facility Condition Assessment**

**For  
City of Novato  
Carlile House  
853 Reichert Avenue, Novato, CA**

***March 4, 2013***

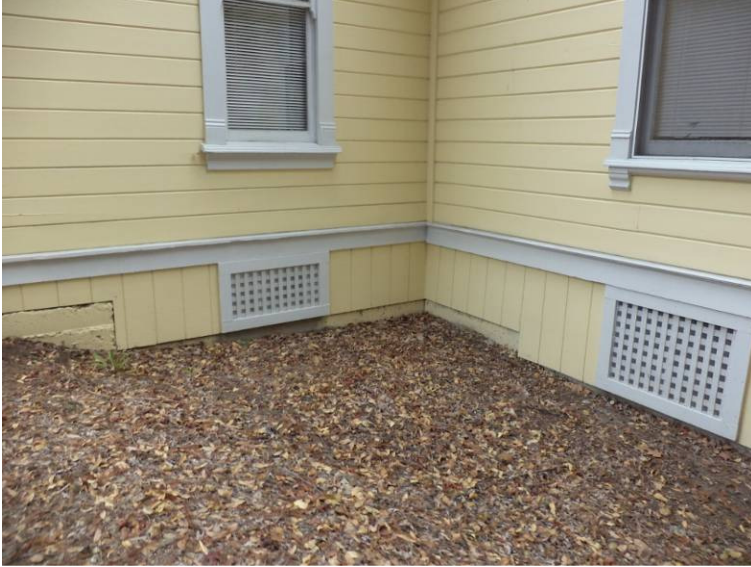
**Photograph No. 1**

View of grills to allow cross ventilation to the crawl space.

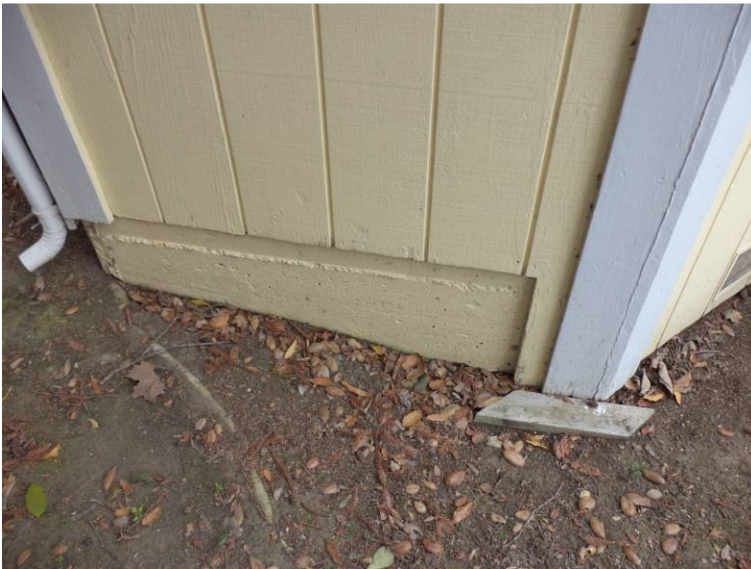
**Photograph No. 2**

View of the concrete footings.

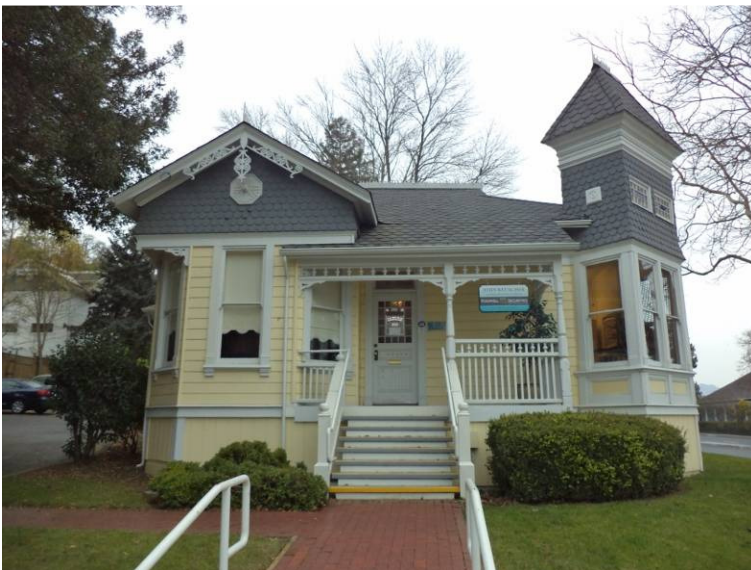
**Photograph No. 3**

The steep-sloped roof areas 1 through 4 contained diagonal/honeycomb slatted carriage house asphalt shingles with mineral surface granules bonded to underlayment on a plywood sheathing deck (reference Photographs 3 through 5 in Appendix B). Low-sloped roof area 5 is assumed to contain a rolled asphalt roof covering. The age of these roof areas are unknown. The roof levels generally drain to perimeter gutters and downspouts.

View of the east elevation and roof covering.

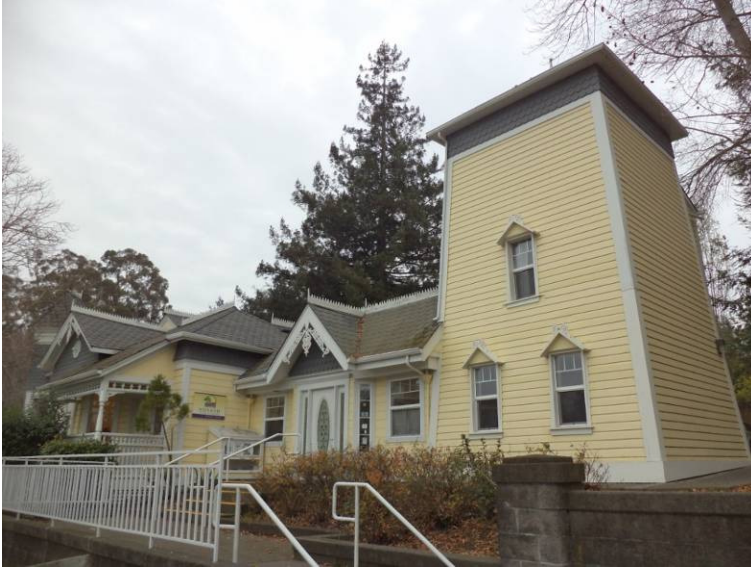
**Photograph No. 4**

View of the north elevation and water tower.

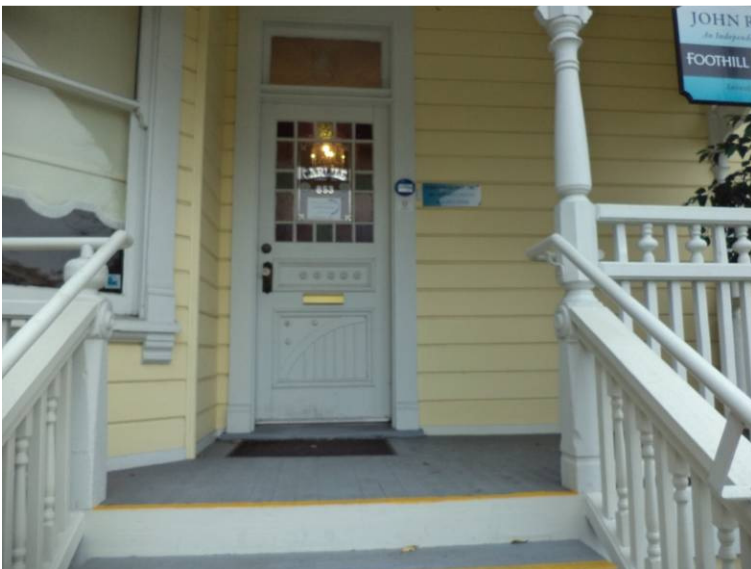
**Photograph No. 6**

The building contained single wood doors with glazed vision panels and painted finish surfaces (reference Photographs 6 and 10 in Appendix B). Door hardware consisted of knob door handles.

View of the entrance door at the east elevation. Also the wood floor decking and siding.

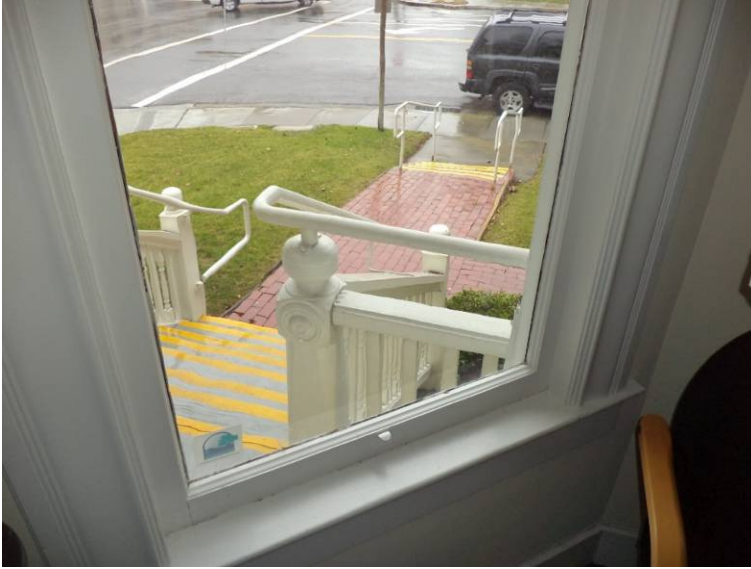
**Photograph No. 7**

The building contained a mixture of window unit types, with fixed and double-hung wooden single pane windows generally throughout the first floor level. The water tower section of the building contains a combination of PVC double-hung insulated as well as metal casement and sliding single pane window units (reference Photographs 1 through 9 in Appendix B).

View of the single pane wood window units.

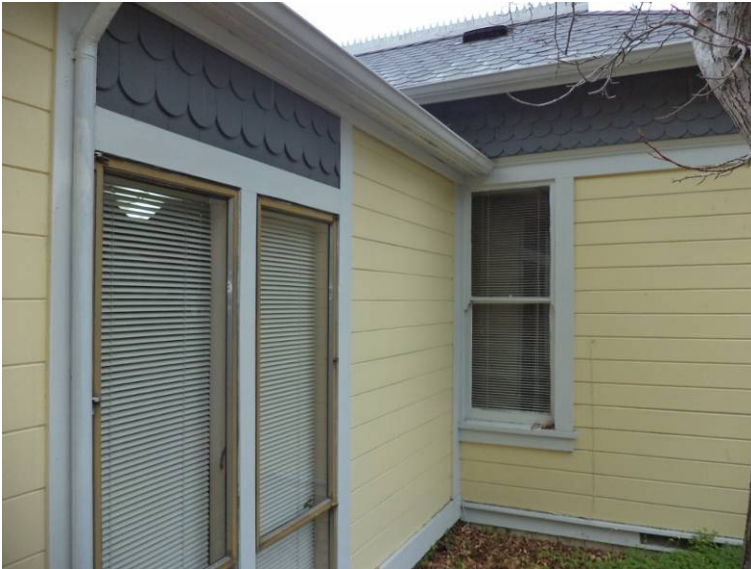
**Photograph No. 8**

View of the single pane metal window units.

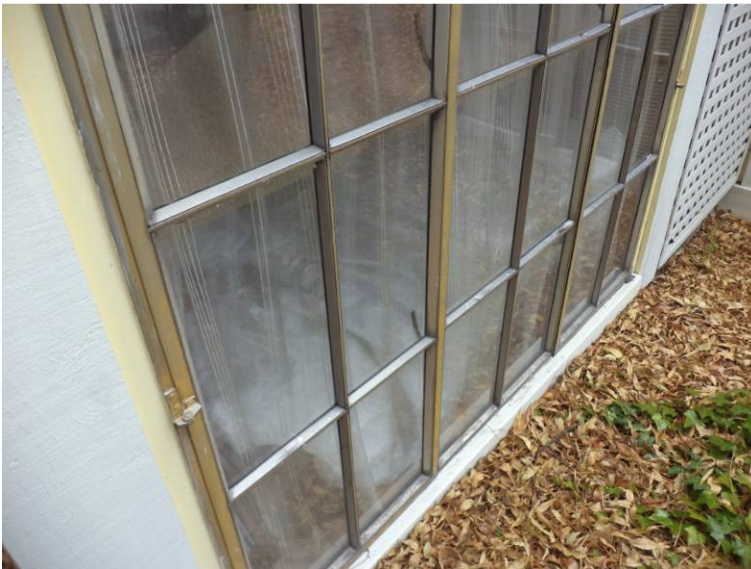
**Photograph No. 9**

View of the single pane metal window units.

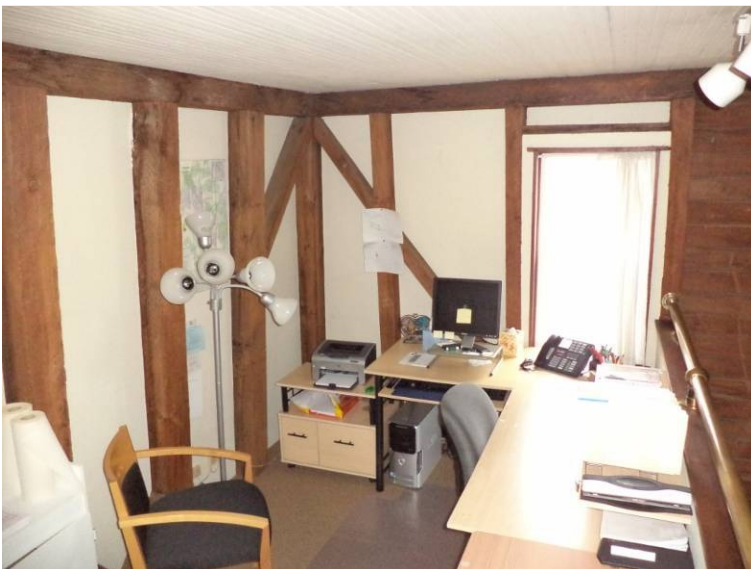
**Photograph No. 12**

View of the the timber post and beam construction at the water tower section of the building.

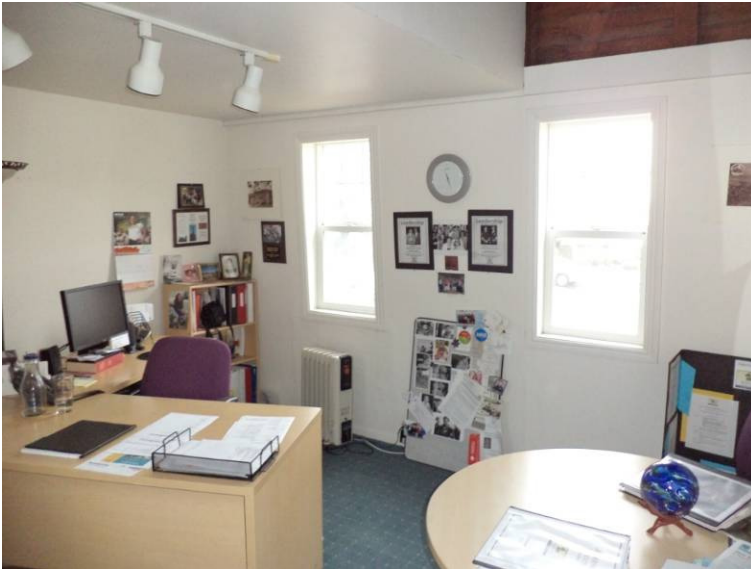
**Photograph No. 14**

View of the finishes within one of the offices.

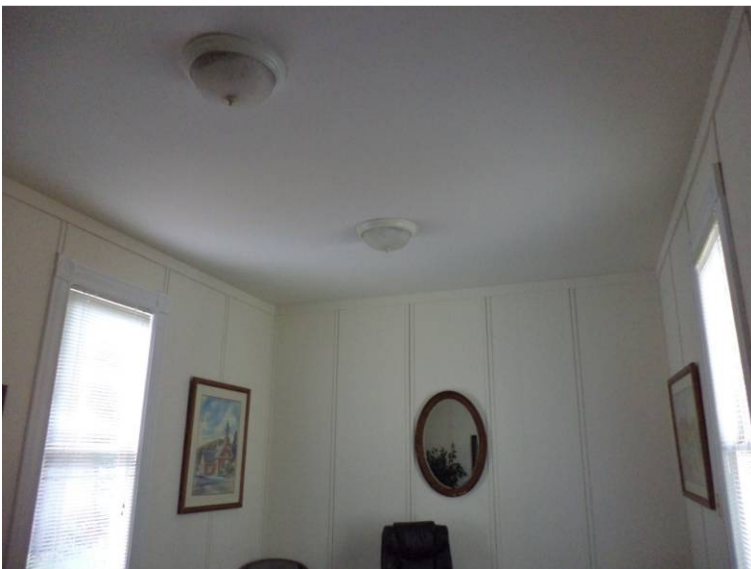
**Photograph No. 15**

View of the finishes within the meeting room.

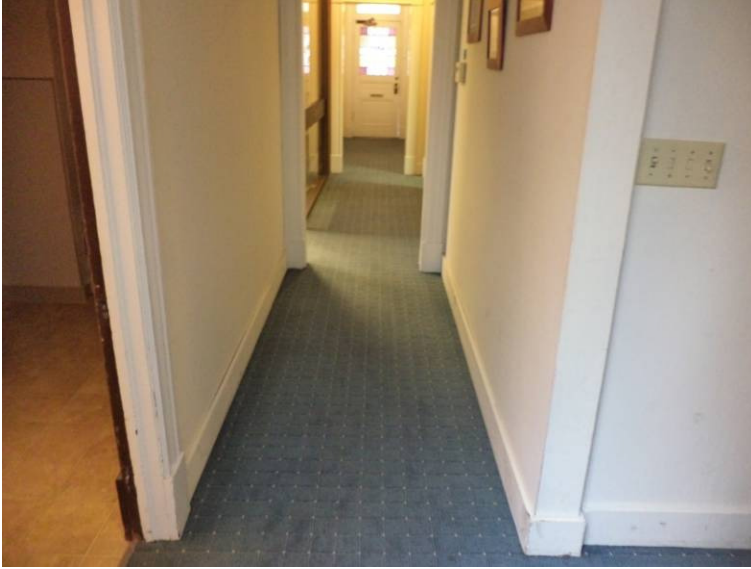
**Photograph No. 16**

The building contained wood stud and frame with gypsum board surfaced partitions at varying thicknesses, with assumed fiberglass batt insulation (reference Photograph 16 in Appendix B).

View of the finishes within the corridor.

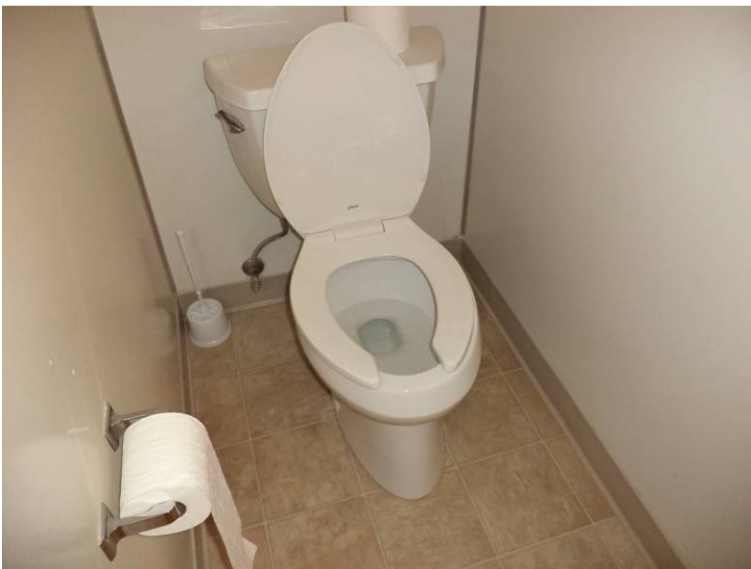
**Photograph No. 18**

The building contains one floor mounted vitreous china water closet with (reference Photograph 18 in Appendix B).

View of one of the floor mounted water closet.

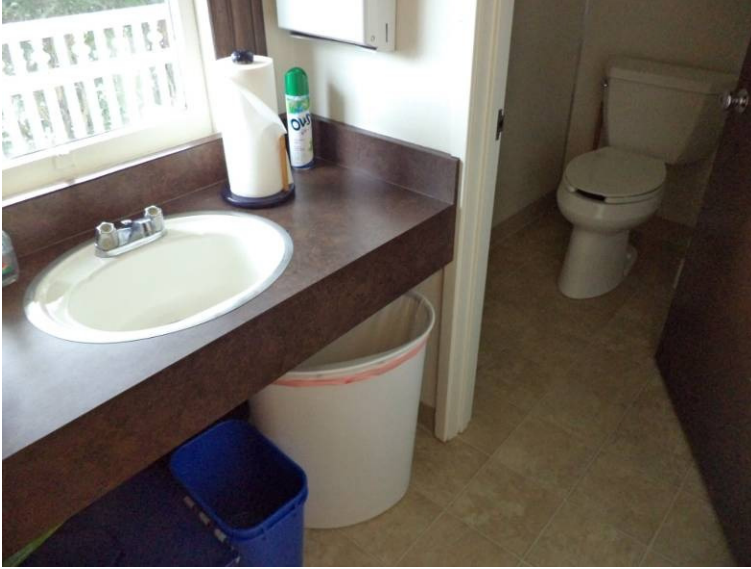
**Photograph No. 19**

The building contains two vitreous china vanity lavatories (reference Photograph 19 in Appendix B). The lavatories consisted of swan neck non-metering faucets with lever type handles. Water is supplied via copper pipe and assumed drained through cast iron pipe work and fittings.

View of the vanity and lavatory.

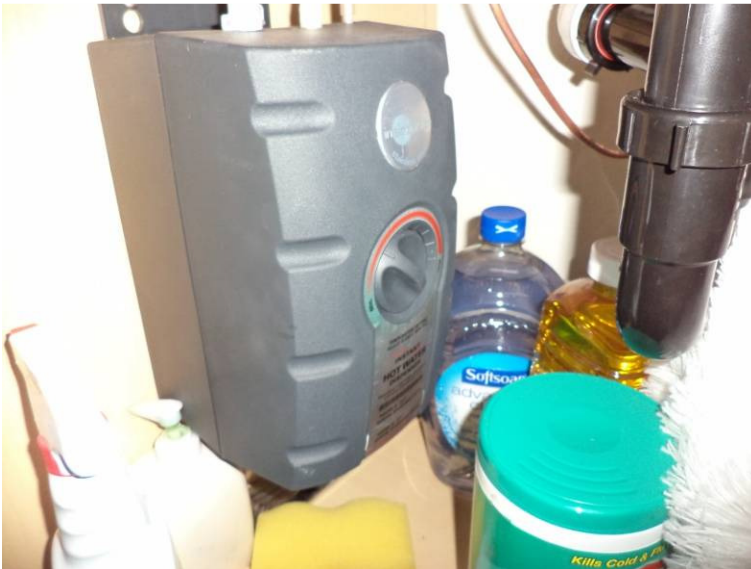
**Photograph No. 21**

Domestic hot water was generated via one instantaneous point-of-use electric water heater located below the worktop in the break area (reference Photograph 21 in Appendix B).

View of the instant water heater.

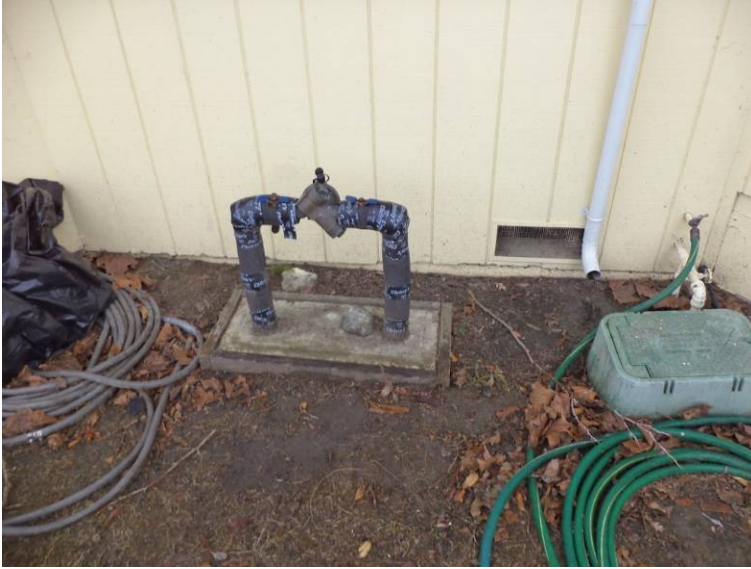
**Photograph No. 22**

Cold water piping throughout the building consisted of copper. We believe the cold water service for the facility is supplied directly from the street pressure. Taps are made to the water line downstream of the meter and routed to plumbing fixtures via copper pipe work. The backflow preventer and supply enters the building at the north elevation (reference Photograph 22 in Appendix B).

View of the water supply back flow preventer.

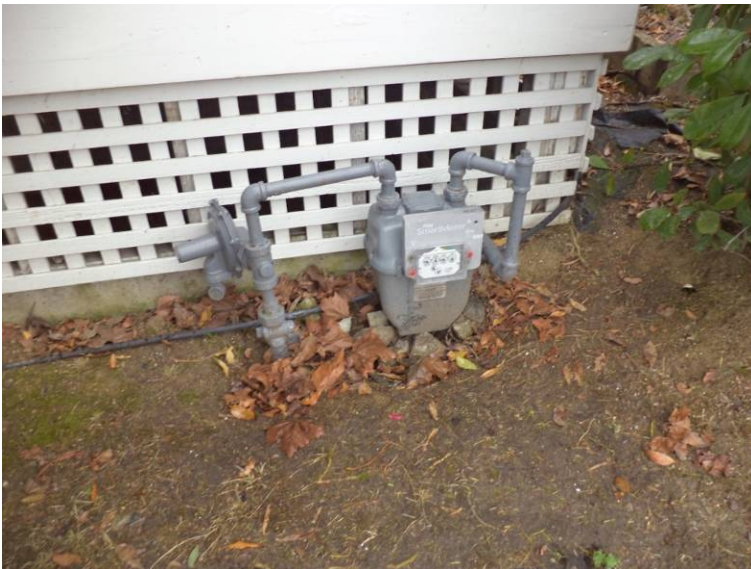
**Photograph No. 23**

There is natural gas service to the building. The pressure reducing station and gas meter are located at the west side. Gas service is routed to the package units (reference Photograph 23 in Appendix B). The service is at the north side of the building.

View of the gas supply and meter.

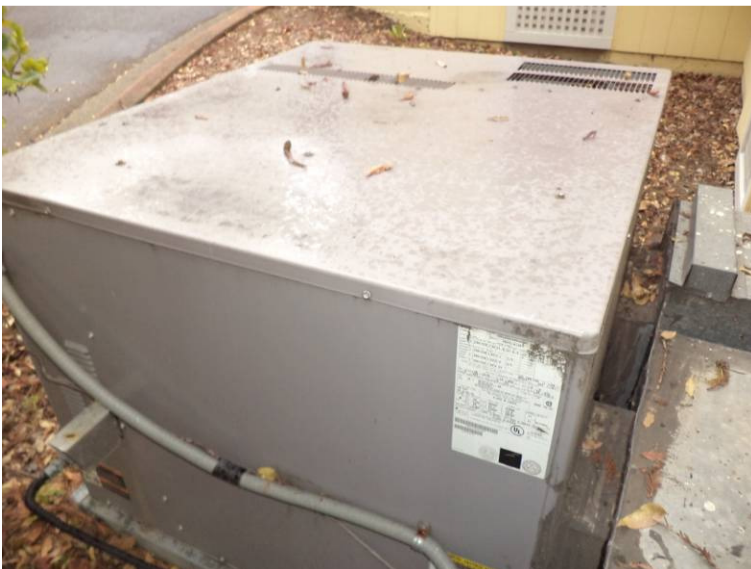
**Photograph No. 24**

Heating and cooling at the building is provided by two single package natural gas and electric cooling units which are manufactured by Bryant (reference Photographs 24 and 25 in Appendix B). One of the package units is located a ground level and the over at roof level. The units have a capacity of 3.5 and 4 tons.

View of the ground mounted package unit.

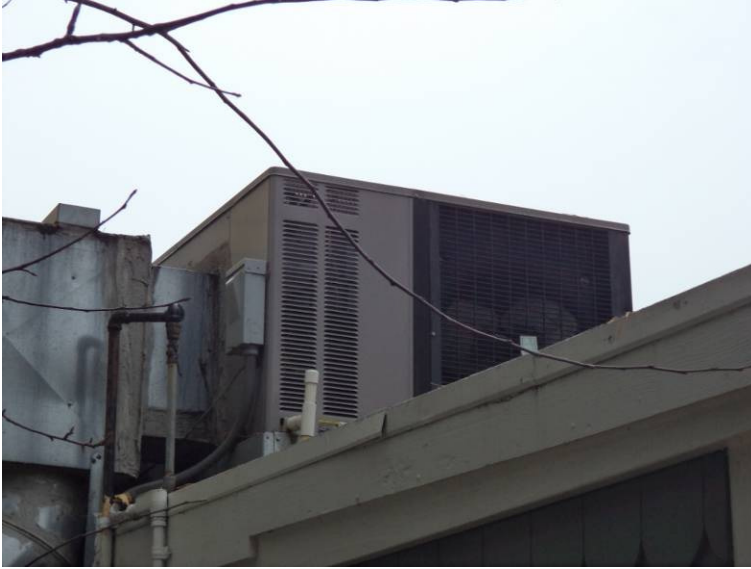
**Photograph No. 25**

View of the roof mounted package unit.

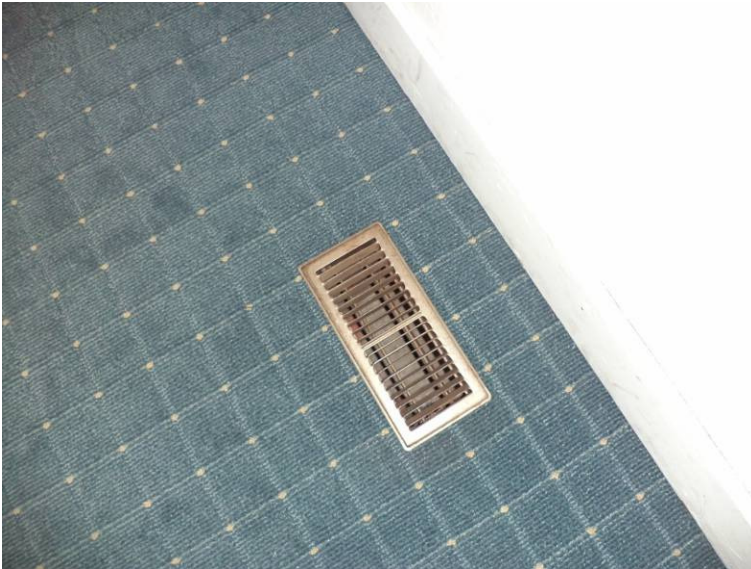
**Photograph No. 26**

The conditioned air is distributed throughout the building via metal ductwork located below the first floor and vents through grills (reference Photograph 26 in Appendix B).

View of floor grills.

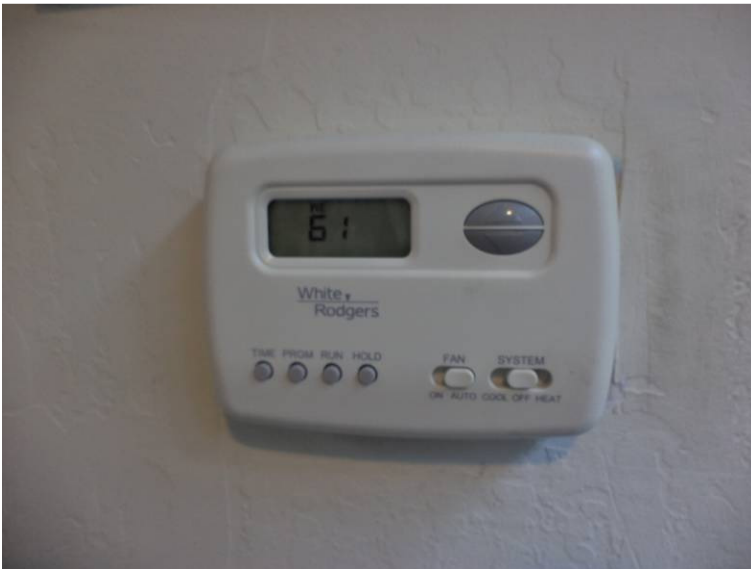
**Photograph No. 27**

The buildings HVAC system is controlled by individual wall mounted digital thermostats located in the areas the units serves (reference Photographs 27 and 28 in Appendix B).

View of a thermostat.

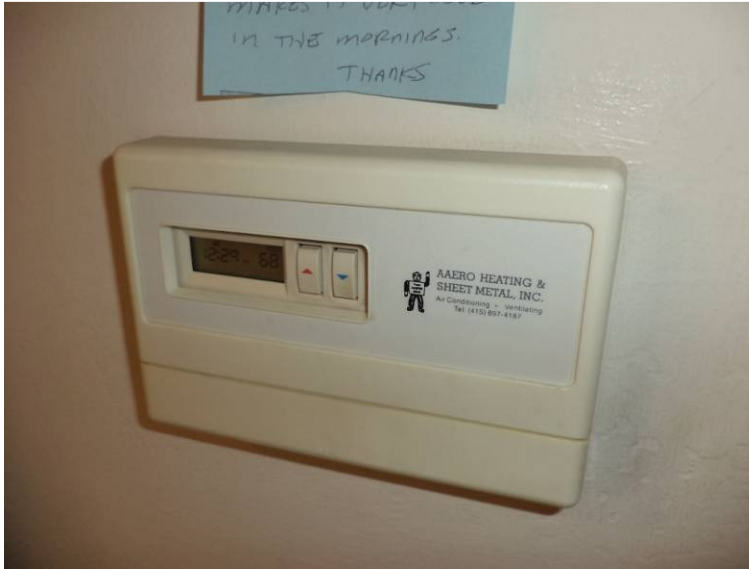
**Photograph No. 28**

View of the other thermostat.

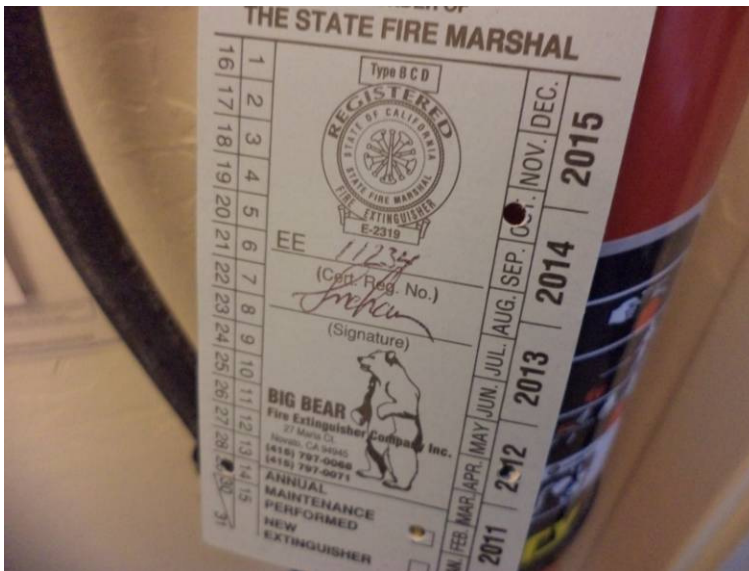
**Photograph No. 29**

Multipurpose portable wall mounted handheld fire extinguishers were provided throughout the building (reference Photograph 29 in Appendix B).

View of the fire extinguisher tag.

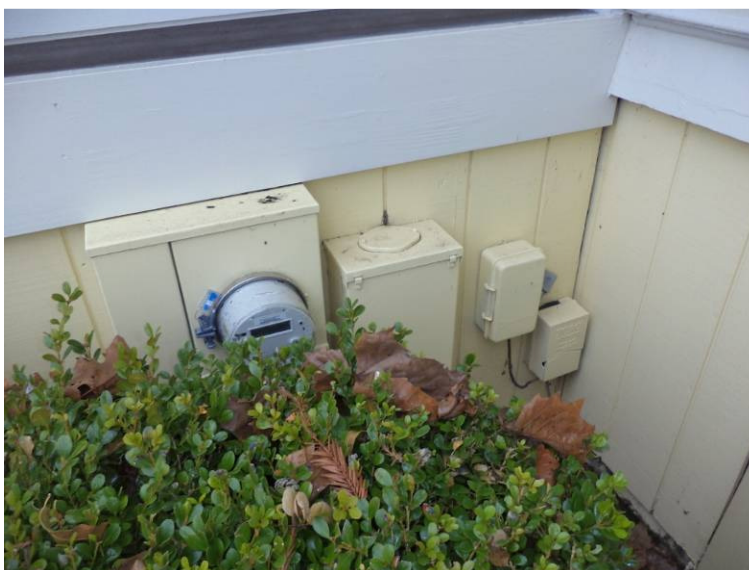
**Photograph No. 30**

View of the electrical meter and panel.

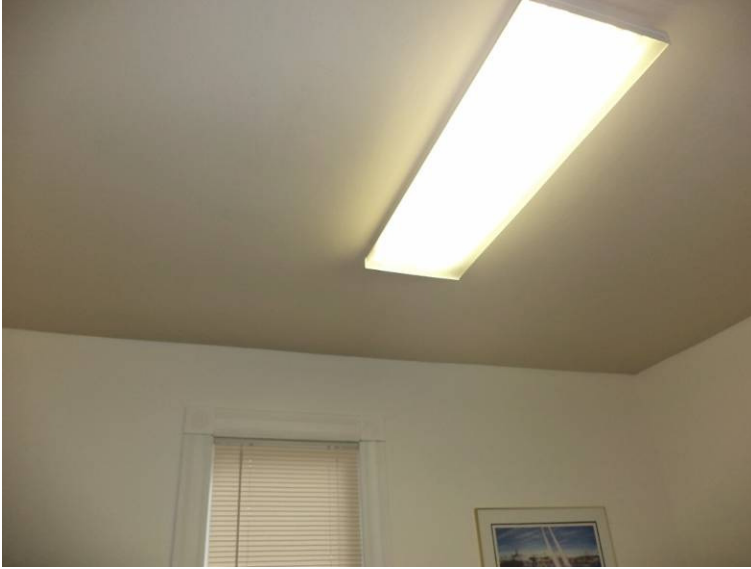
**Photograph No. 31**

View of the surface mounted light fixtures.
