Novato Parks Facility Condition Assessment and Maintenance Analysis
Executive Summary Report

Updated: December 11, 2013

Faithful+Gould, Inc.

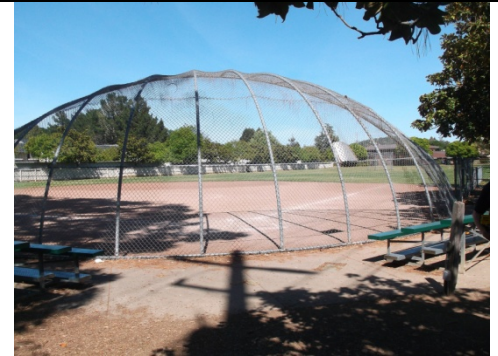
MARION RECREATION AREA		
<p> Marion Recreation Area 1720 Grant Ave. </p>	<p>1.98</p>	<p>Marion Recreation Area consists of a youth softball field with benches and a large grassy play area. The park is fenced and contains shade trees at the perimeter. There is a concession/storage building that appears to be no longer in use. There are no restroom facilities or onsite parking.</p>
<p>CONDITION SUMMARY</p>		
<p> Marion Recreation Area </p>		<p>The park was observed to be generally in fair-to-good condition at the time of our assessment. Routine maintenance items include normal repairs to the irrigation system.</p> <p>The baseball field's chain link backstop and fence along the south elevation appeared to be in poor condition. The fence and backstop appear to have exceeded the typical EUL of 15 years for a chain link fence; therefore, based on its EUL and observed condition, we recommend it is replaced at the start of the study period (reference Photographs 1 through 3 in Appendix B).</p>

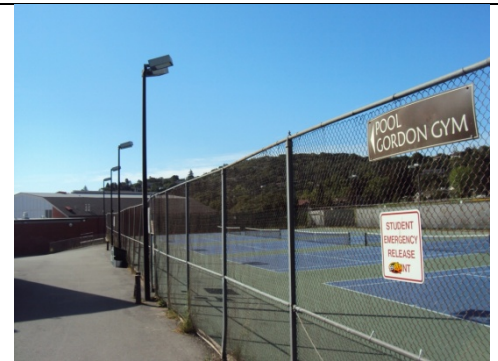
NOVATO HIGH SCHOOL TENNIS COURTS		
<p> Novato High School Tennis Courts 625 Arthur St. </p>	<p>N/A</p>	<p>City of Novato Public Works Department is only responsible for maintaining the light fixtures and controls at the Novato High School Tennis Courts. The court surfaces and fencing are maintained by the school district.</p>
<p>CONDITION SUMMARY</p>		
<p> Novato High School Tennis Courts </p>		<p>The tennis court lighting fixtures appeared to be in fair condition. The typical EUL for high pole lighting is 20 years; therefore, based on condition and EUL, we anticipate replacement will be necessary early in the study period (reference Photographs 1 and 2 in Appendix B).</p> <p>The tennis court lighting controls appeared to be in fair condition. The typical EUL for court lighting controls is 15 years; therefore, based on condition and EUL, replacement will be necessary at the start of study period and again in 15 years (reference Photograph 3 in Appendix B).</p>
