Citywide
Facility Condition Assessment

Report of
Facility Condition Assessment

For
City of Novato
Archery Shed
Miwok Park, Novato, CA

March 4, 2013

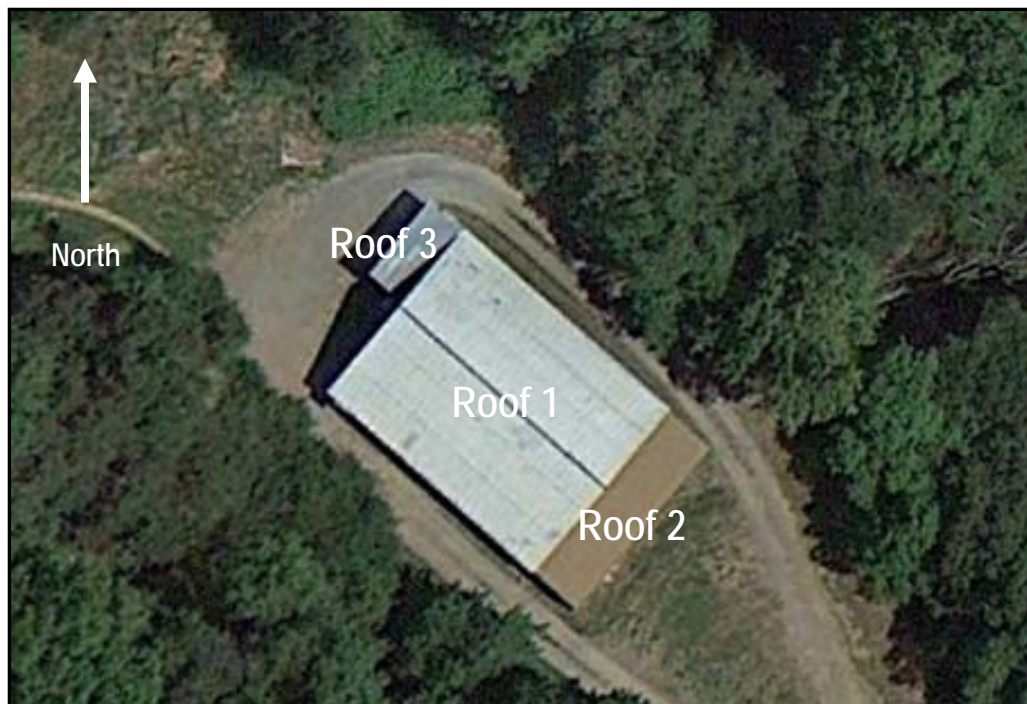
Overview of Roof Locations & Configurations

The facility contained two low-sloped roof areas and one steep-sloped roof area; these roof areas are shown on the following aerial plan:

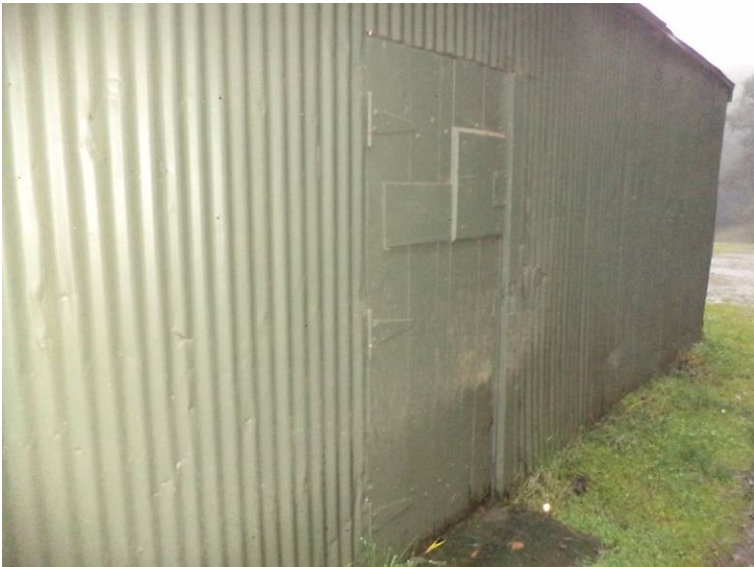
Photograph No. 5

View of the painted corrugated sheet metal forming the outer part of the exterior wall construction. Also shows single wood entrance door.

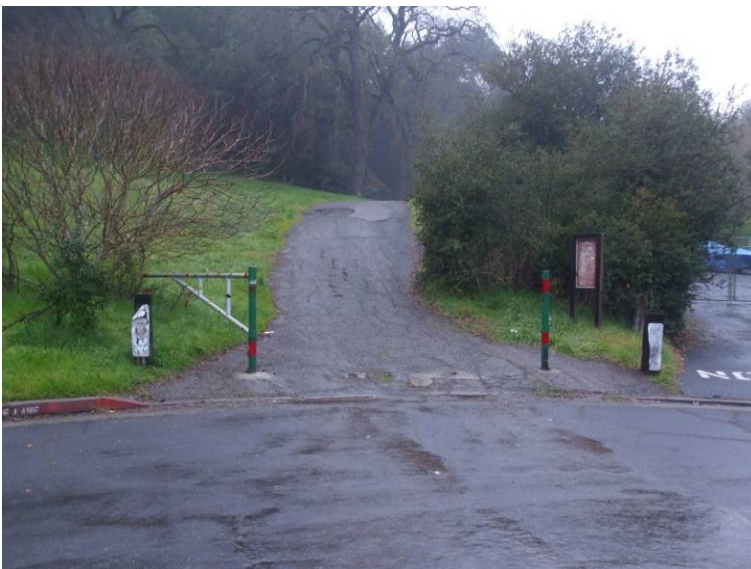
Photograph No. 20

View of grass parking area available for the building users.
