**Citywide  
Facility Condition Assessment**

**Report of  
Facility Condition Assessment**

**For  
City of Novato  
Council Chambers  
901 Sherman Avenue, Novato, CA**

***March 4, 2013***

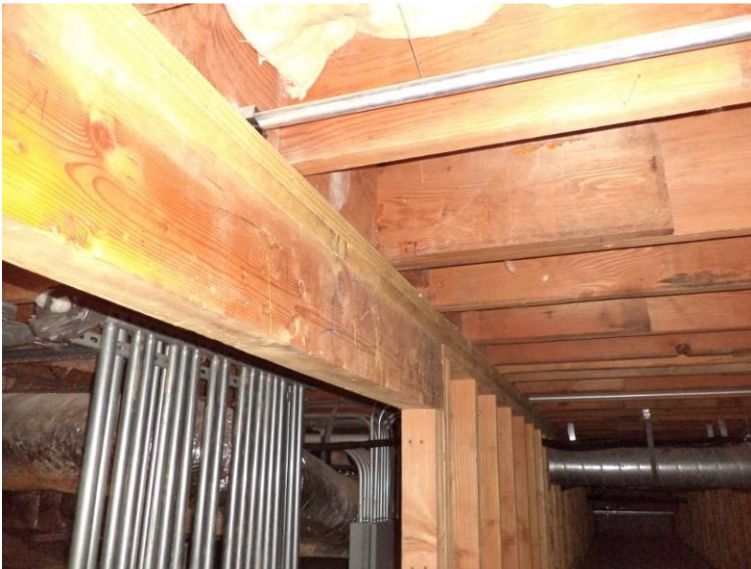
**Photograph No. 1**

View of the floor construction at the west section (Annex) of the building.

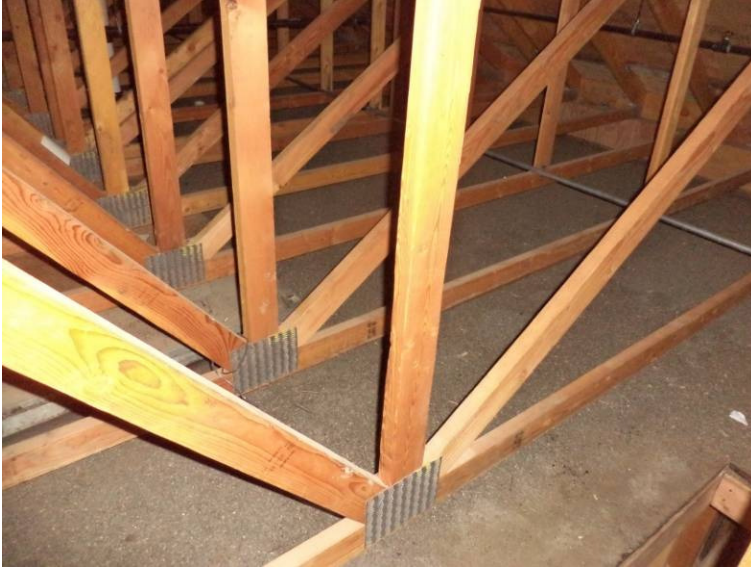
**Photograph No. 3**

The steep-sloped roof sections consist of pre-engineered roof trusses which are generally spaced at 24" centers at each section of the building forming a gable end roof detail at the council chamber and hip roof detail at the annex building (reference Photographs 3 and 4 in Appendix B). The roof covering can be viewed in the roof covering section of this report.

View of the roof construction.

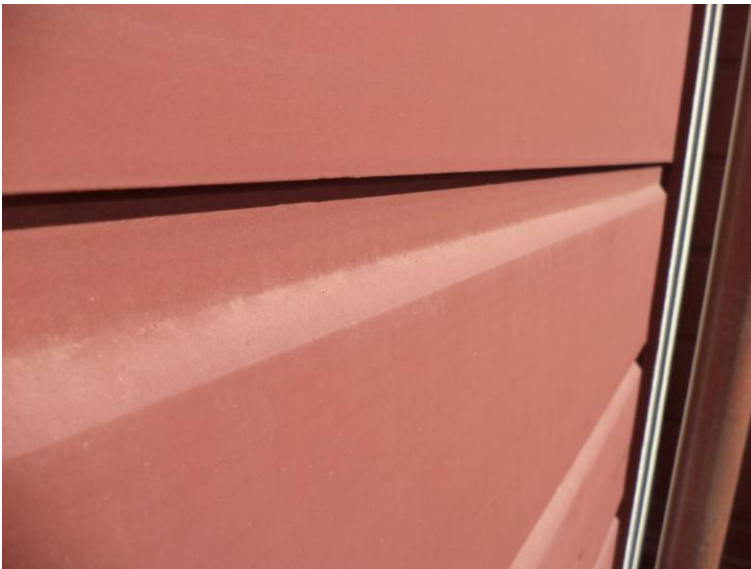
**Photograph No. 7**

The building contained a mixture of window units, with the historic section of the building (council chamber) containing wood arched fixed sash window units with single pane glazing (reference Photographs 6, 7 and 10 in Appendix B) and the lobby and annex sections containing white anodized aluminum window units with fixed transom type and double hung type openable sections with insulated glazing (reference Photographs 11 and 12 in Appendix B).

View of the exterior siding and roof covering.

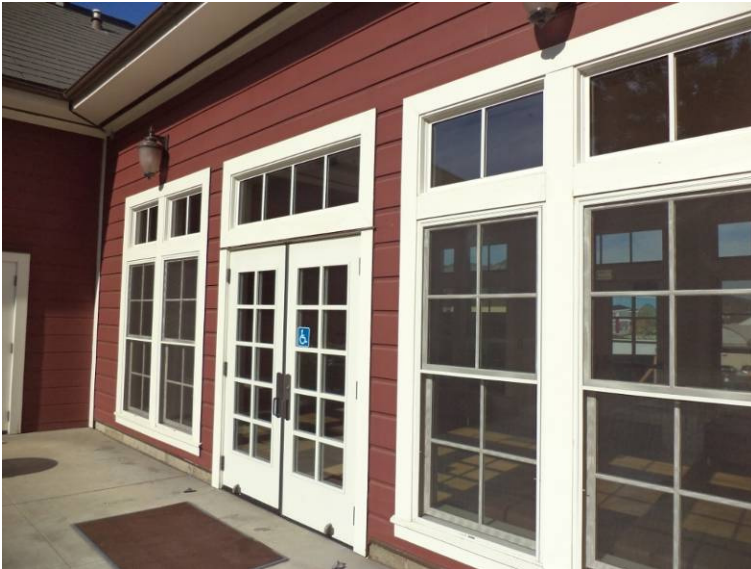
**Photograph No. 10**

View of the wood sash window units.

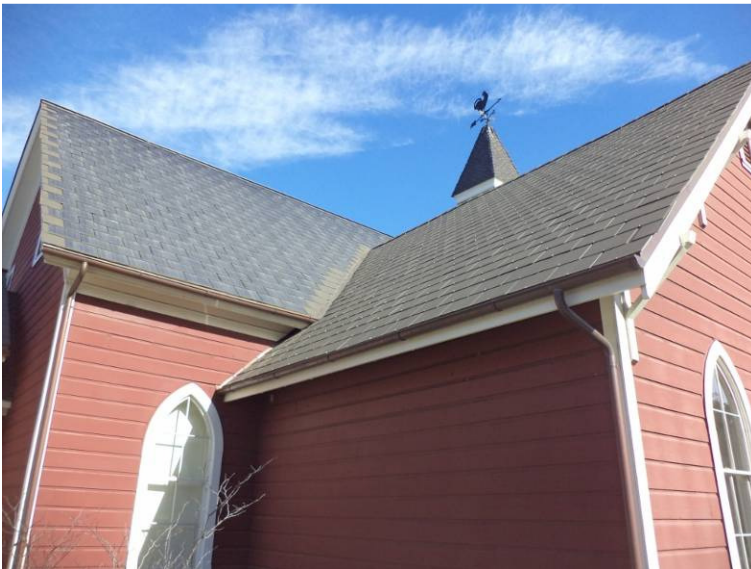
**Photograph No. 14**

The steep-sloped roof areas 1 through 4 contained a composite fiber cement slate shingle roof covering with a back-up of felt underlayment and battens (reference Photographs 14 and 15 in Appendix B). The ridges contain ridge vents to assist with the cross ventilation from the soffits. The roof constructions have R-30 batt insulation present. The shingle roof covering has photovoltaic solar modules integrated within it at the south facing slopes; these are shown on the aerial plan above. The Roof areas 5 and 6 both contain standing seam copper roof panels.

The fiber cement slate shingle and the standing seam copper panel roof coverings appeared to be in good condition at each of the roof areas, with no roof leaks reported. However we noted a few slipped shingles which we recommend are re-fixed immediately (reference Photographs 14 and 15 in Appendix B). Both of these roof coverings have a typical EUL of more than thirty-years therefore as they were installed as part of the renovation works in 2010; no replacement actions have been included for within this study. We recommend that the shingle roof covering is monitored periodically to assess if any shingle has slipped, so that they can be re-fixed accordingly.

View of the roof construction.

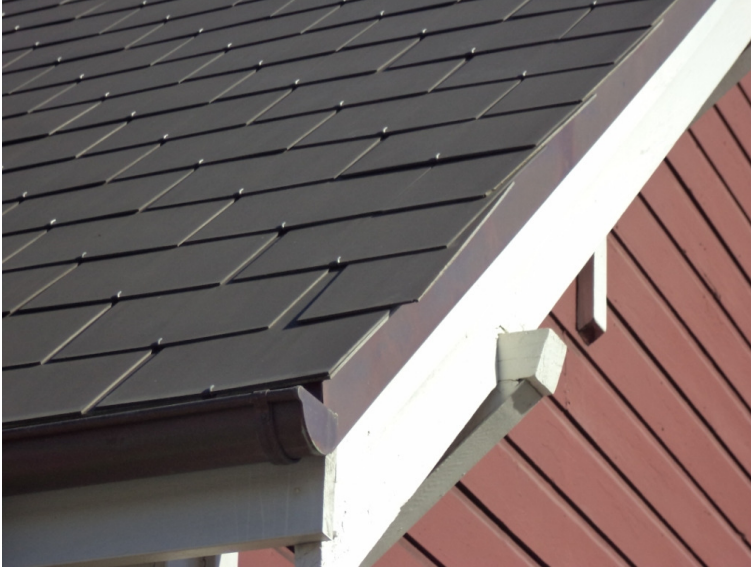
**Photograph No. 15**

View of the roof construction and the solar tiles.

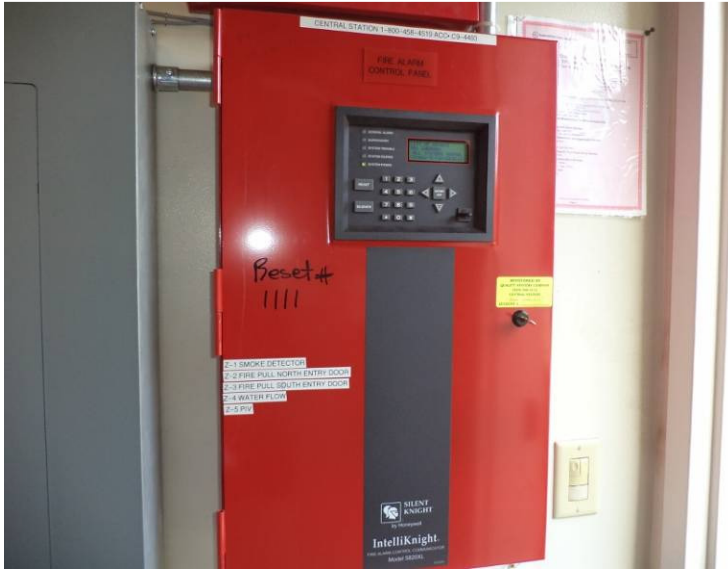
**Photograph No. 36**

The building is protected by a digital automatic fire detection alarm system which consists of 5 zones. The main Fire Alarm Control Panel (FACP) is located within the electrical room, and is manufactured by Silent Knight by Honeywell. The FACP model is an IntelliKnight model 5820XL (reference Photographs 36 and 37 in Appendix B). An annunciation panel is located in the lobby. Addressable devices are located throughout the building such as smoke detectors, pull stations and fire bell. The system is monitored by Bay Cities Fire Protection, tel: 707-579-8694.

The building contains an intruder alarm system, which consists of a programmable security alarm panel and motion sensors (reference Photograph 36 in Appendix B). The alarm panel is located within the lobby and the motion sensors are located throughout the building. We understand that the security system is also monitored 24/7 by Quality Systems Company, tel: 925-586-4112.

View of the fire annunciator panel and security panel.

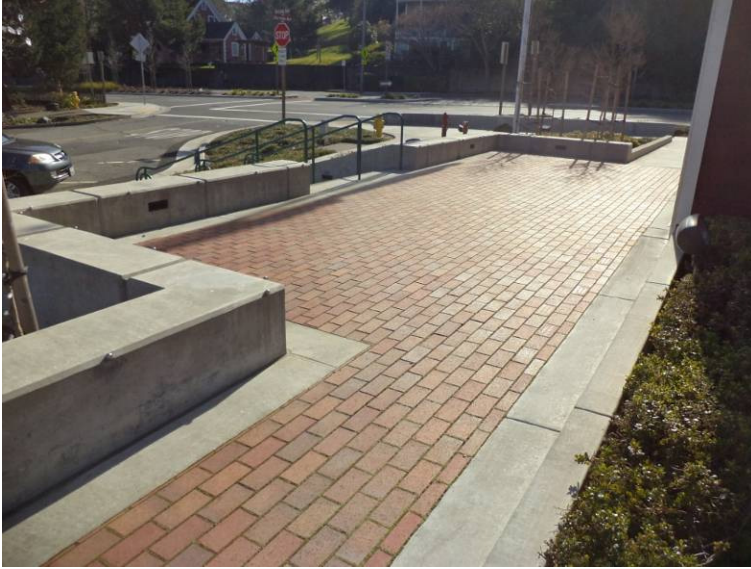
**Photograph No. 42**

The building contained cast-in-place concrete steps at the east side of the building, immediately opposite the main entrance and also a concrete ramped access at the north-west corner. The steps and ramp contained steel tubular handrails at either side (reference Photograph 42 in Appendix B).

View of pedestrian paving at the main entrance.
