**Citywide
Facility Condition Assessment**

**Report of
Facility Condition Assessment**

**For
City of Novato
Downtown Recreation Center
950 Seventh Street, Novato, CA**

March 4, 2013

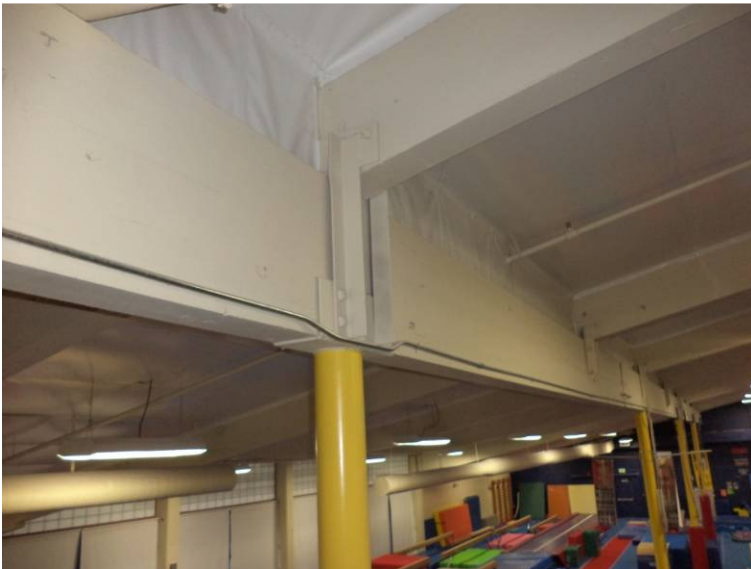
Photograph No. 1

As explained building A has reinforced cast-in-place concrete columns sized at 1'-2" x 1'-2" at the perimeter, which appear to support the glulam beams that span north-south (reference Photograph 1 in Appendix B).

The concrete columns appeared to be in good condition. We do not anticipate the replacement of such structural elements during the cost study period.

View of the concrete columns supporting the glulam beams.

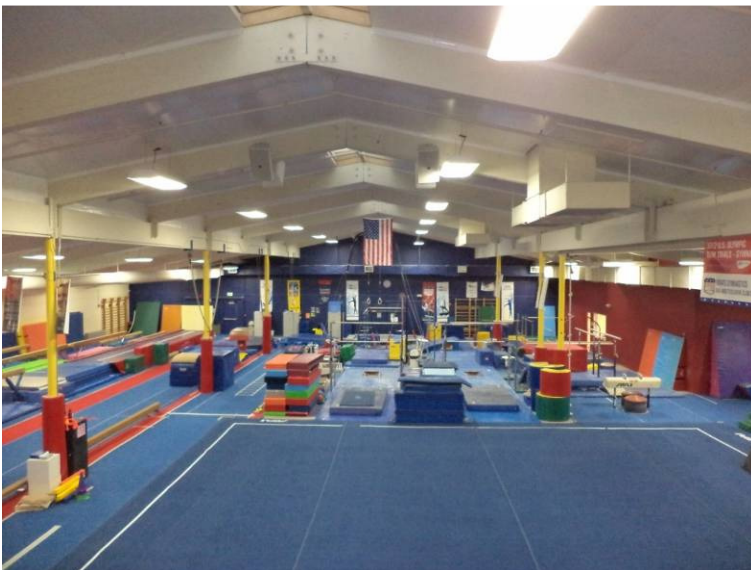
Photograph No. 2

In addition to the concrete columns, building A also contains 7" diameter posts supporting the glulam girders that span east-west (reference Photograph 2 in Appendix B).

View of the supporting steel posts and the glulam girder.

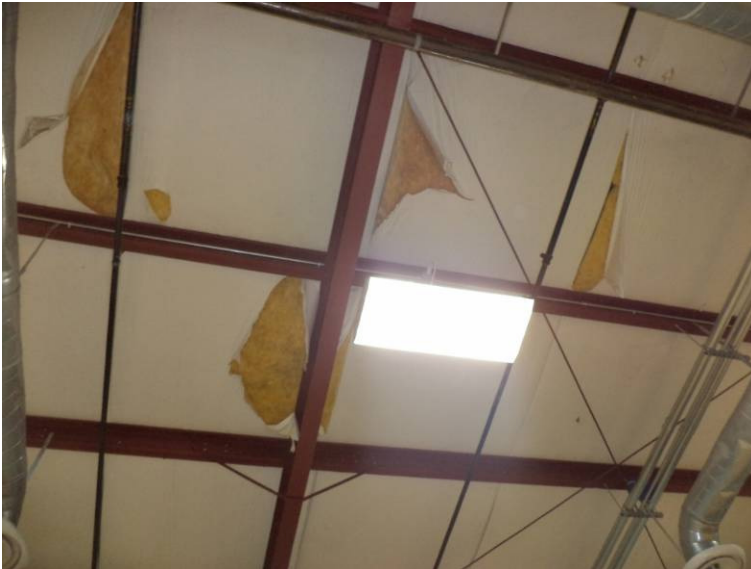
Photograph No. 4

The rigid frame at building B are sized with approximately 2'-0" thick steel at the upper section which support metal "I" section steel joists that are 5" deep spanning north-south (reference Photographs 4 and 5 in Appendix B). These joists support the metal roof deck/covering.

Building B contains a rigid structural steel frame spanning east-west, supporting the wall and roof constructions (reference Photograph 4 in Appendix B). The rigid frame consists of two columns and a beam/girder that are rigidly connected at their joints.

View of the steel rigid frame structure in building B.

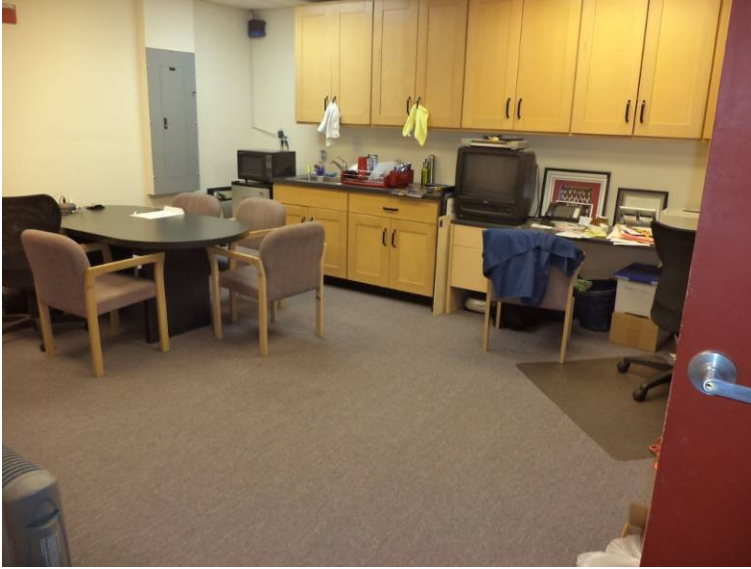
Photograph No. 24

Interior walls throughout each section of the building generally contained a painted gypsum wall board surface. The restrooms at both sections of the building both contained ceramic 2" x 2" wall tiles in select locations from floor to ceiling height. In addition the restrooms within building A also contained a 5'-0" high PVC wainscot behind the urinals (reference Photographs 24 through 25, 27 and 35 in Appendix B).

View of the painted walls within the gymnasium area.

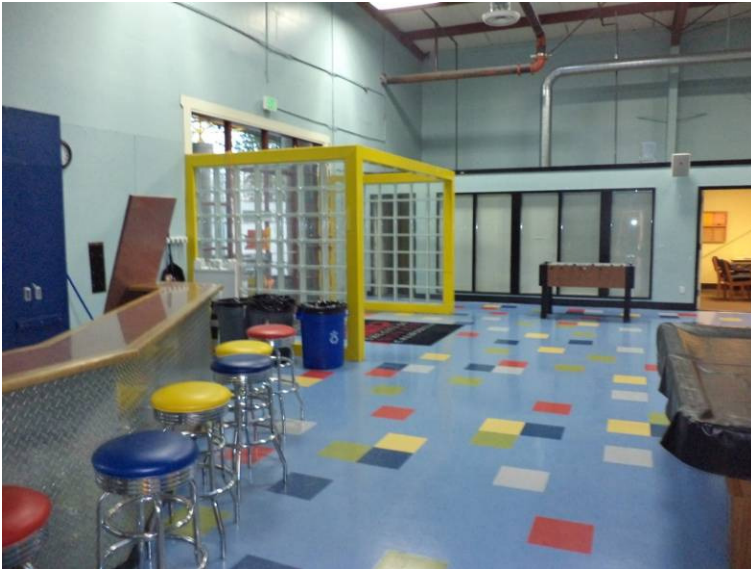
Photograph No. 25

View of the finishes within the recently created gym offices.

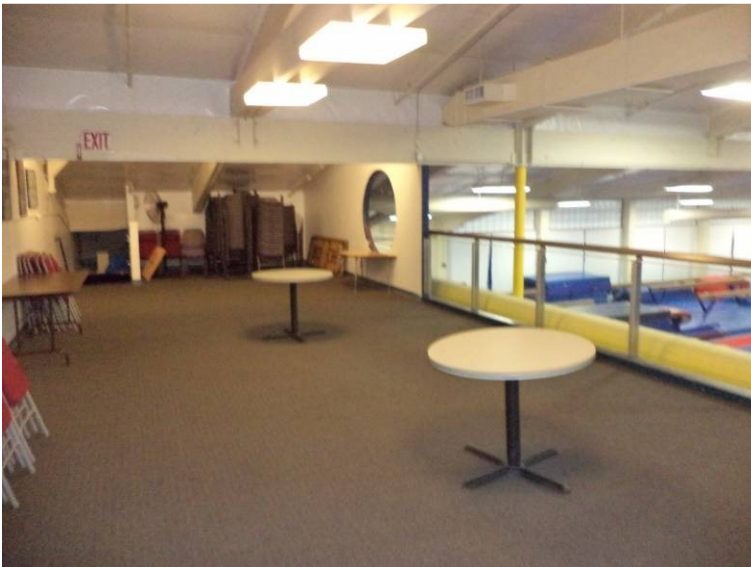
Photograph No. 29

The building contained wood stud gypsum board partitions throughout, with a painted finish (reference Photograph 29 in Appendix B).

View of finished within the main office.

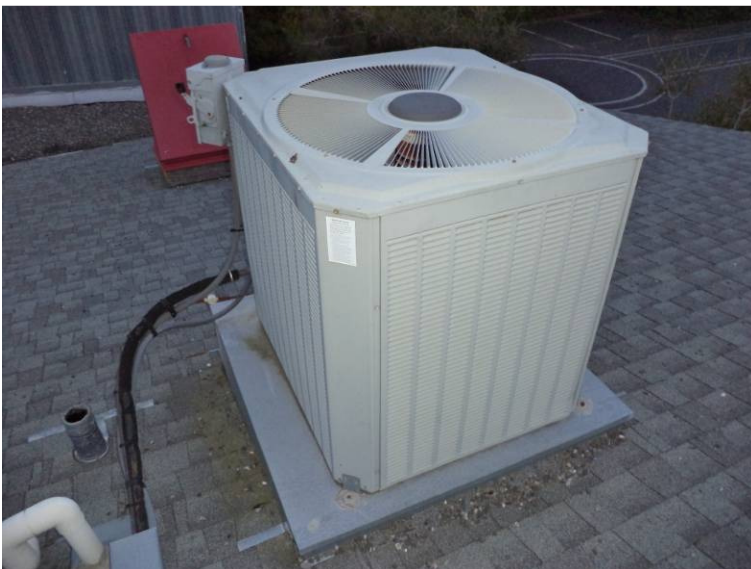
Photograph No. 41

View of one of the air-cooled condenser units.

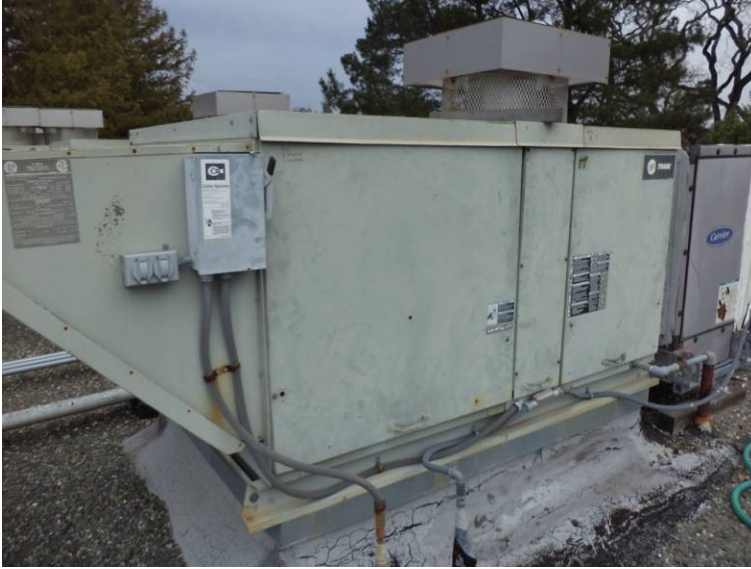
Photograph No. 42

View of the heat pump unit.

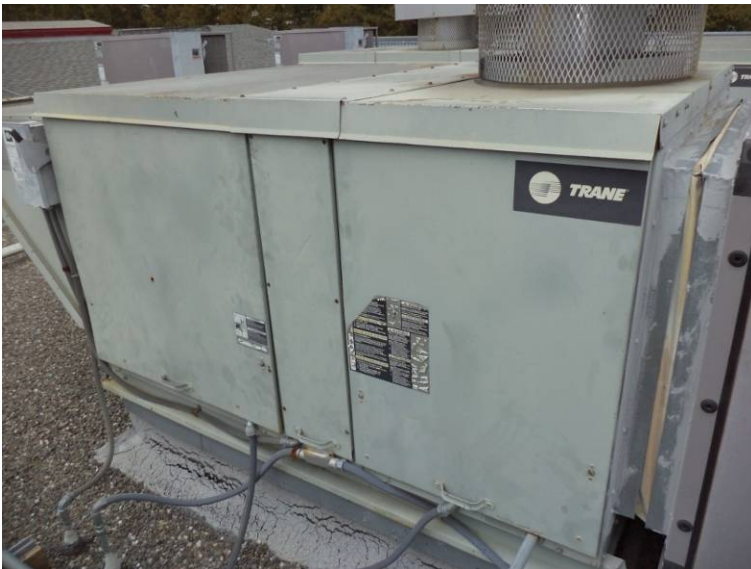
Photograph No. 43

View of one of the air handler units.

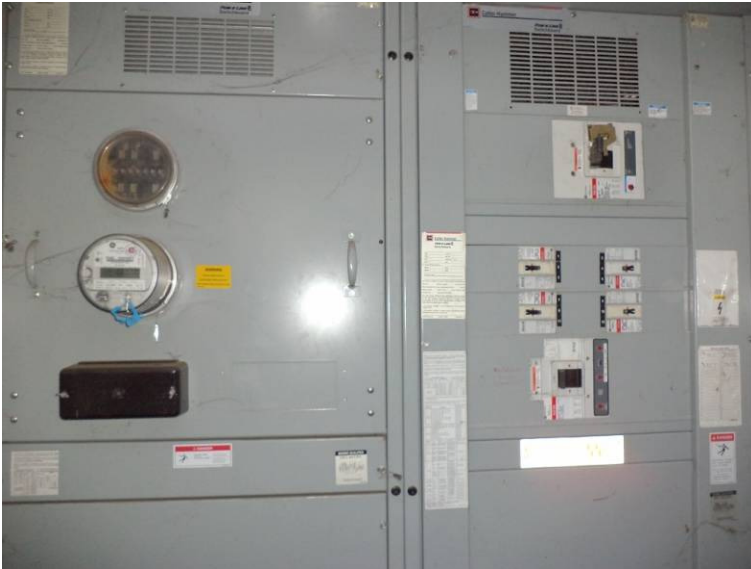
Photograph No. 49

Electrical power is supplied by the local utility provider to a dedicated, utility owned pad mounted transformer located at the south side of the building. The Main Distribution Panel (MDP) is manufactured by Cutler Hammer and is rated at 208Y/120 volts at 1,000-amps and is located within an exterior enclosure at the south-east side of the building. Branch panels are located throughout the building and are rated at varying amps (reference Photographs 49 and 50 in Appendix B).

View of the MDP enclosure.

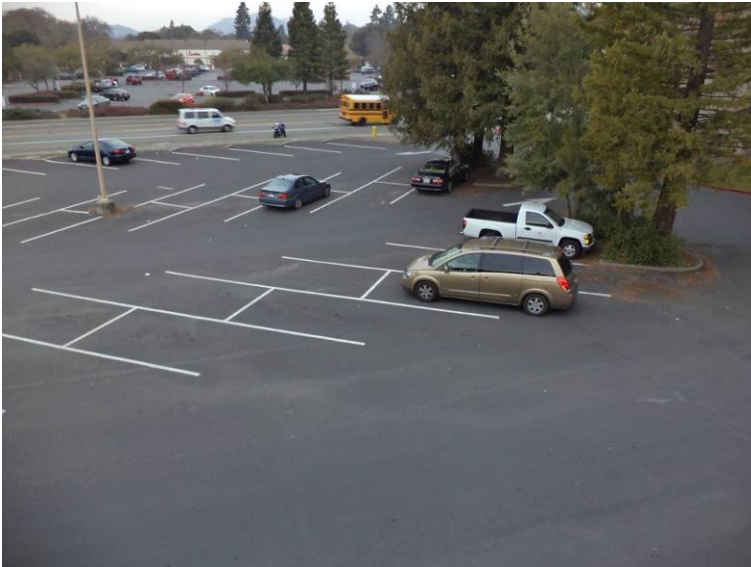
Photograph No. 58

The building has a parking lot at the west side of the building that is accessed from 7th street. The parking lot has an asphalt surface with white line striping denoting areas of parking stalls (reference Photographs 58 and 59 in Appendix B). We were not provided with the original specification details of the paving and therefore cannot comment on the specific asphalt mix type, classification or its suitability for its existing use. Table G20-1 provides a summary of the site systems.

View of the asphalt parking lot.
