Citywide  
Facility Condition Assessment

Report of  
Facility Condition Assessment

For  
City of Novato  
Hamilton Community Center  
503 South Palm Drive, Novato, CA

*March 4, 2013*

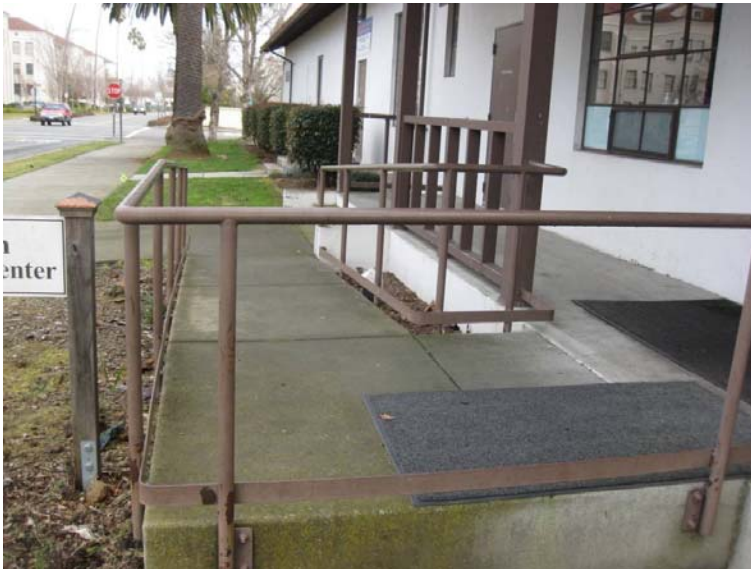
**Photograph No. 2**

View of main entrance ramp.

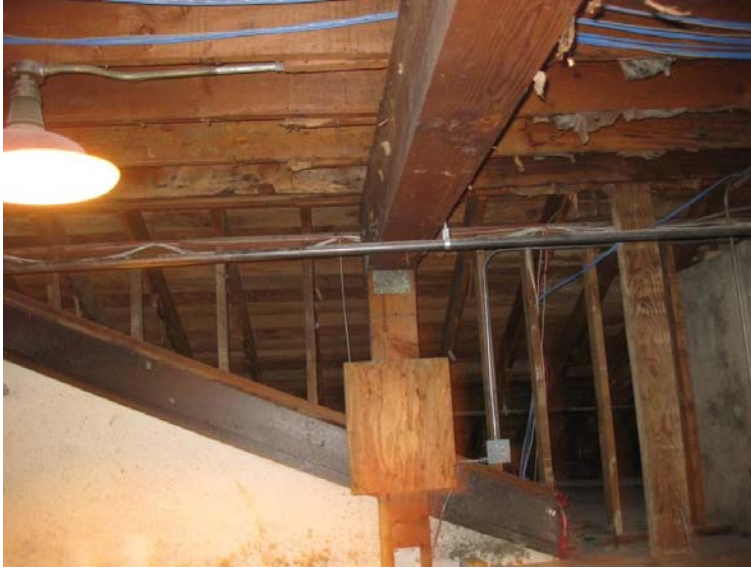
**Photograph No. 4**

View of the pitched roof construction.

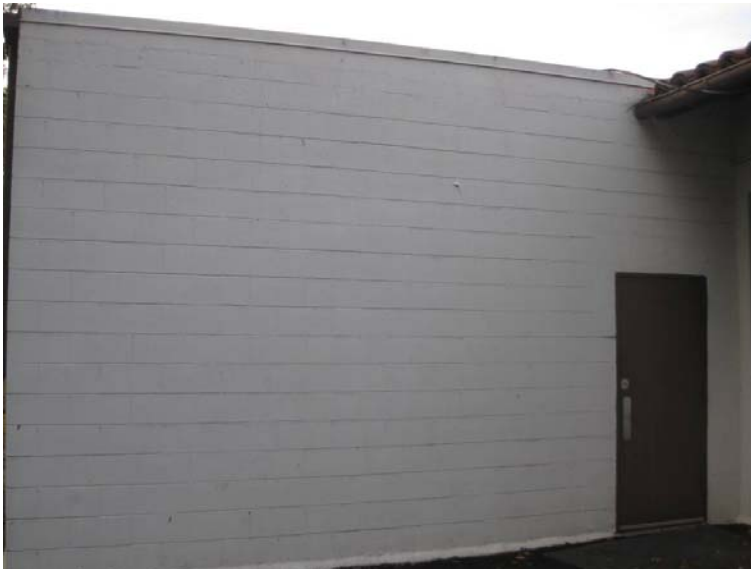
**Photograph No. 5**

The exterior wall system consisted of cast-in-place concrete walls (reference Photograph 6 in Appendix B) with an approximate thickness of 16". The surface of the wall appeared to contain a painted smooth stucco surface on all elevations. In the center of the building on the south elevation there was an addition which consisted of painted CMU walls (reference Photograph 5 in Appendix B).

View of the CMU wall construction that make up the building's extension. Also shows a single hollow metal door.

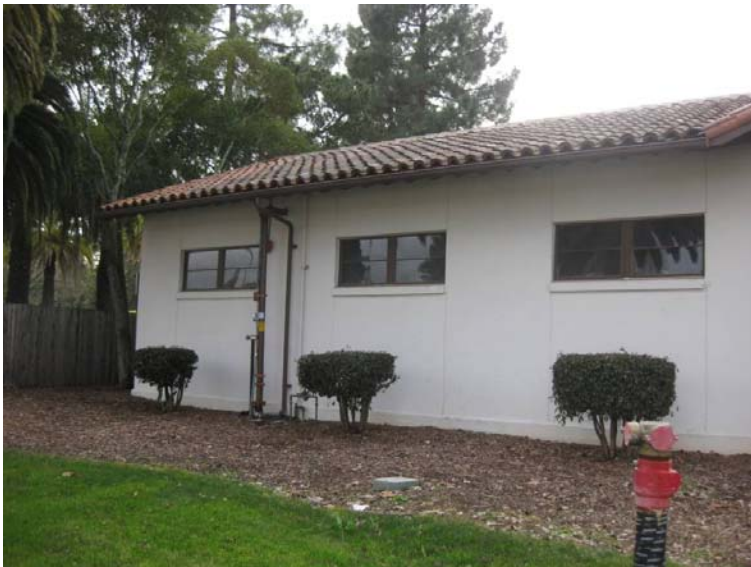
**Photograph No. 6**

Shows the cast-in-place concrete walls that make up the main wall construction for the building. Also shows painted metal framed windows.

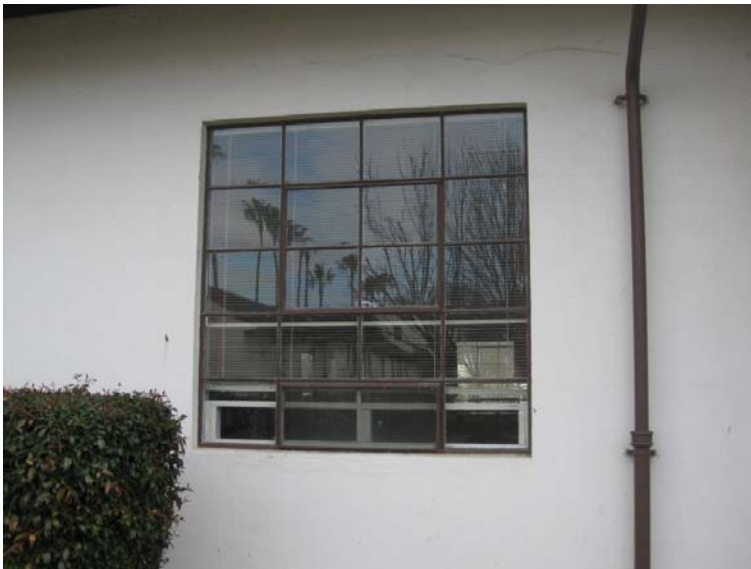
**Photograph No. 8**

At each of the elevations there were steel and aluminum fixed and awning windows with single and dual pane glazing (reference Photographs 8 and 9 in Appendix B). It appeared that the newer aluminum framed windows were located at the west side of the building and at the addition on the south side of the building. The window frames contain caulking at the point where they meet the wall construction.

View of a painted metal window on the north facing elevation.

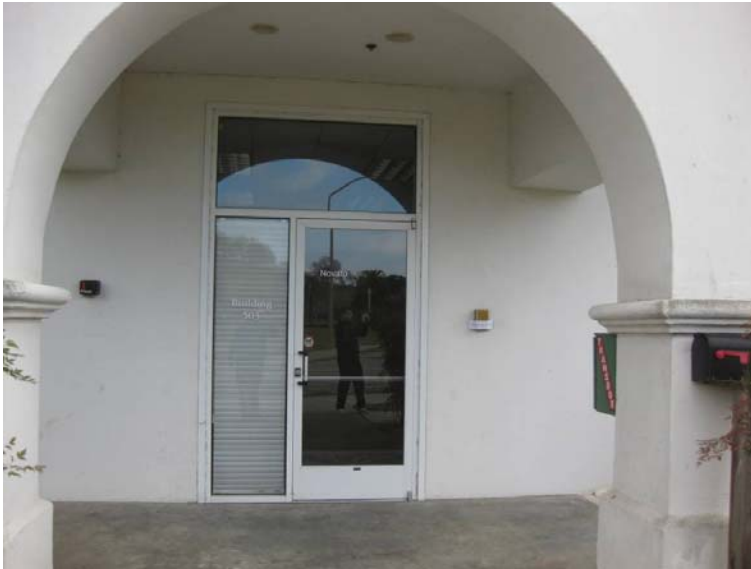
**Photograph No. 10**

The entrances at the north and west contained glazed aluminum doors with a side light (reference Photographs 10 and 11 in Appendix B). The glazed door at the north elevation had an operable transom window. Door hardware consisted of pull handles with an emergency push bars at the interior and door closers.

View of the glazed aluminum main entrance door unit with side window.

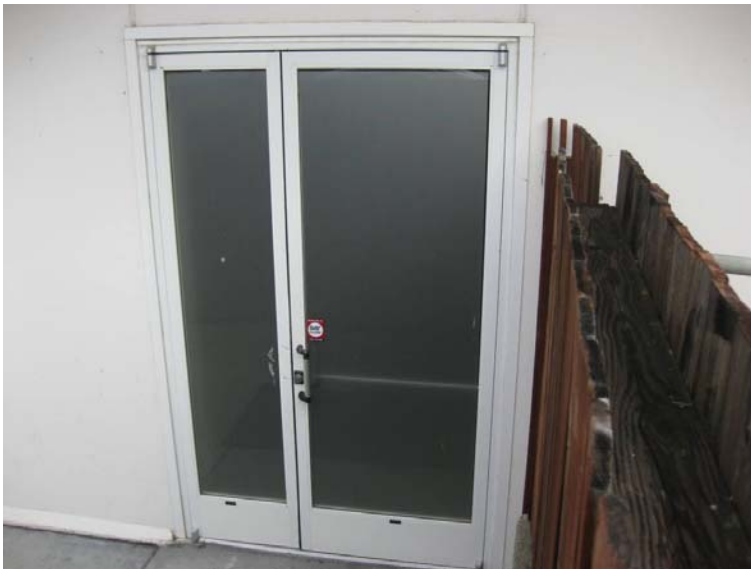
**Photograph No. 11**

View of a glazed aluminum frame door unit with window on the east facing elevation.

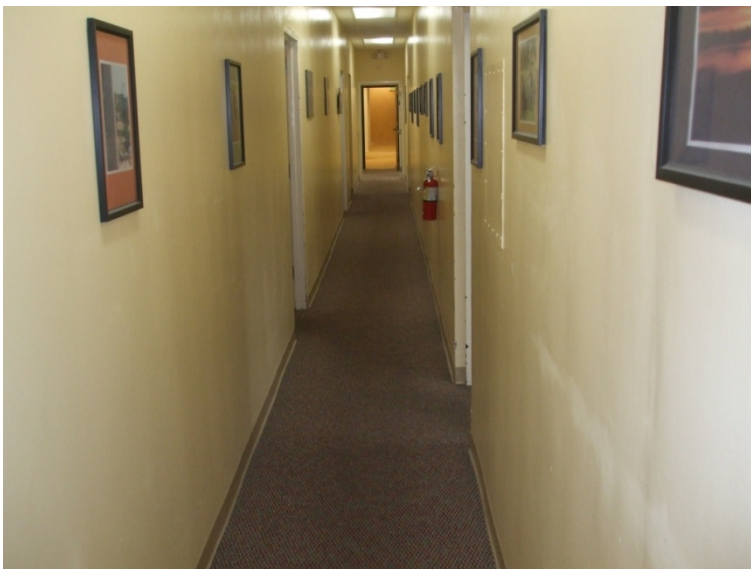
**Photograph No. 15**

The building contained a combination of cast-in-place concrete wall constructions and 4" stud spaced at 16" centers with gypsum board partitions, with fiberglass batt insulation throughout the building (reference Photograph 15 and in Appendix B).

View of the painted gypsum board partitions that form the corridor in the east part of the building.

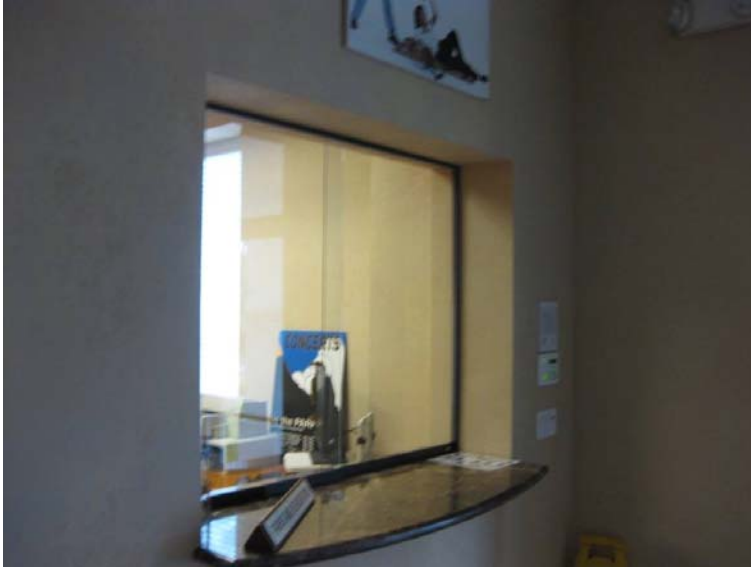
**Photograph No. 16**

The interior lobby contained a 4' x 5' aluminum framed sliding window with a granite window sill which acts as a reception counter (reference Photograph 16 in Appendix B).

View of an interior window in the lobby area.

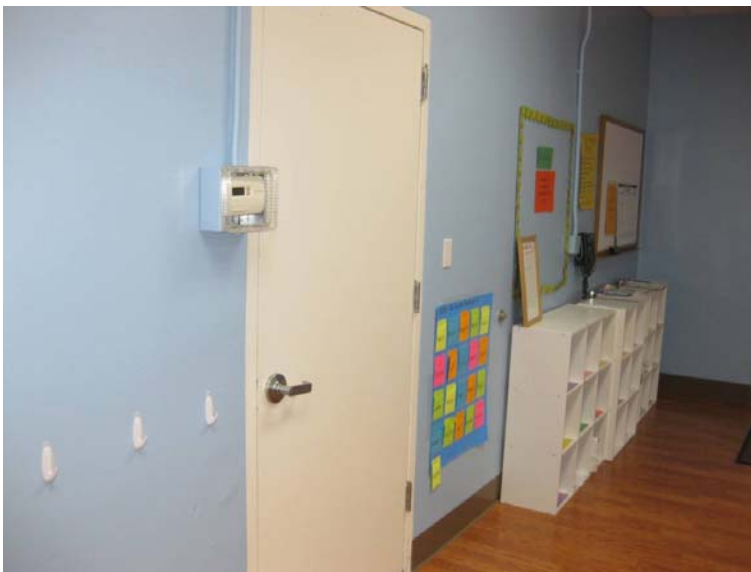
**Photograph No. 17**

The building generally contained single flush wood doors with a number that contained glazed panels which are housed within metal frames (reference Photograph 17 in Appendix B). The doors all appeared to be one directional swing operation.

View of an interior single painted wood door.  
Also shows painted gypsum board wall finish.

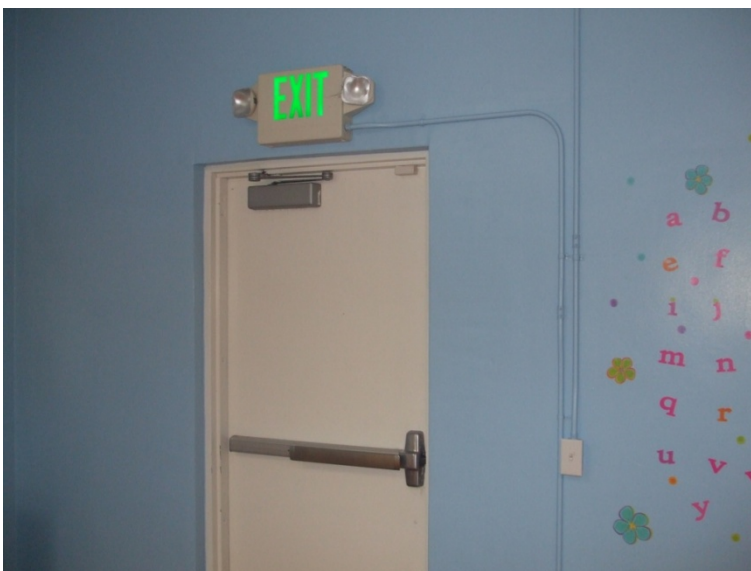
**Photograph No. 18**

The building contained single and double hollow metal doors and frames at the perimeter, mainly at the south elevation (reference Photograph 12 in Appendix B). Door hardware consisted of a combination of push and pull handles, with emergency push bars at the interior (reference Photograph 18 in Appendix B).

View of a single painted fire escape door with  
panic hardware.

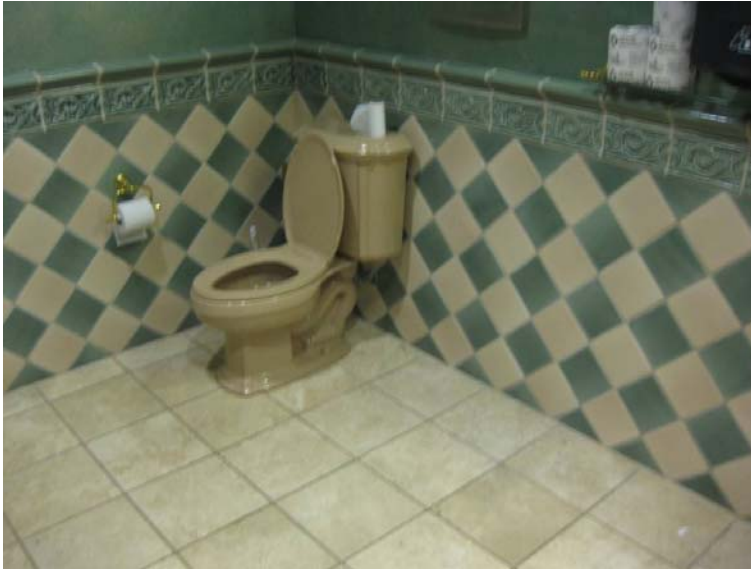
**Photograph No. 19**

Interior walls throughout the building contained either a painted cast-in-place concrete or gypsum wall board surface (reference Photographs 15, 17 and 18 in Appendix B). The restrooms on the west side of the building both contained ceramic 6" x 6" wall tiles to mid height (reference Photograph 20 in Appendix B) while the restrooms on the east side of the building both contained 4" x 4" ceramic wall tiles to mid height (reference Photograph 19 in Appendix B).

View of the ceramic wall tile finish and the ceramic floor tile finish in the men's lobby restroom. Also shows vitreous china water closet.

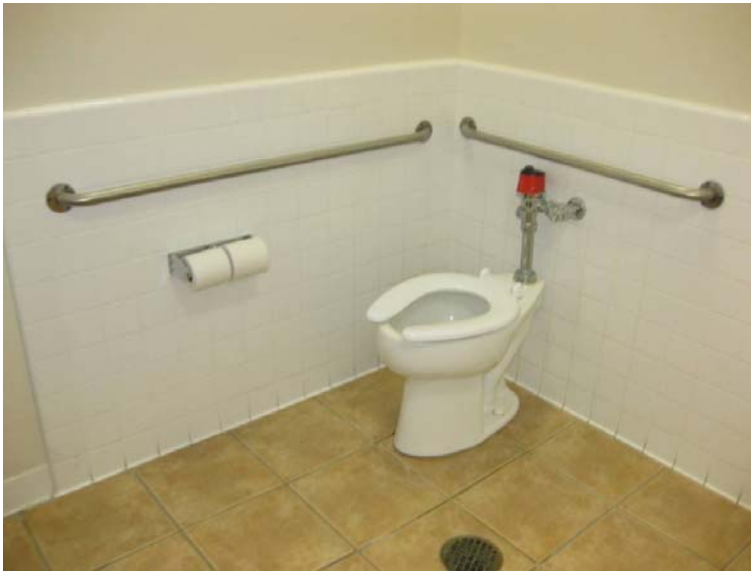
**Photograph No. 20**

View of the ceramic wall tile finish and the ceramic floor tile finish in the men's 'east wing' restroom. Also shows ADA compliant vitreous china water closet.

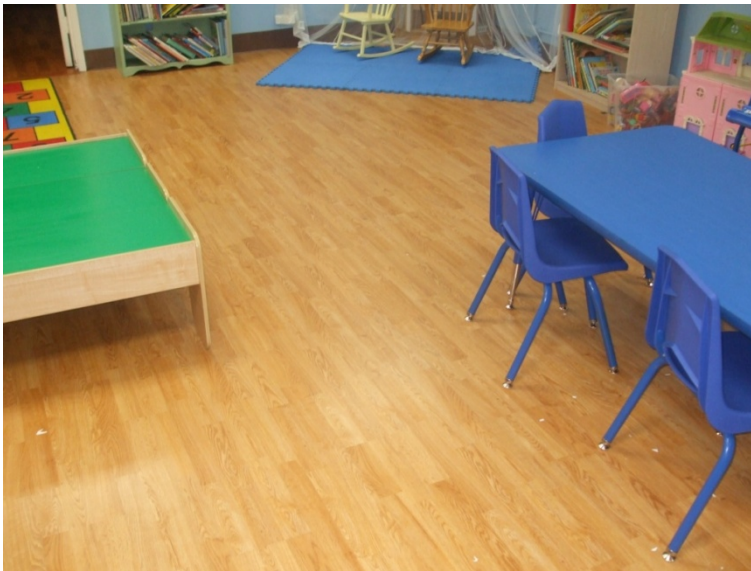
**Photograph No. 21**

View of the laminate wood floor system in the children's playroom.

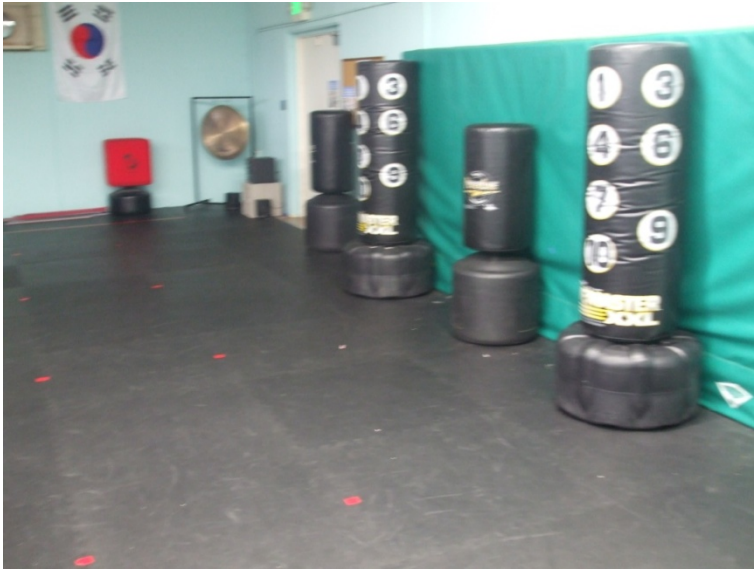
**Photograph No. 22**

The building contained a combination of floor coverings which consisted of ceramic tile in the restrooms and kitchen area as well as natural stone floor tiles within the entry way (reference Photograph 23 in Appendix B). In addition there is also laminate wood flooring located in the classrooms (reference Photograph 21 in Appendix B) and standard wood plank floor located in the ballet/dance room. The Taekwondo room had a rubber floor tile finish to absorb sound and aid fall protection (reference Photograph 22 in Appendix B).

View of the rubber tile floor system in the taekwondo room.

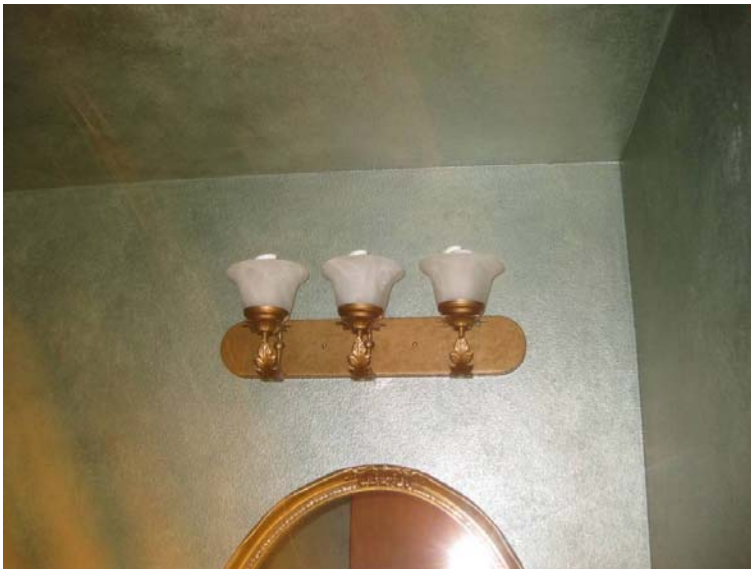
**Photograph No. 26**

There were painted gypsum board ceilings throughout the restroom areas (reference Photograph 26 in Appendix B) and formed to create soffits at various locations throughout the main community center areas.

View of the painted gypsum board ceiling finish. Also shows decorative light fixture.

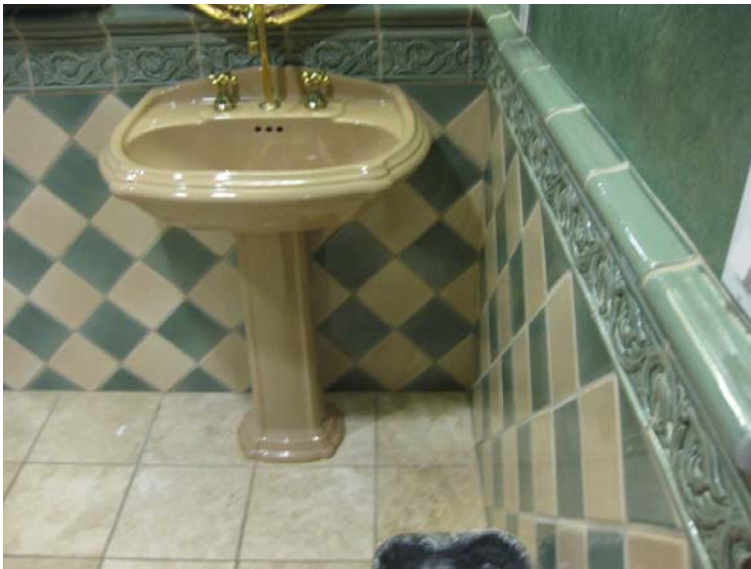
**Photograph No. 29**

View of the wall mounted vitreous china pedestal lavatory in the men's lobby restroom.

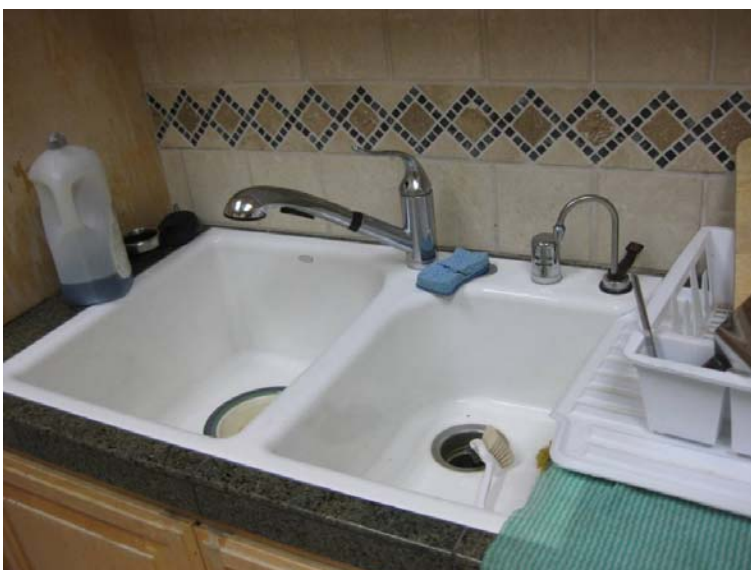
**Photograph No. 30**

View of double countertop sink in the kitchen.

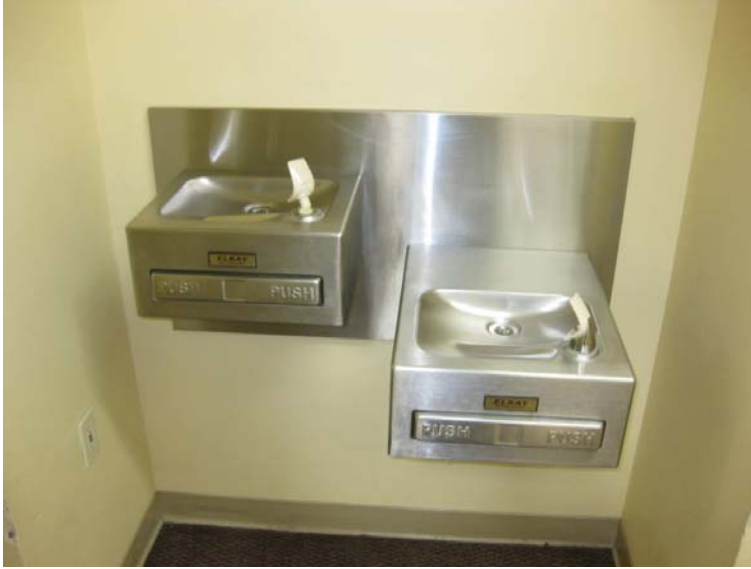
**Photograph No. 31**

View of two wall mounted drinking fountains in the east part of the building.

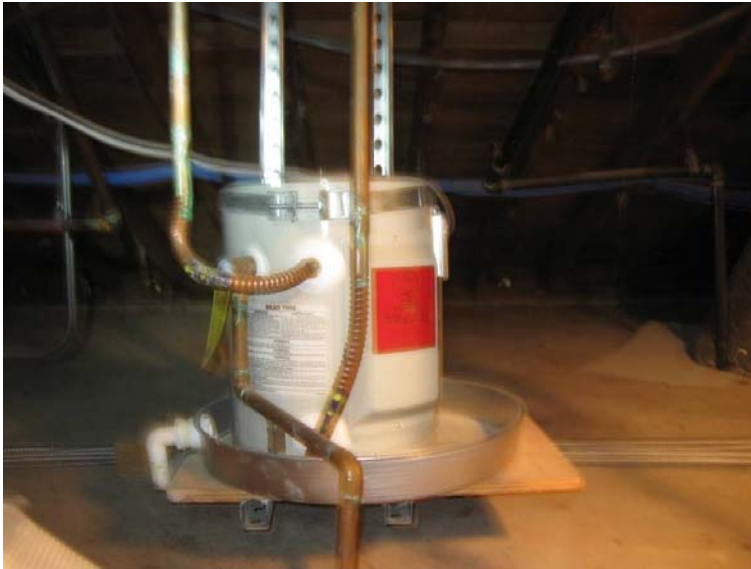
**Photograph No. 32**

Domestic hot water was generated via a single electric 6 gallon water heater located in the attic area (reference Photograph 32 in Appendix B).

View of the electric domestic water heater located in the attic space.

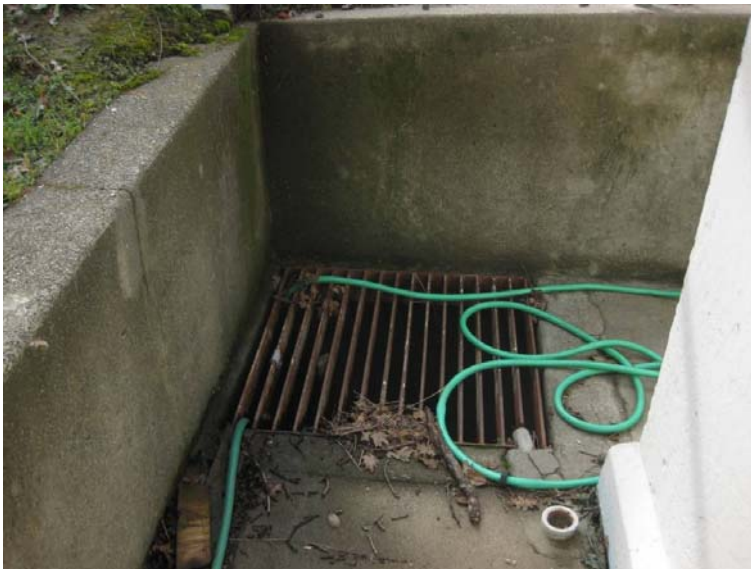
**Photograph No. 33**

View of a site drain, located at the rear of the property.

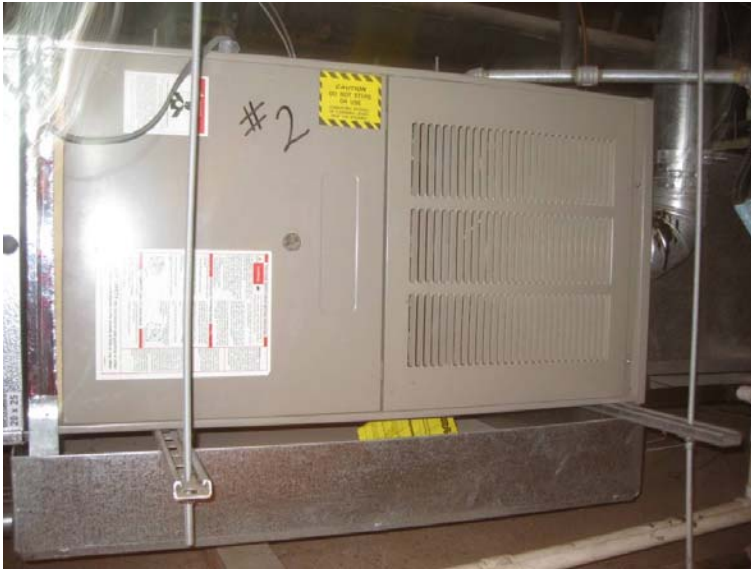
**Photograph No. 34**

The building utilizes six air handler units that are manufactured by Carrier, Bryant, and Goodman and are located at the mezzanine space between the ceiling and roof levels (reference Photograph 34 in Appendix B). Only two of these units were accessible.

View of a gas powered air handling unit located in the attic space.

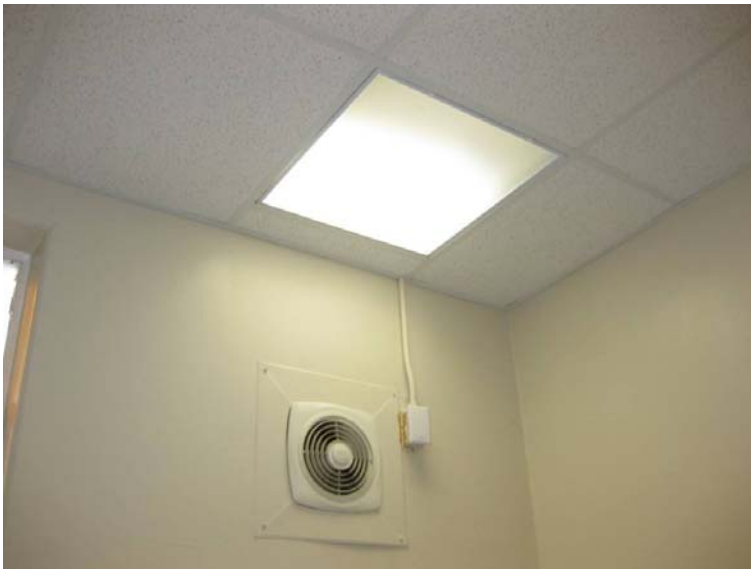
**Photograph No. 40**

The interior lighting within the building is provided by recessed 2' x 4' 3 lamped fluorescent fixtures (reference Photograph 27 in Appendix B), 2' x 2' (reference Photograph 41 in Appendix B), 4' strip light fixtures (reference Photograph 40 in Appendix B) and surface mounted 1' x 2' double lamped fluorescent fixtures. The fluorescent fixtures all contained F32 T8 32W lamps and electronic ballasts. All of the in-room lighting is controlled via local switching in the respective rooms. We also noted wall mounted decorative light fixtures within the lobby restrooms (reference Photograph 26 in Appendix B).

View of a 4' strip light fixture with no lens.

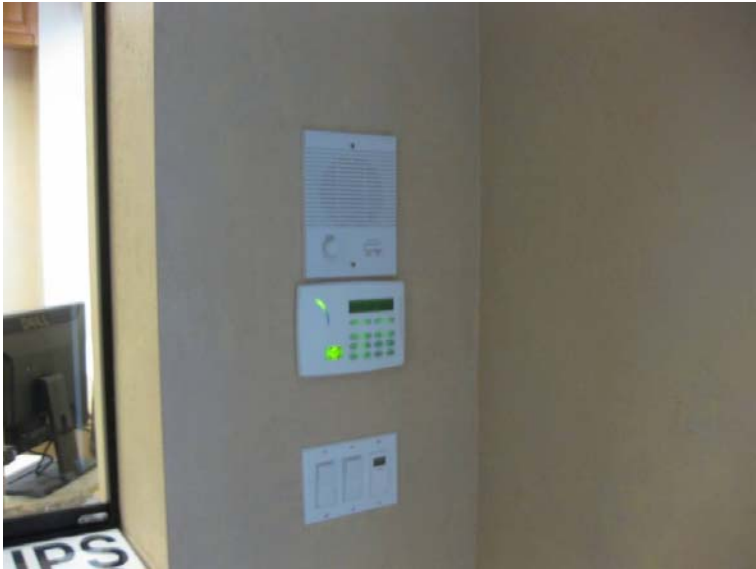
Photograph No. 43

Photograph 43 in Appendix B). Addressable devices are located throughout the building such as smoke detectors, pull stations and fire bell. The system is monitored by Bay Alarm Tel: 707.769.3524

View of the fire alarm system.

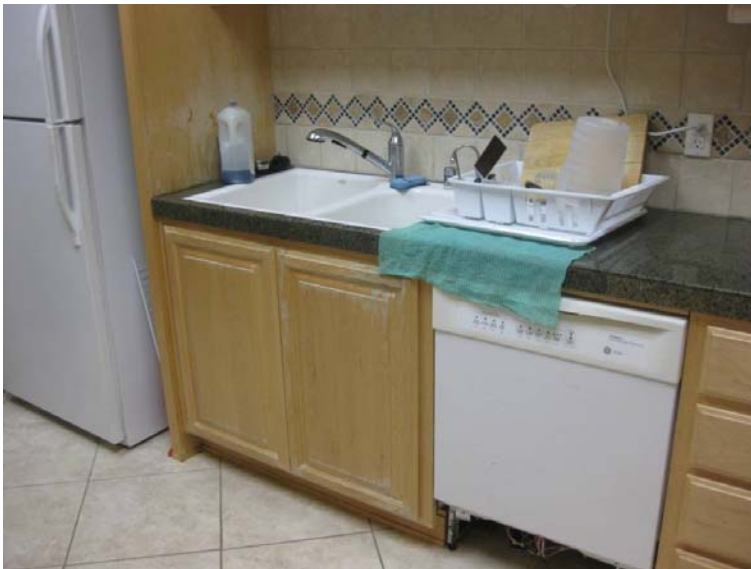
**Photograph No. 47**

The building contained wood constructed fixed casework within the break room/kitchen and classroom (reference Photographs 47 and 48 in Appendix B). The wood cabinets generally consisted of hardwood frames and plywood panels with wooden door panels. The worktop consisted of a ceramic tile counter.

View of a dated fixed wooden cabinet which will soon need replacing. Also shows countertop double stainless steel sink.
