Citywide
Facility Condition Assessment

Report of
Facility Condition Assessment

For
City of Novato
Hamilton Firehouse
555 Hangar Avenue, Novato, CA

March 4, 2013

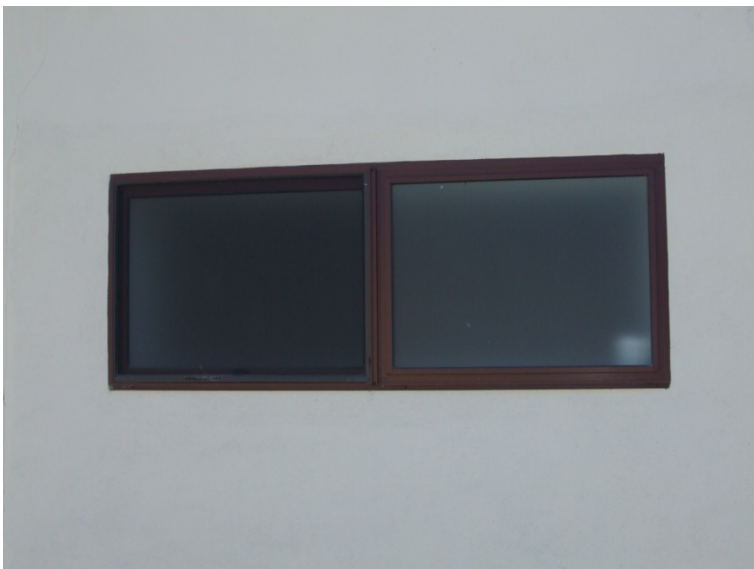
Photograph No. 8

View of a typical painted metal window.

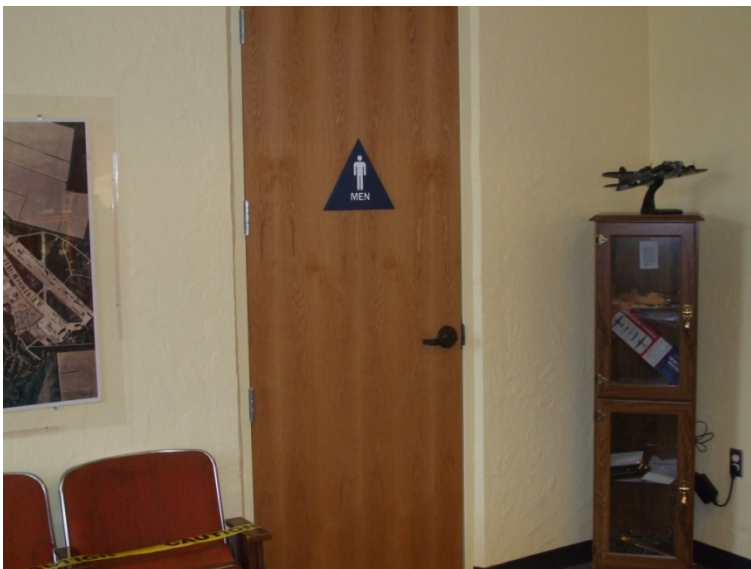
Photograph No. 15

We noted 3' X 3' unbonded carpet squares throughout the lobby as well as the main museum display areas (reference Photograph 15 in Appendix B).

View of the lobby. Shows carpet tile floor and stud walls with rough plaster finish.
