Citywide  
Facility Condition Assessment

Report of  
Facility Condition Assessment

For  
City of Novato  
Hamilton Pool & Bath House and Pool Pump Building  
203 El Bonito Drive, Novato, CA

*March 4, 2013*

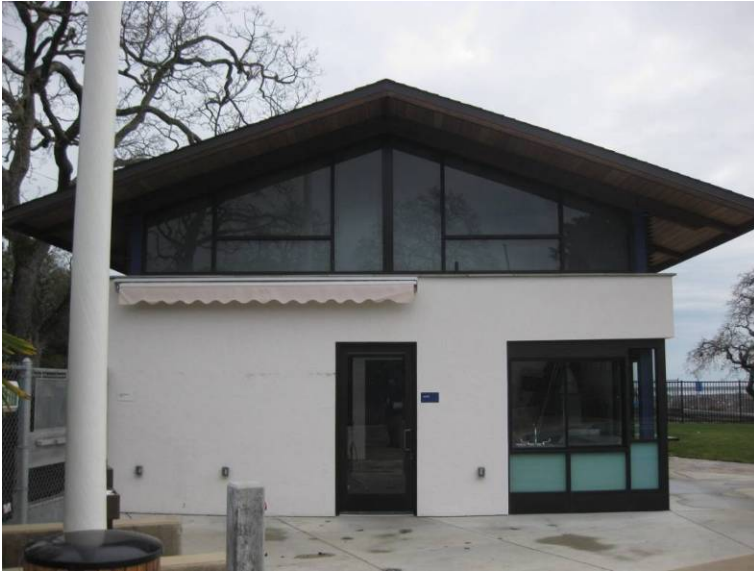
#### Photograph No. 3

The steep-sloped roof areas 1, through 4 contain asphalt shingles on a wood decking (reference Photographs 3 and 33 in Appendix B). There is no specific storm water drainage present at any of the roof levels; rain water is discharged over the edge to the ground below.

View of the steel and wood wall mounted canopy. Also shows exterior CMU wall construction with stucco finish and exterior hollow metal prefinished door surfaces. Also shows the asphalt shingle roof covering.

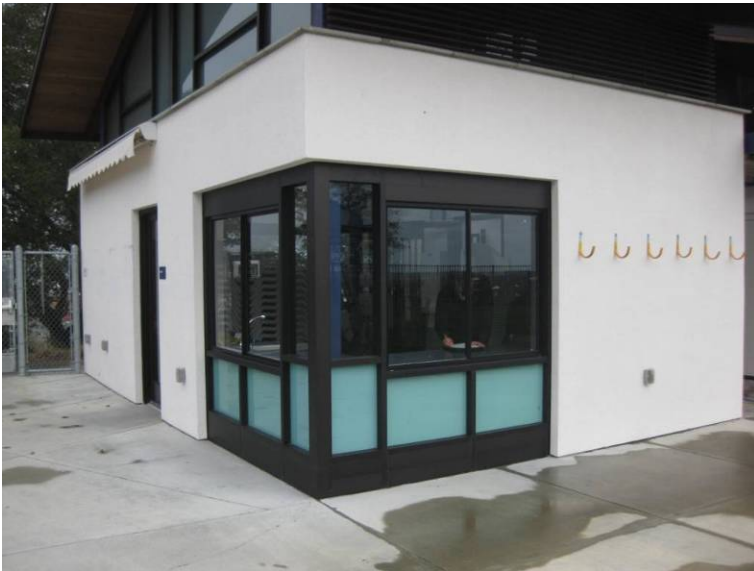
**Photograph No. 4**

The Pool & Bath House contained a celestory detail (reference Photograph 4 in Appendix B) at each elevation of the roof level which contained a 1" x 4" wood screen and large windows at the gable ends.

The Pool & Bath House contained aluminum fixed dual pane window units at all elevation (reference Photograph 4 in Appendix B). The Pool Pump Building contained steel fixed single pane window units at the south elevation (reference Photograph 30 in Appendix B). The outer perimeter of the window frame and the exterior wall construction is sealed with variable thickness urethane sealant.

View of the clerestory window system that spans the top portion of the building. Also shows single glazed aluminum door.

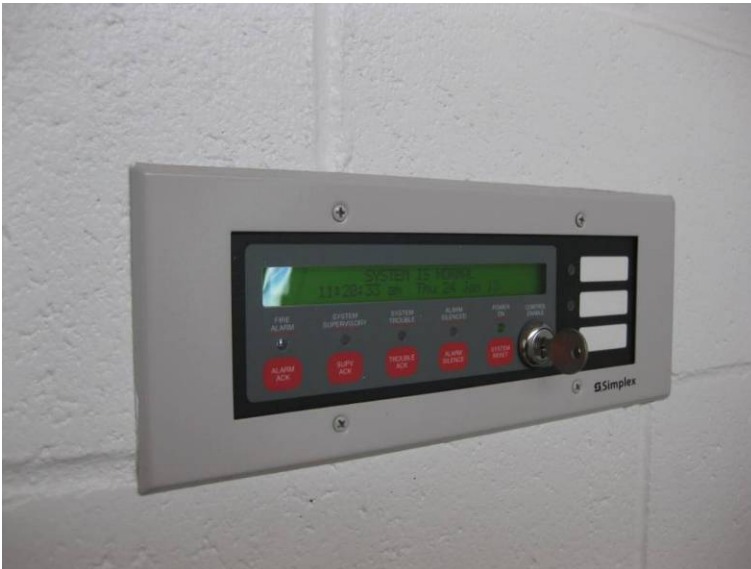
Photograph No. 22

The building is protected by a digital automatic fire detection alarm system. The main Fire Alarm Control Panel (FACP) is located within the office area and is manufactured by Simplex. The FACP model is 4008 (reference Photograph 22 in Appendix B). Addressable devices are located throughout the building such as smoke detectors, pull stations and fire bell. We understand that the system is monitored by Bay Alarm Company.

View of the fire alarm control panel.

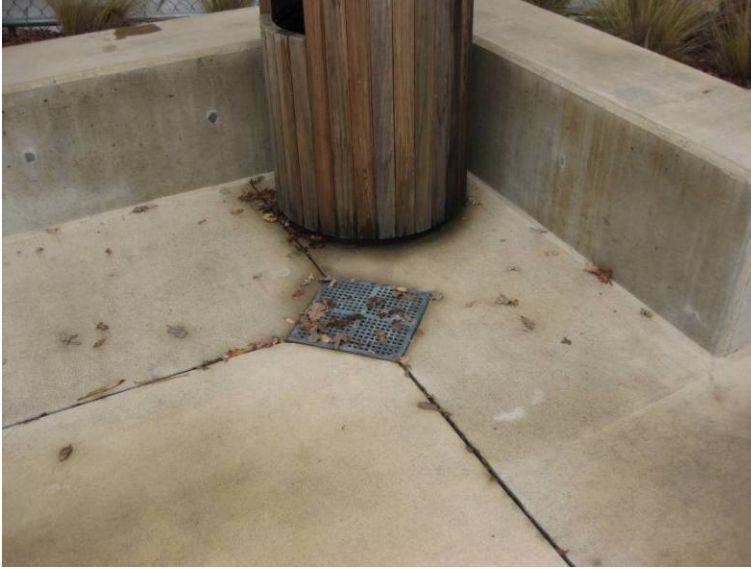
**Photograph No. 46**

The concrete pavements appeared to be generally in good condition with a few isolated areas of cracking in the sealant (reference Photograph 46 in Appendix B). There are no major instances of cracking to the pavements. We recommend that the caulking is removed and new applied late in the study period, we have calculated two replacement periods into the buildings expenditures.

View of deteriorated sealant, present between some paving slabs.

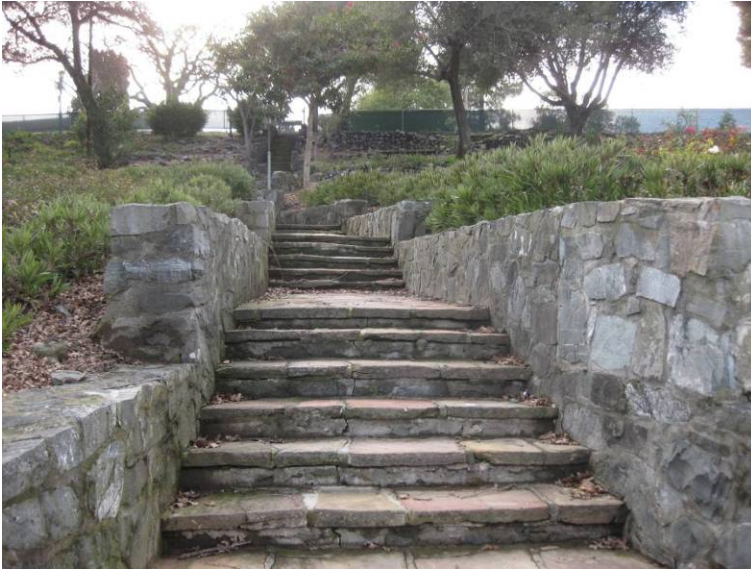
**Photograph No. 49**

The pool complex contained cast-in-place concrete steps as well as stone steps along the south elevation at pool level (reference Photographs 49 and 50 in Appendix D). The steps allowed access from the pool level up to street level.

View of site steps leading to nearby parking lot.

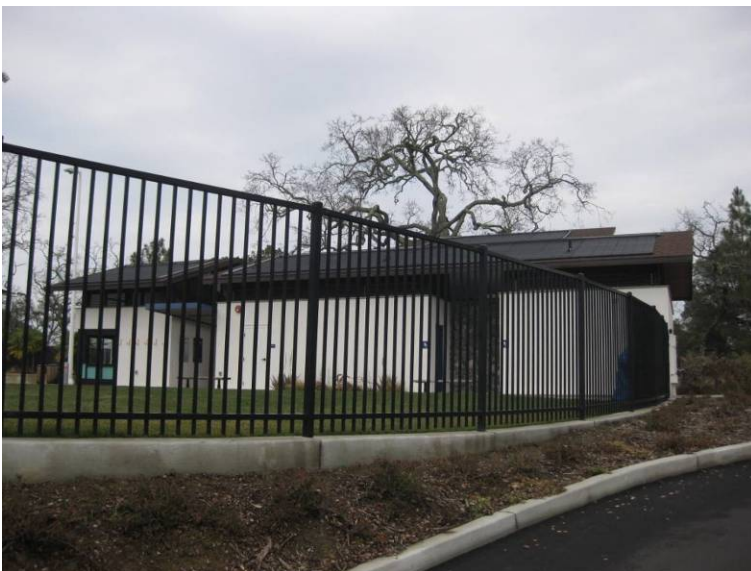
**Photograph No. 51**

The building contained a 6' high metal post chain link fence at the facility perimeter as well as a metal painted fence (reference Photographs 51 and 52 in Appendix B).

Exterior lighting at the pool area consisted of 25' high pole lighting (reference Photograph 53 in Appendix B) which generally contained two large high pressure sodium light fixtures per pole and two smaller floodlights. There are also a number of 4' tall lighted bollards that provide pathway lighting (reference Photograph 51 in Appendix B).

View of site lighting for sidewalk. Also shows galvanized steel chainlink fence around pool area.
