**Citywide
Facility Condition Assessment**

**Report of
Facility Condition Assessment**

**For
City of Novato
Lu Sutton Child Care Trailers
1800 Center Road, Novato, CA**

March 4, 2013

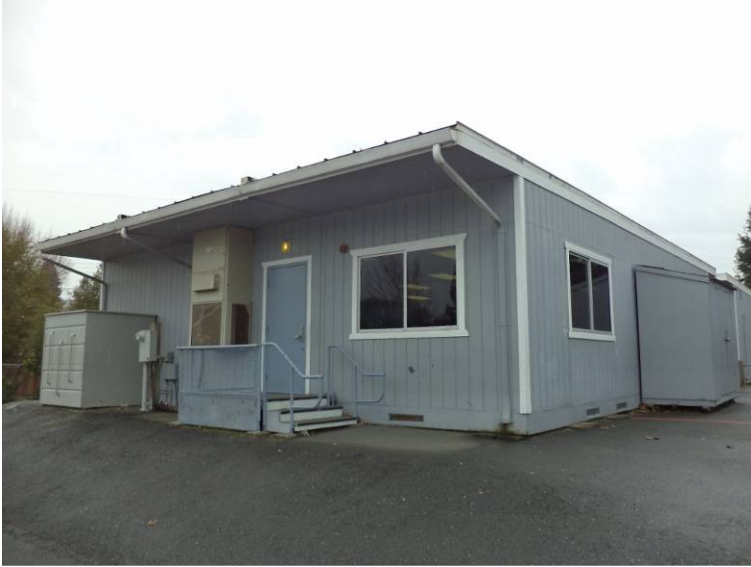
Photograph No. 1

The exterior wall construction at both of the modular buildings consists of wood stud walls with wood board siding at each of their exterior elevations. The wood siding is in a vertical tongue and groove formation with a painted finish (reference Photographs 1, 15, 17 and 18 in Appendix B). There is a crawl space below the raised first floor with ventilation openings at each of the elevations to allow cross ventilation in this space. The openings are protected against insects and vermin with wire mesh grills present within the wood inserted paneling (reference Photograph 2 in Appendix B).

Electrical supply at the buildings is provided via one exterior mounted electrical panel and meter at the north side of Trailer (North) which we assume has a rating of 100-amp or less, 120/240-Volt (reference Photographs 1 and 27 in Appendix B). Limited information was present at the panel. Each of the buildings has its own interior wall mounted electrical panel board which are manufactured by Westinghouse.

View of the north elevation showing the wall mounted heat pump unit, electrical panel, exterior door and steps.

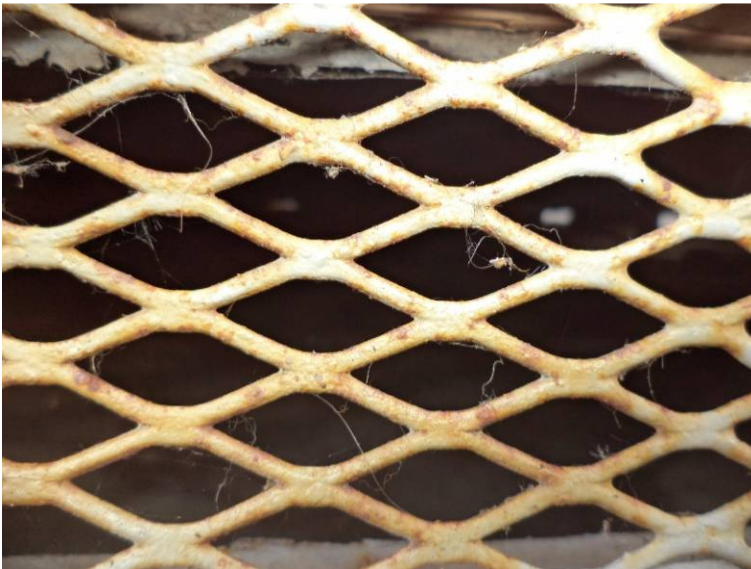
Photograph No. 2

The buildings both contained a raised first floor; as the building is of a modular construction the first floor is raised off the ground with crawl space below (reference Photograph 2 in Appendix B). The structure consists of wood joists and a wood deck subfloor.

View of the grill at the crawl space.

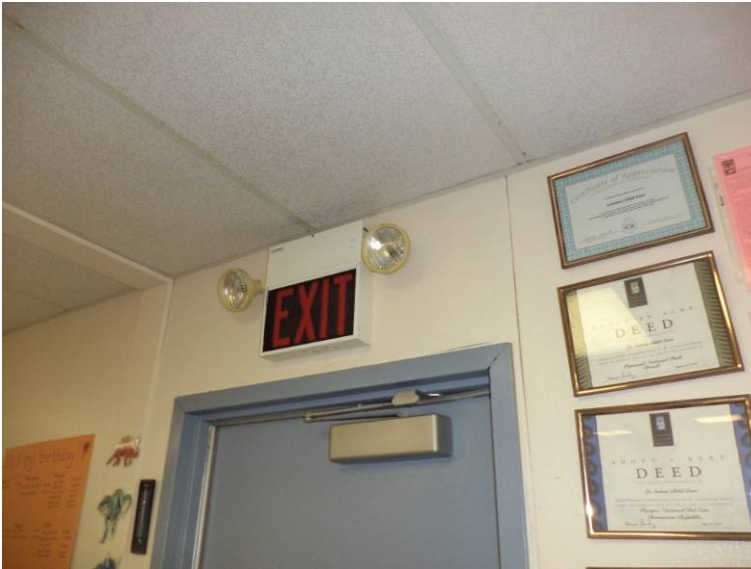
Photograph No. 5

Emergency exit lighting with battery back-up are provided at exit routes from each of the buildings (reference Photograph 5 in Appendix B).

View of the door closers and exit sign.

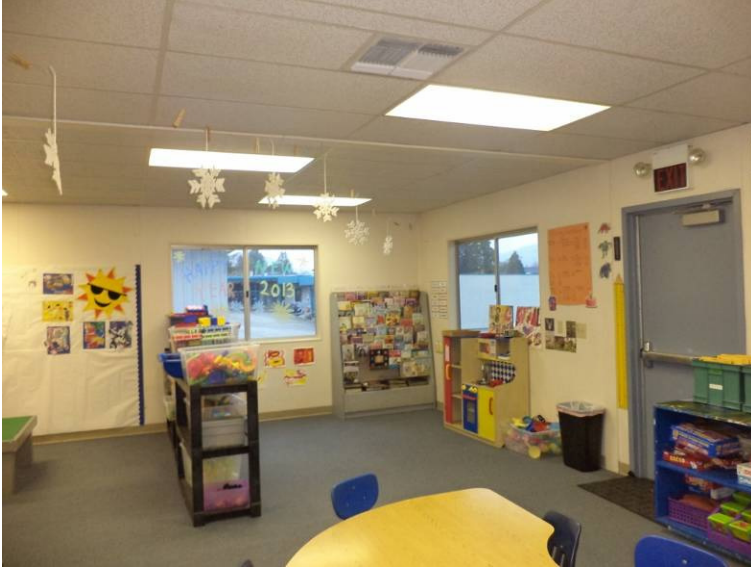
Photograph No. 7

The buildings each contained sheet carpet within the main class room areas (combined with vinyl) (reference Photographs 7 in Appendix B).

View of the interior finishes.

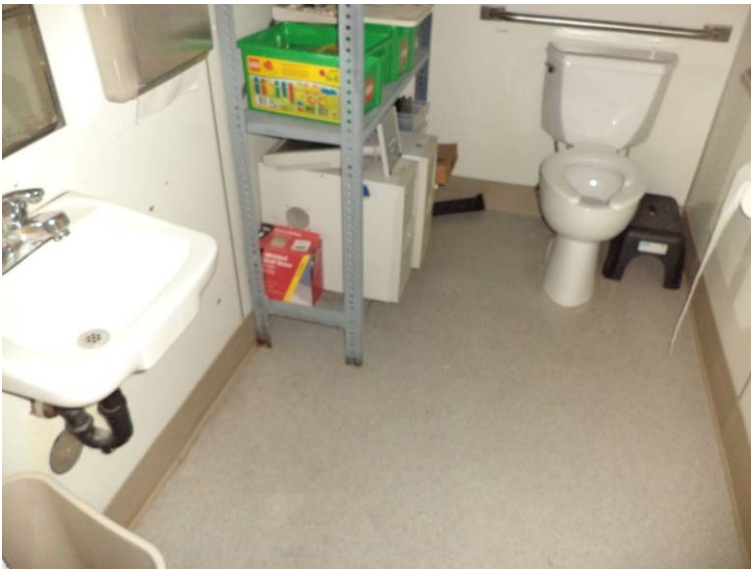
Photograph No. 8

The buildings both contain vinyl sheet floor coverings within the main class room areas (combined with carpet) and also within the restrooms (reference Photographs 8 and 23 in Appendix B).

The buildings contained floor mounted vitreous china water closets which have their own tanks (reference Photographs 8 and 23 in Appendix B).

The buildings contained wall mounted vitreous china lavatories (reference Photographs 8 and 23 in Appendix B). The lavatories generally consisted of single-handle lever type, non-metering faucets. Water is supplied via copper pipe work and drained through cast iron pipe work and fittings.

View of the restroom finishes and fixtures.

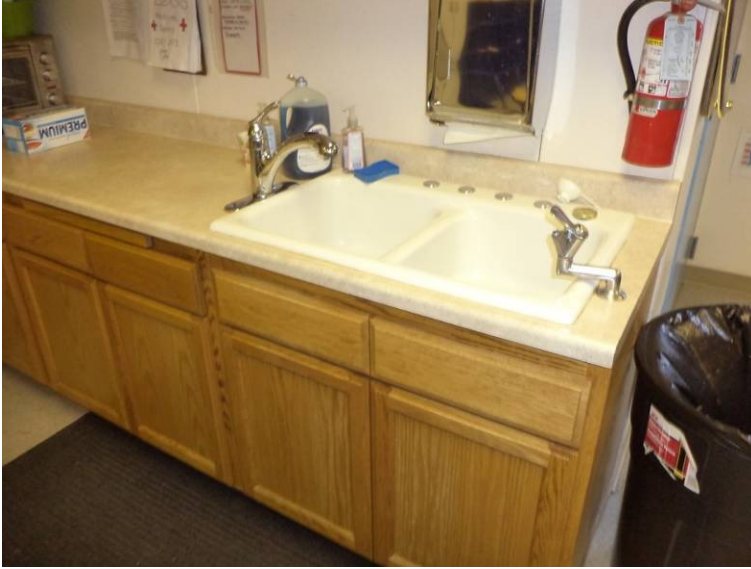
Photograph No. 10

The Trailer (North) building contained a double vitreous china sink and the Trailer (South) building contained a single stainless steel sink at the fixed cabinet areas (reference Photographs 10 and 24 in Appendix B). The sinks contained non-metering single lever mixing handle faucets and are self rimming, mounted within a counter that consisted of a plastic laminated faced counter top.

The building contained a sink mounted eye wash unit (reference Photograph 10 in Appendix B). None present at the Trailer (South) building.

View of the vitreous china sink and eye wash.

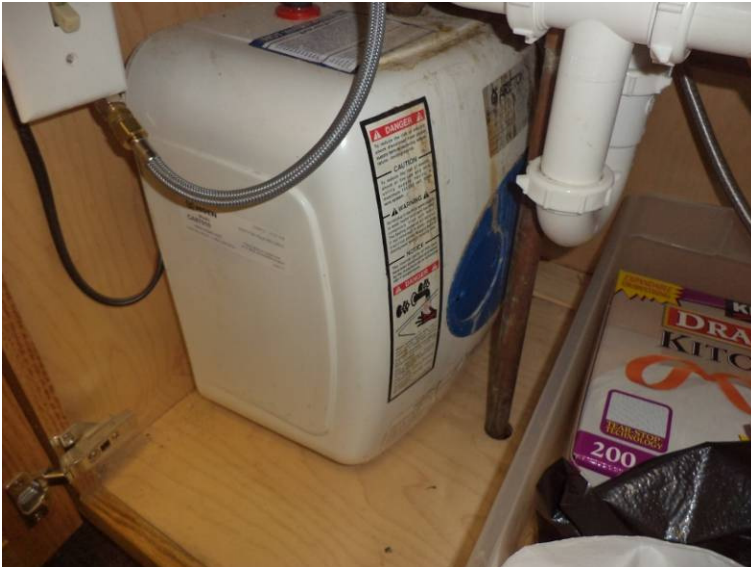
Photograph No. 11

View of undercounter water heater.

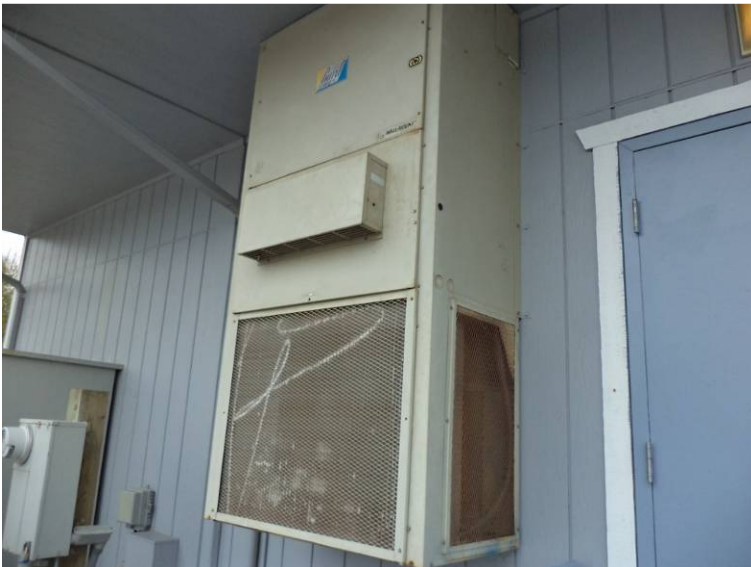
Photograph No. 12

View of the wall mounted heat pump unit.

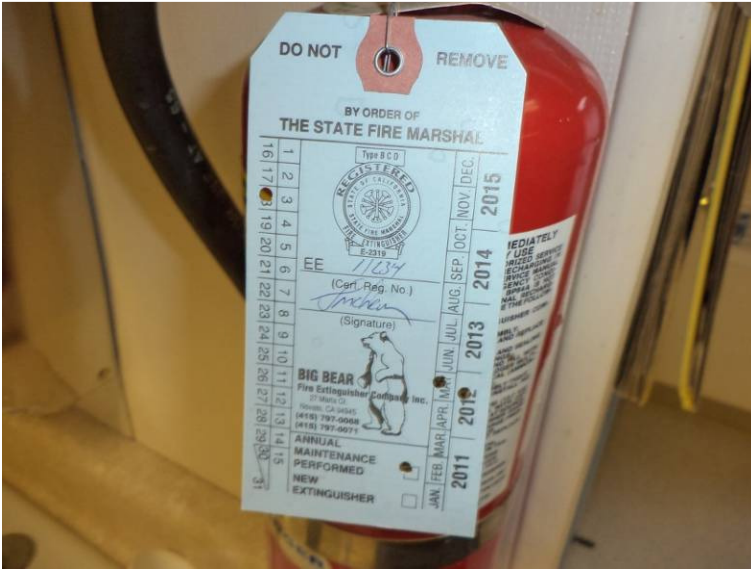
Photograph No. 13

Multipurpose portable wall mounted handheld fire extinguishers were provided throughout the building (reference Photograph 13 in Appendix B).

View of the fire extinguisher tag.

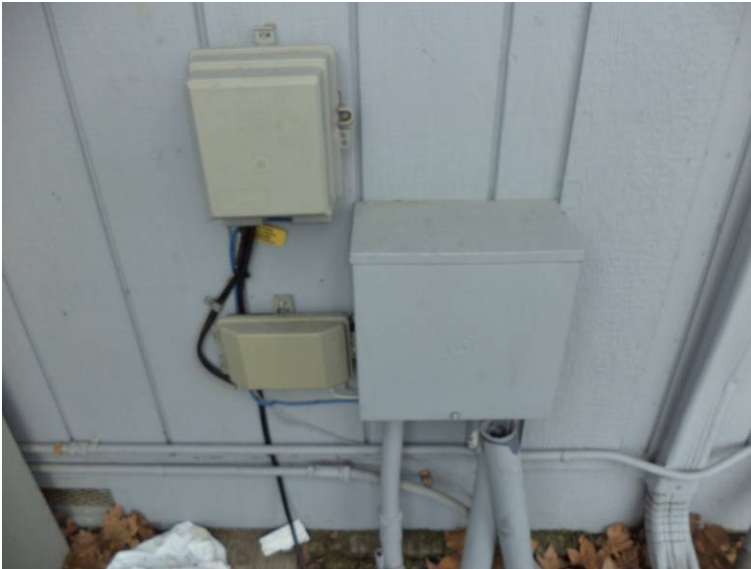
Photograph No. 14

Telephone terminal/junction box was present at the north side of Trailer (North) and enters the building at this location (reference Photograph 14 in Appendix B).

View of the telephone terminal box.

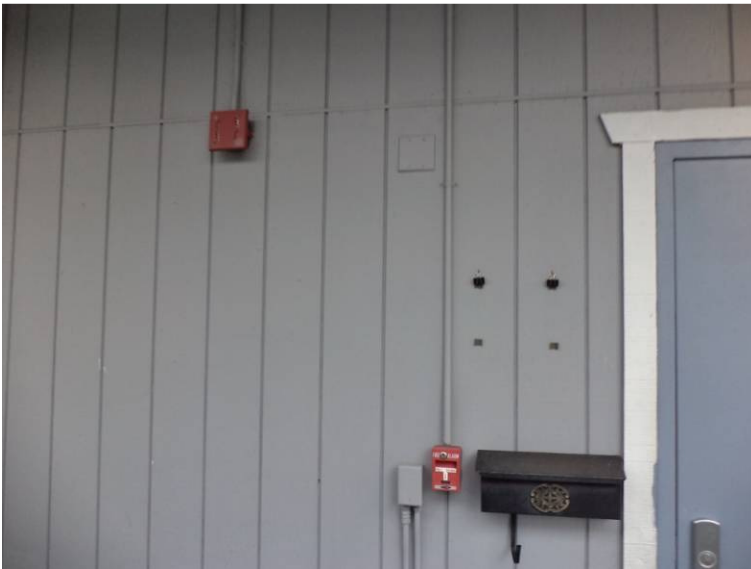
Photograph No. 15

The buildings contain a stand-alone fire alarm system which consists of pull stations at the exterior wall next to the entrance doors which are connected to a visual warning devices within the restrooms and sounder which notify persons to vacate the buildings (reference Photographs 15 and 28 in Appendix B). In addition we noted ceiling mounted stand-alone smoke detectors within the main classroom areas. As far as we are aware the system is not connected to the main school building fire alarm system.

View of the pull station and sounder.

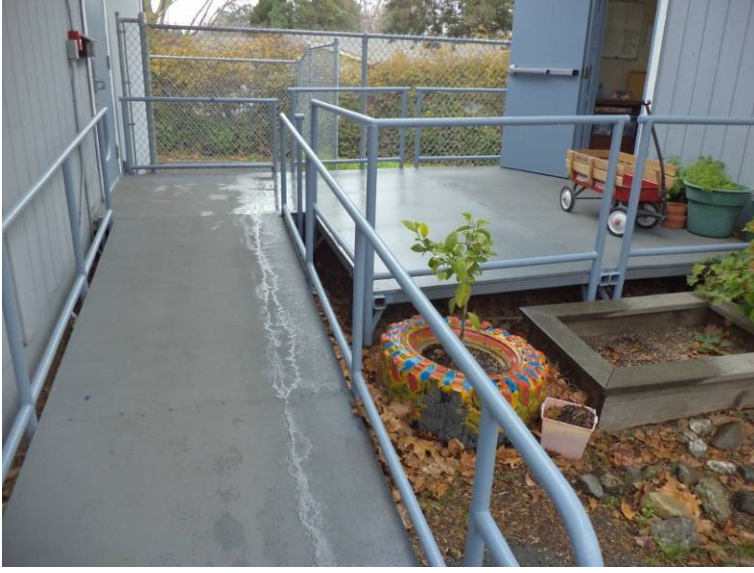
Photograph No. 16

View of the platform and ramp.

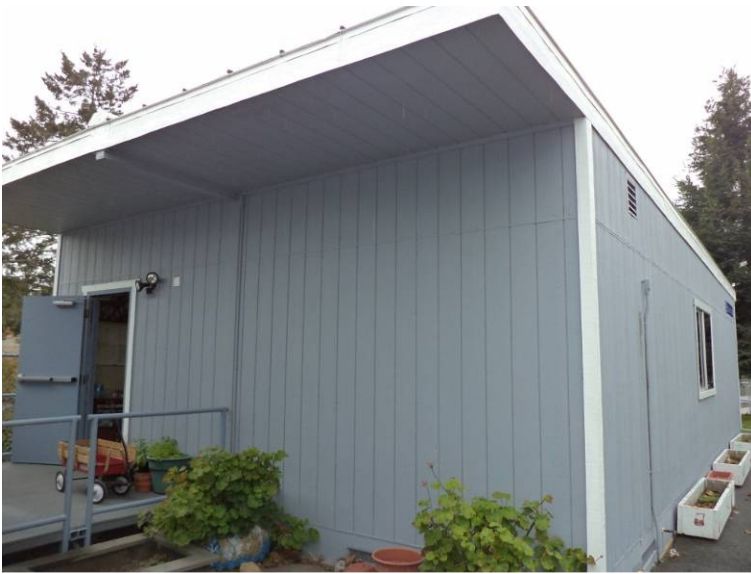
Photograph No. 17

View of the north and west elevations.

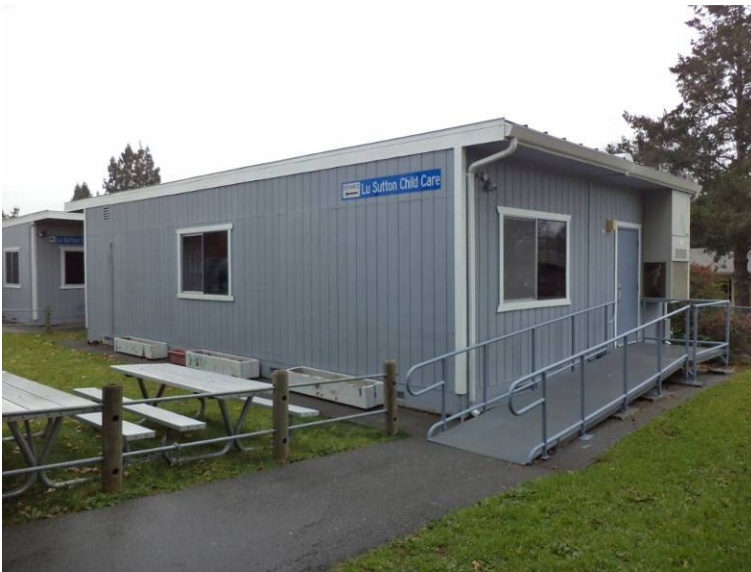
Photograph No. 18

Both buildings contained different sized sliding metal window units with tempered safety glass incorporated (reference Photographs 1, 4 and 18 in Appendix B).

View of the south and west elevations. Also shows the wall mounted heat pump unit and ramp.

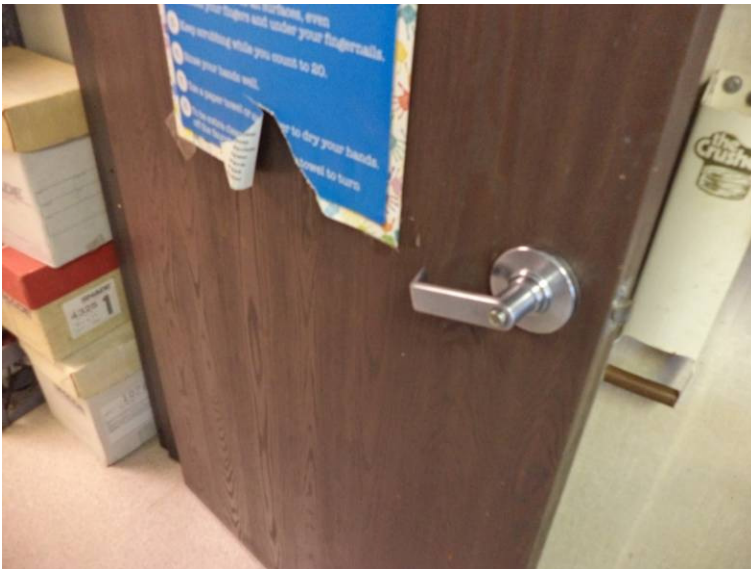
Photograph No. 21

View of the interior door at the restroom and lever handles.

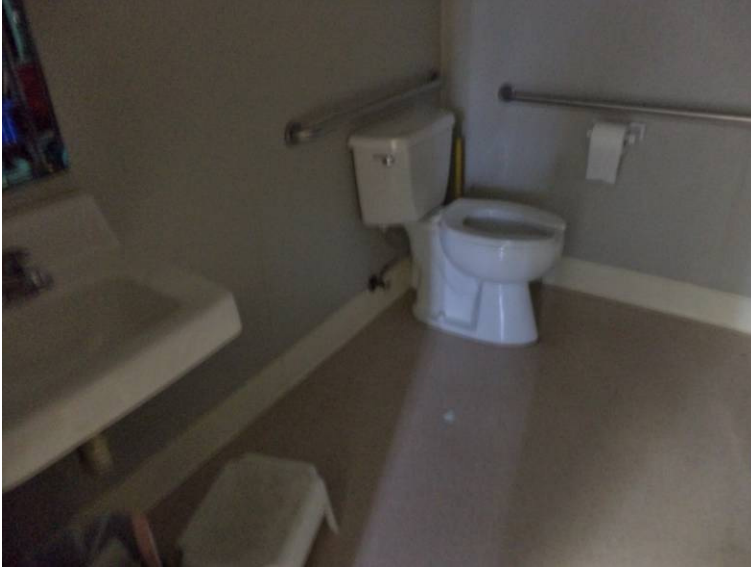
Photograph No. 23

View of the restroom finishes and fixtures.

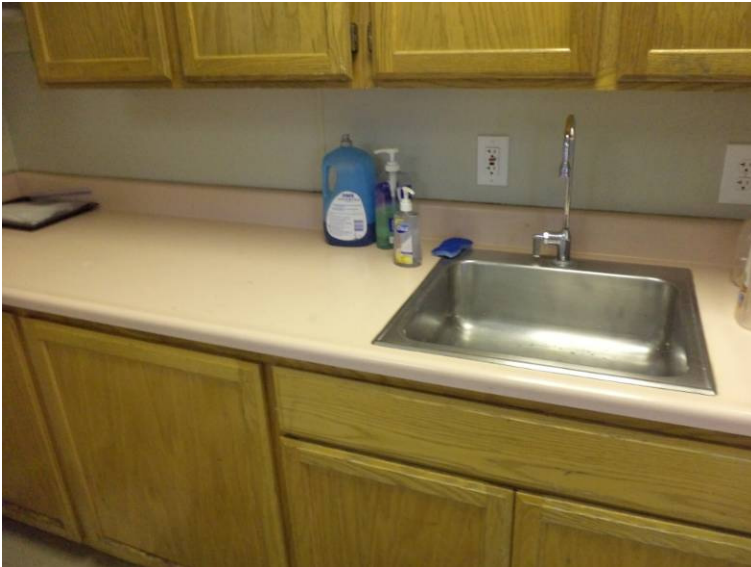
Photograph No. 24

View of the stainless steel sink and fixed cabinets.

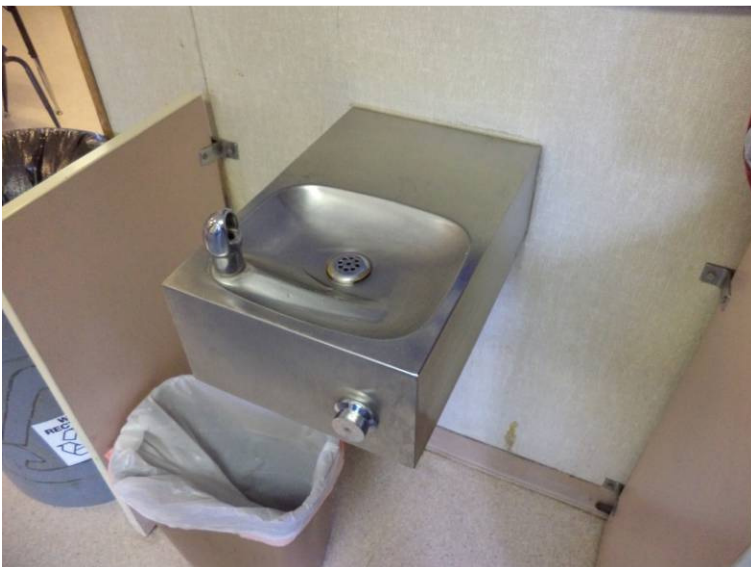
Photograph No. 25

The building contained one wall mounted stainless steel drinking fountain which is located opposite the restroom. The water fountain is wall mounted with front-mounted push-button valve (reference Photograph 25 in Appendix B).

View of the drinking fountain.

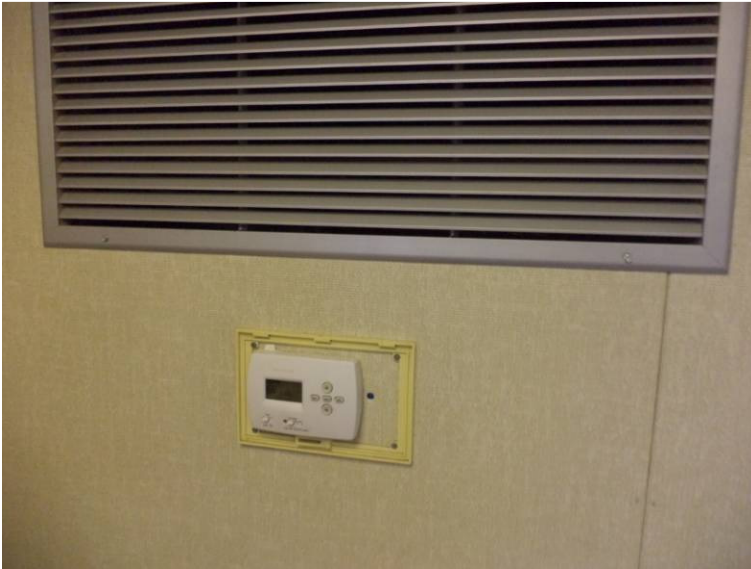
Photograph No. 26

View of wall mounted thermostat and the supply grill.
