Citywide
Facility Condition Assessment

Report of
Facility Condition Assessment

For
City of Novato
New Hamilton Gym
530 Nave Drive, Novato, CA

March 4, 2013

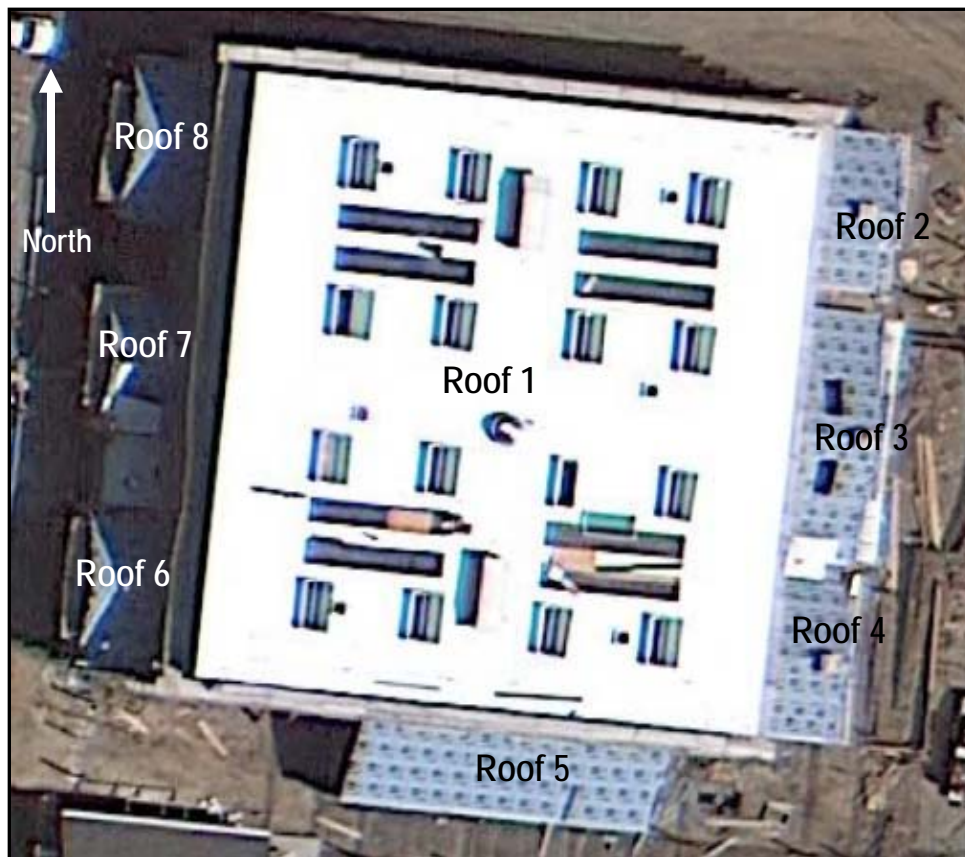
Overview of Roof Locations & Configurations

The facility contained seven steep-sloped roof areas along with a large low-sloped roof area; these roof areas are shown on the following aerial plan:

The low sloped roof area 1 contained an adhered Thermoplastic Polyolefin (TPO) single-ply membrane on a 1 ½" metal decking. The steep-sloped roof areas 2 through 8 contained an asphalt shingle roofing system with R-30 insulation and a vapor retarder on a plywood deck (reference Photographs 10 and 11 in Appendix B). The perimeter parapet wall constructions are finished with a 24 gauge galvanized sheet metal flashing.
