**Report of
Facility Condition Assessment**

**For
City of Novato
Postmaster's House
815 DeLong Avenue, Novato, CA**

March 4, 2013

Faithful+Gould, Inc.

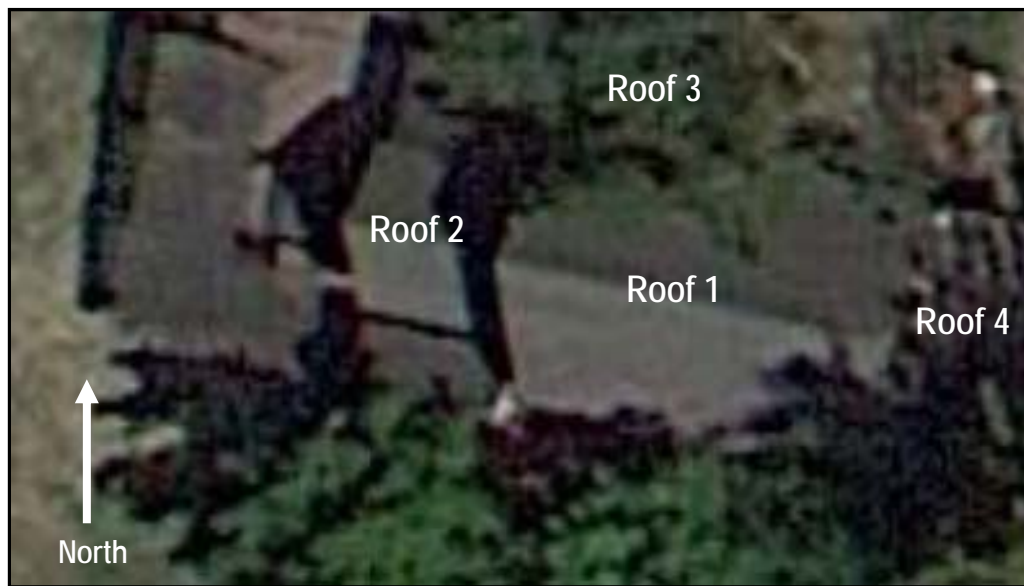
Overview of Roof Locations & Configurations

The facility contained two steep-sloped and two low-sloped roof areas; these roof areas are shown on the following aerial plan:

The steep-sloped roof areas 1 and 2 contained asphalt shingles with mineral surface granules bonded to a felt underlayment and plywood sheathing deck with felt between (reference Photographs 4, 6 and 8 in Appendix B). Low-sloped roof areas 3 and 4 at the canopy structures, which we assume contain rolled asphalt Built-Up Roof (BUR) covering. The age of these roof areas are unknown and it appears that when the roof coverings have been replaced they have been overlaid straight on top of the original coverings, which we assume was intended as a recovery system. There is no storm water capture such as gutters or downspouts at the building. The storm water discharges from the roof levels straight to ground level immediately below.

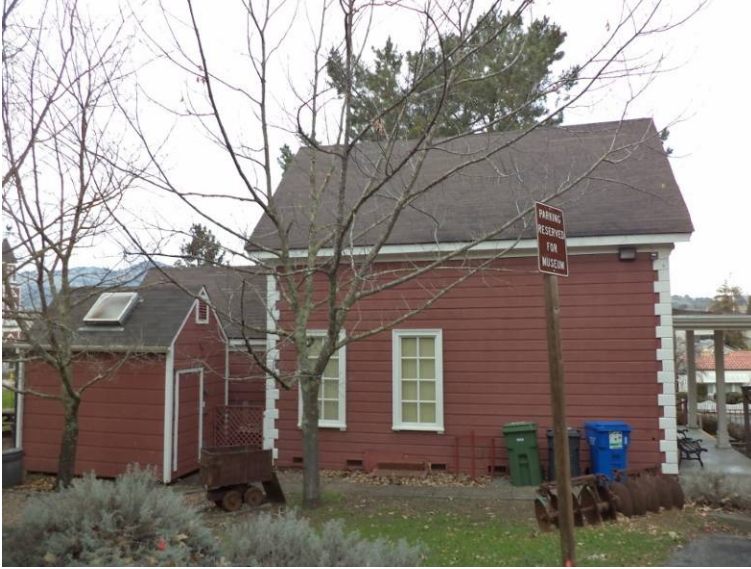
Photograph No. 3

Exterior lighting at the buildings consisted of a combination of surface mounted wall packs with aluminum housing (reference Photograph 3 in Appendix B).

View of the wood siding upper floor windows and wall pack light fixtures.

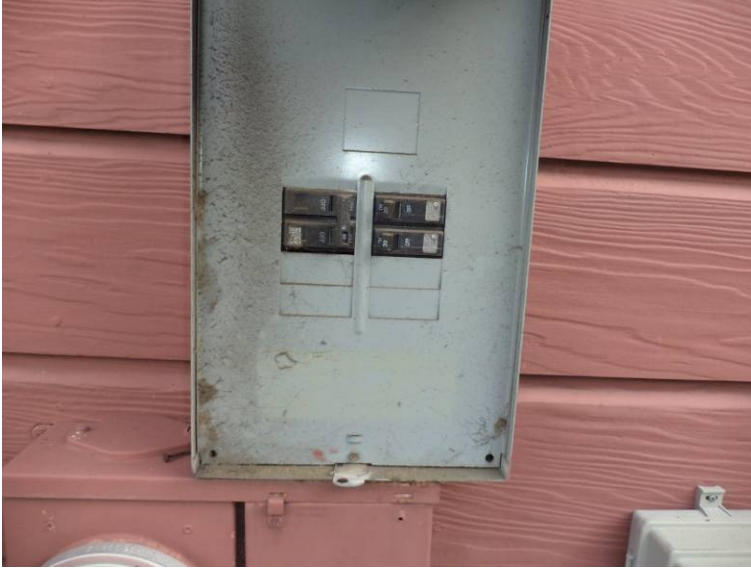
Photograph No. 27

View of the electrical panel and meter.
