Citywide
Facility Condition Assessment

Report of
Facility Condition Assessment

For
City of Novato
Maintenance Buildings
(Vehicle Maintenance and Divis & Lockers)
550 Davidson, Novato, CA

March 4, 2013

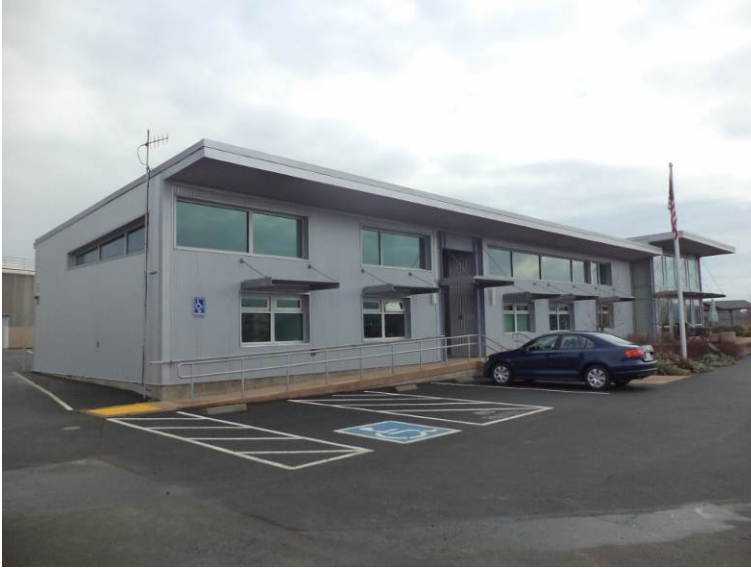
Photograph No. 40

View of Building B's west elevation.
