Citywide
Facility Condition Assessment

Report of
Facility Condition Assessment

For
City of Novato
Novato Arts Center
(Buildings 500, 781, 789 & Hamilton Cafe)
500 Palm Drive & 781/789 Hamilton Parkway, Novato, CA

March 4, 2013

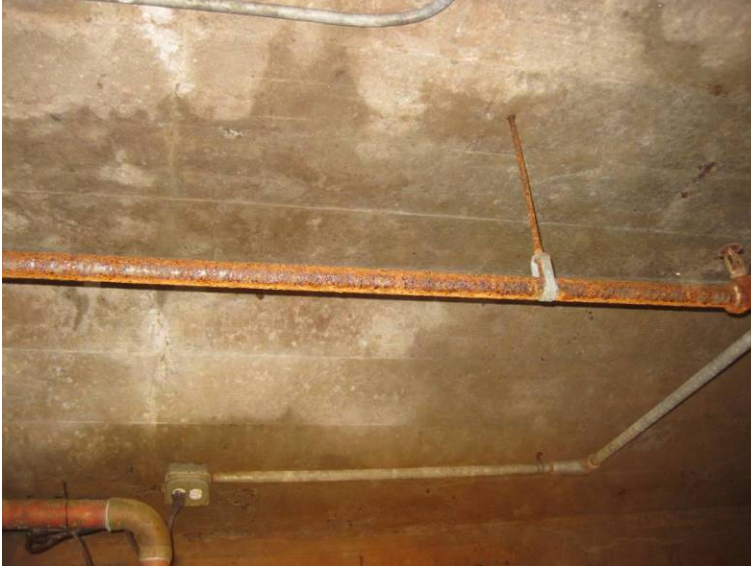
Photograph No. 1

View of the underneath of the first floor concrete floor construction.

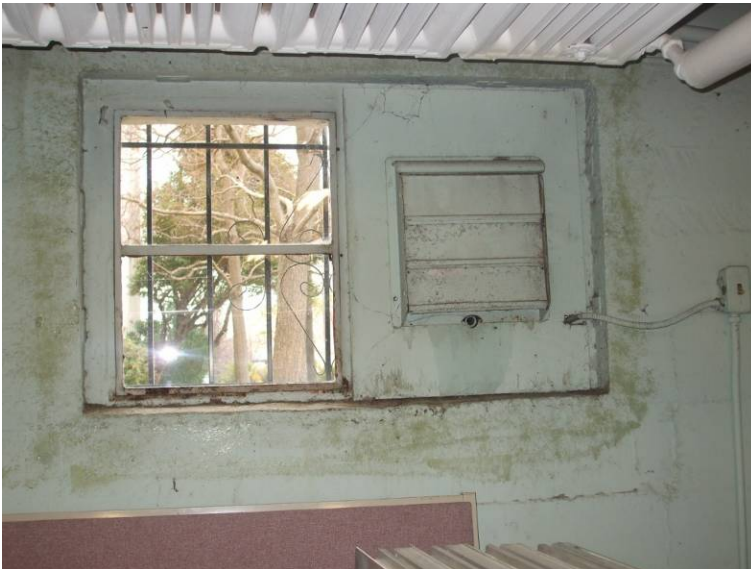
Photograph No. 2

The basement walls consisted of reinforced cast-in-place concrete with a thickness of approximately 12" (reference Photograph 2 in Appendix B). The exterior surface of the above ground areas contained a cement plaster surface with a painted finish, to match the surface of the upper cast-in-place concrete wall construction.

The basement wall construction was observed to be in good condition. No issues or defects could be observed.

View of the basement wall construction. Also shows a metal cased window with exterior security rail surround.

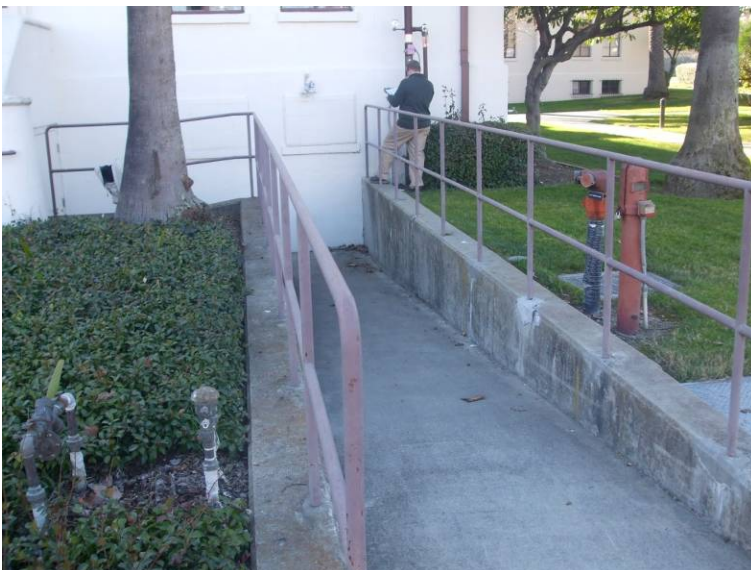
Photograph No. 3

View of an access ramp on the east side of the building.

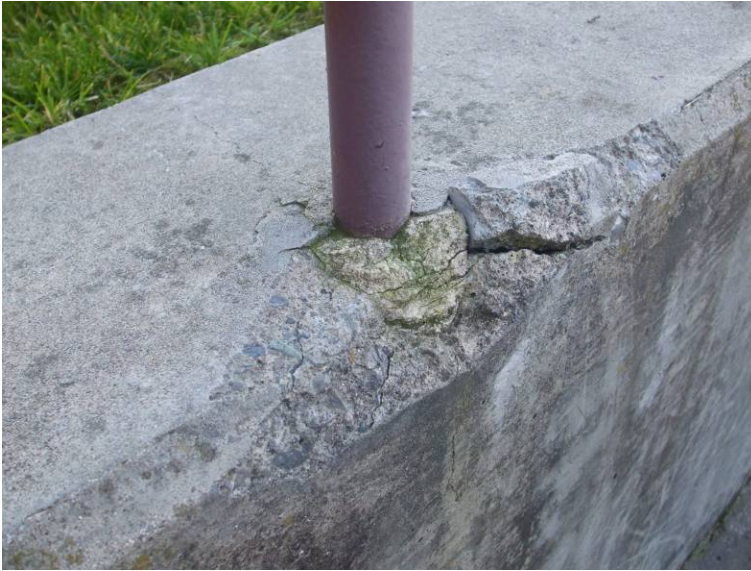
Photograph No. 4

View of the cracking in concrete around base of guardrail.

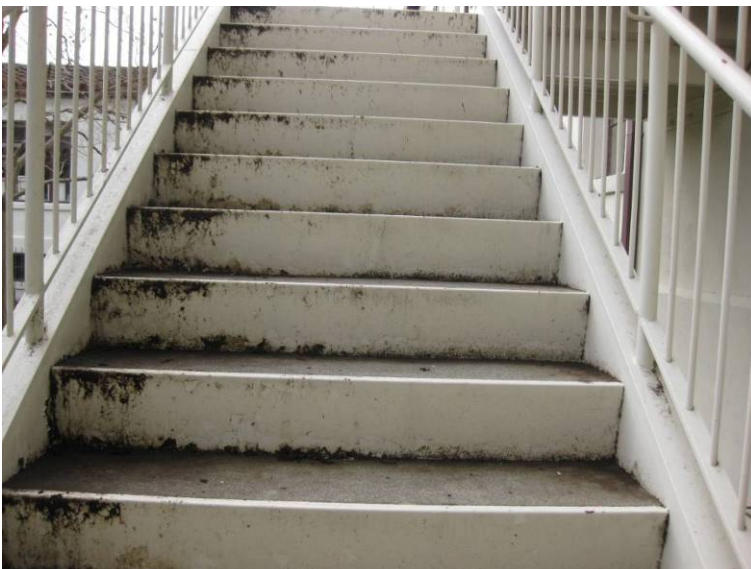
Photograph No. 6

The metal scissor stairs at building 500 appeared to be in fair condition. There is some weathering present on the south side of the staircase (reference Photograph 6 in Appendix B) – we recommend cleaning and carrying out routine maintenance to prevent these issues. We do not anticipate any expenditure within the twenty- year study period.

Further view of the steps showing deterioration. Predominantly on the left side of the staircase.

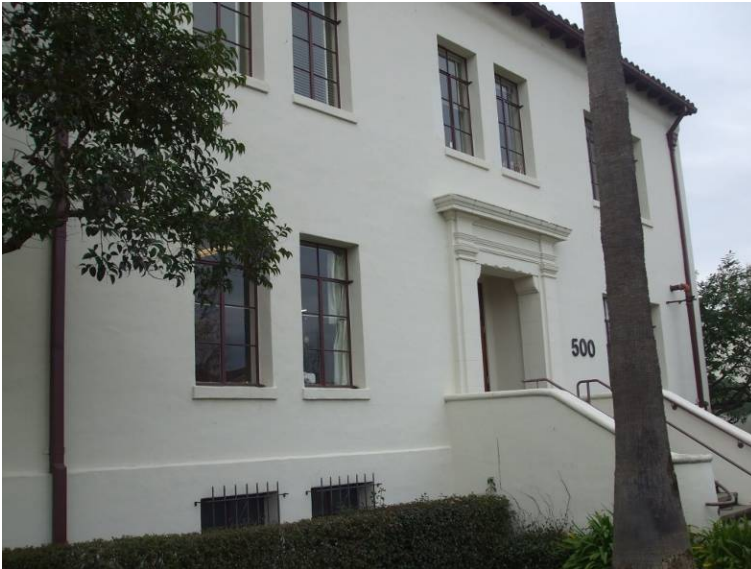
Photograph No. 8

Building 500 contained a load bearing cast-in-place concrete exterior wall construction which supports the roof structures (reference Photograph 8 in Appendix B). The walls had a smooth stucco finish with presumably a latex paint covering. The entrance of the building contained a decorative tabernacle type of detail around the front door (reference Photograph 10 in Appendix B) and a band of 4" x 4" hand painted tiles at mid-level. These exterior walls contained multiple 3" round gable vents to form pyramids to assist with air circulation throughout the building.

View of the cast-in-place concrete walls.

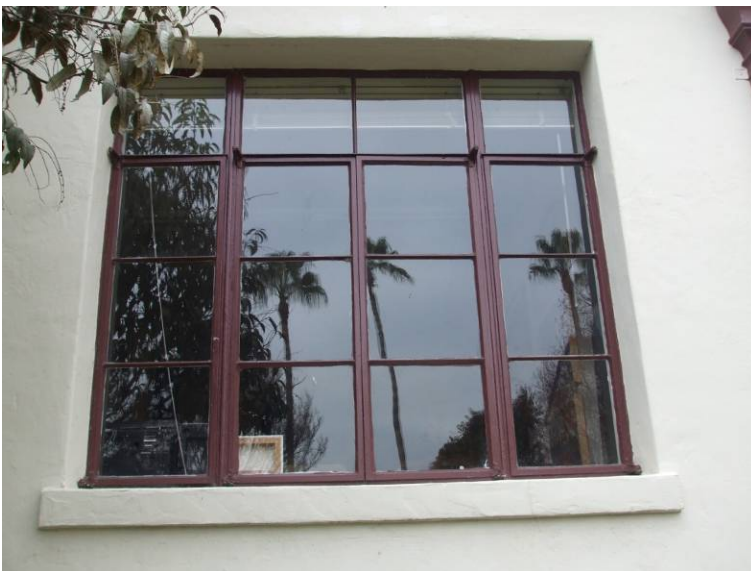
Photograph No. 9

View of a metal cased window.

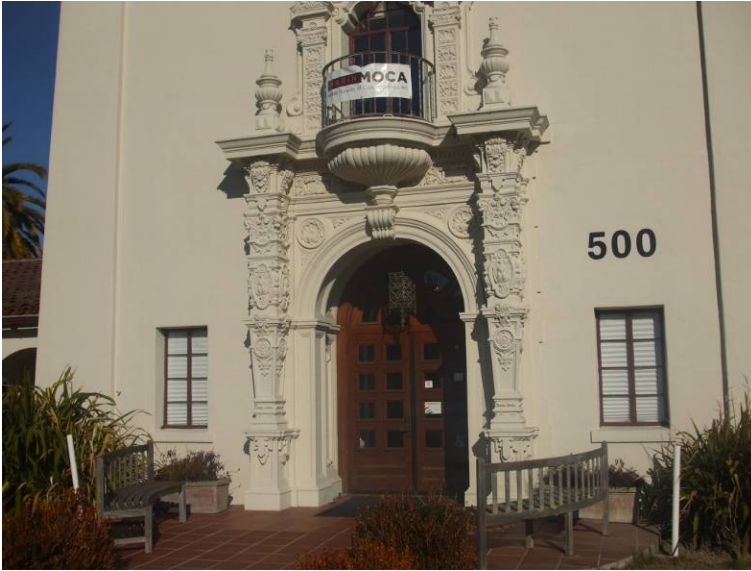
Photograph No. 10

View of a wood double arched door with glass-views on the west side of the property. Also shows decorative door surround.

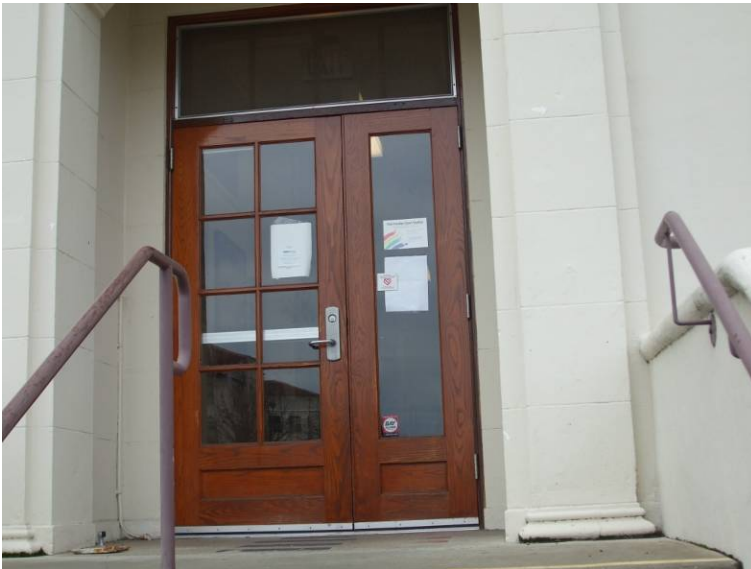
Photograph No. 11

View of a wood door with glass-views and side window unit at the east side of the property.

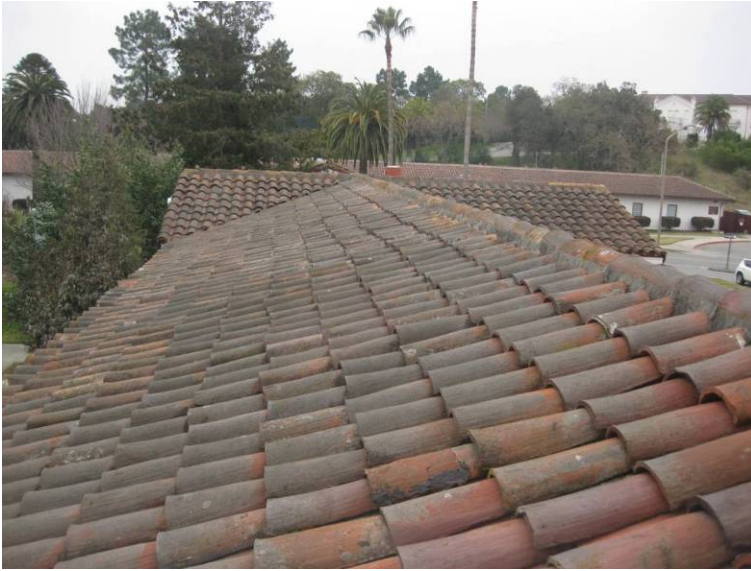
Photograph No. 13

The steep-sloped roof areas 1, 2, 3, 5 and 7 contained a clay tile roof system with tile battens and a felt underlayment (reference Photographs 13, 72 and 160 in Appendix B). The age of the roof covering systems is unknown; however we estimate them to be approximately forty-years old. The roof levels slope to the perimeter gutters which lead to downspouts that drain to ground level and are directed away from the buildings.

View of clay tile roof covering.

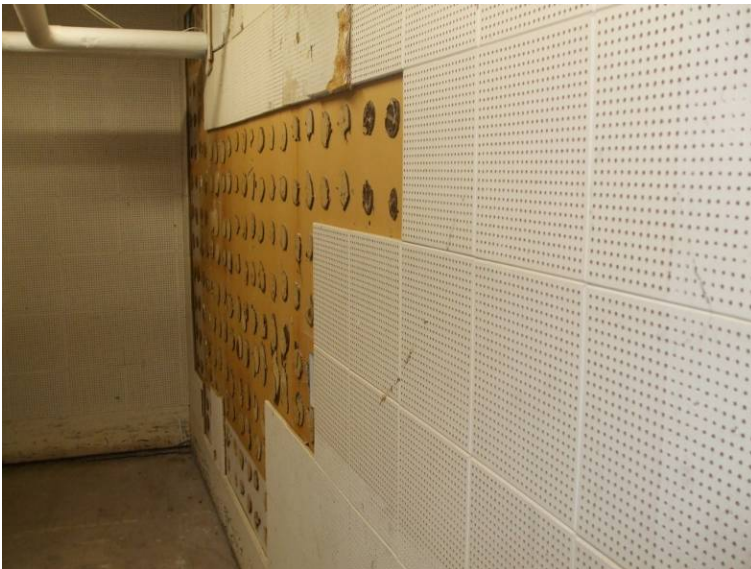
Photograph No. 20

Some rooms in the basement of building 500 contained 12" x 12" acoustical wall tiles (reference Photograph 20 in Appendix B).

View of acoustical wall tiles in the basement.

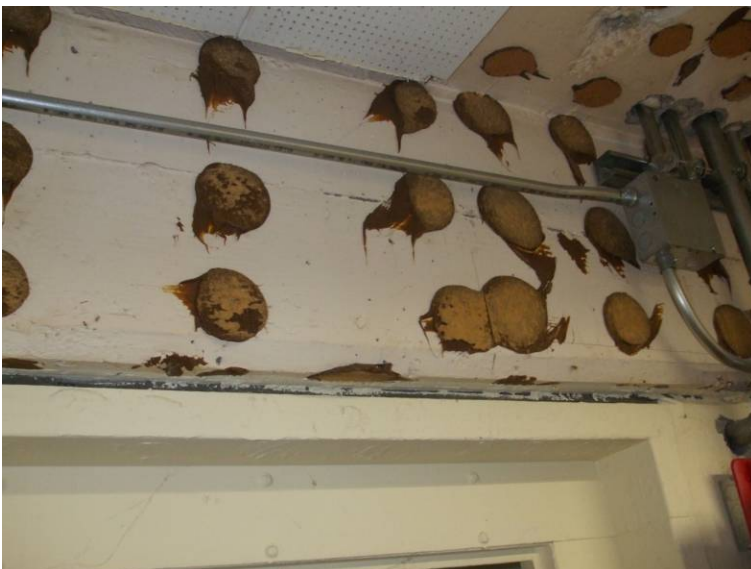
Photograph No. 21

View of absent acoustical wall tiles.

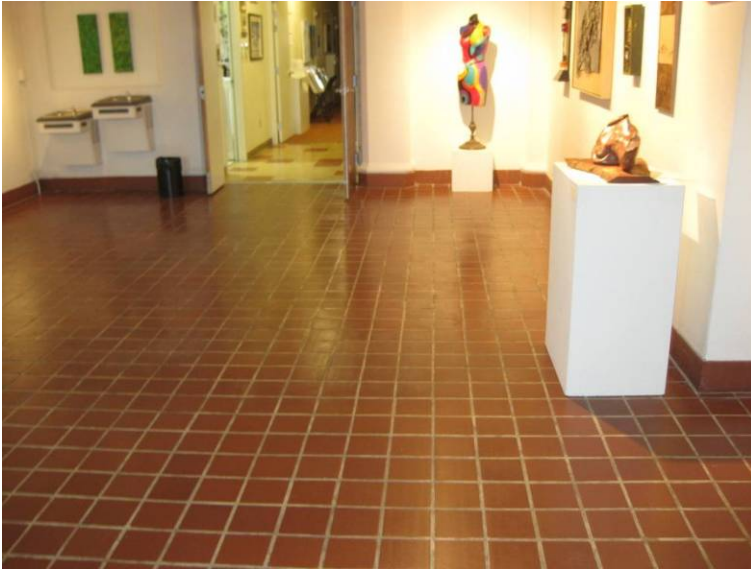
Photograph No. 22

View of ceramic floor tiles in the lobby

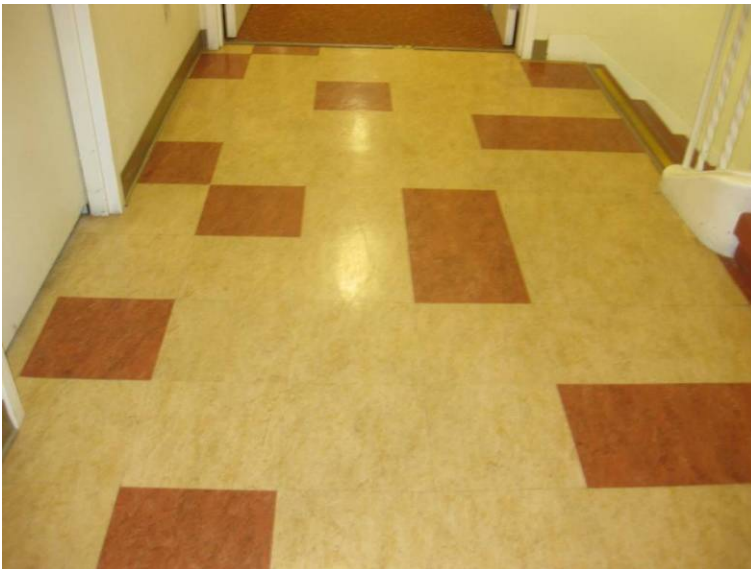
Photograph No. 23

View of the VCT floor on the upper level.

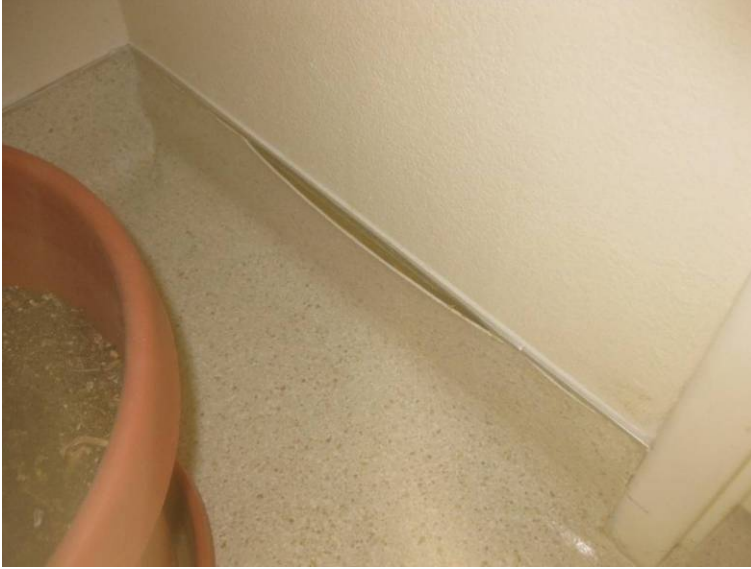
Photograph No. 25

View of the detached vinyl roll floor in the men's restroom.

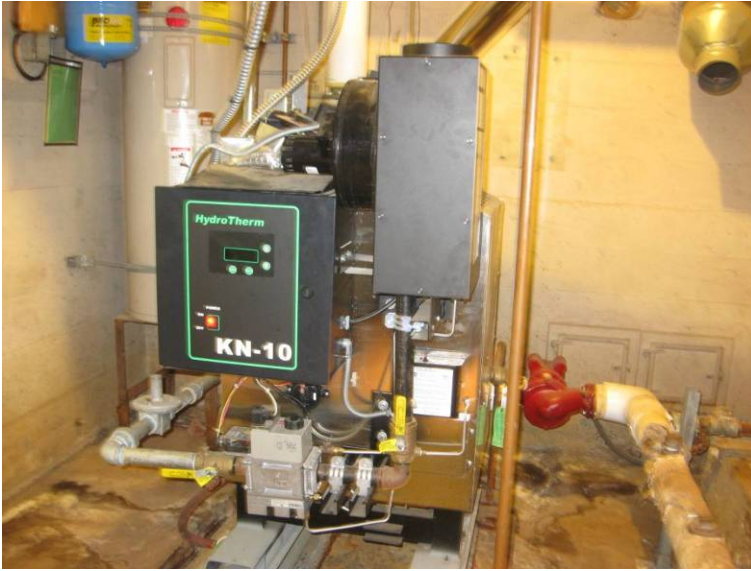
Photograph No. 36

Building 500 contains a cast iron condensing boiler which is manufactured by Hydrotherm and supplies heating for the building. The boiler was recently installed in 2007 and has an output capacity of 850 MBH (reference Photograph 36 in Appendix B).

View of the natural gas boiler.

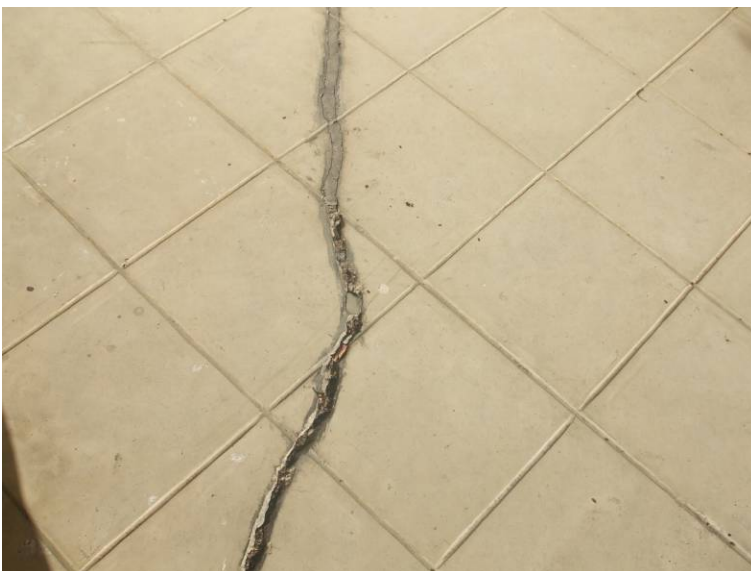
Photograph No. 47

The complex contained cast-in-place concrete paving throughout providing walkways. We assume the paving is supported via a flexible base of sand setting bed and compacted sub grade (reference Photographs 47, 108 and 187 in Appendix B).

View of the paving stones on the exterior walkway.

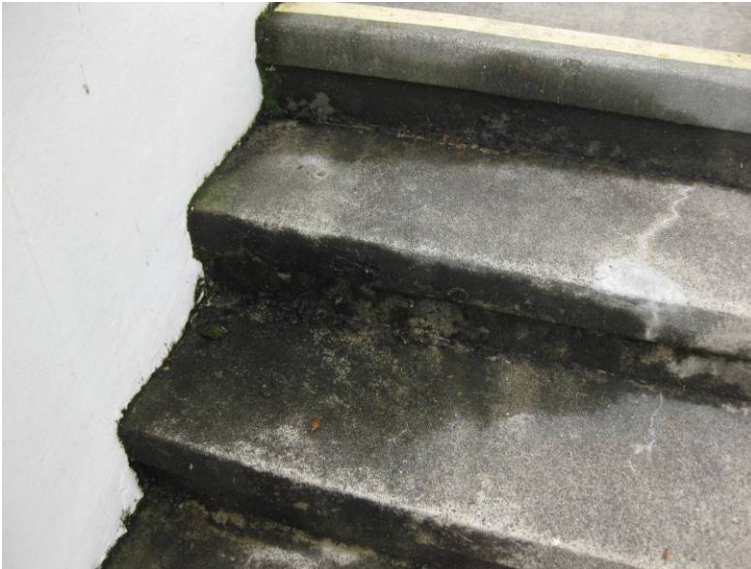
Photograph No. 49

View of the cast in place concrete steps at the east side of the property.

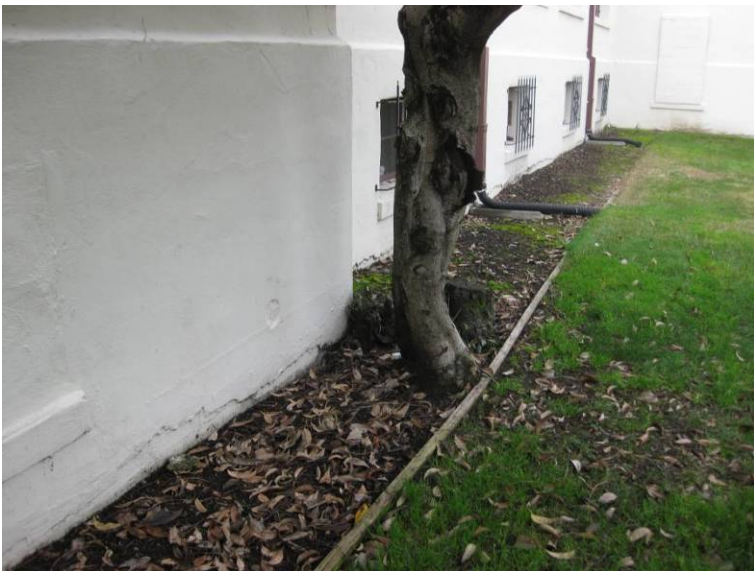
Photograph No. 53

Landscaping consisted of shrubs; succulents and ground cover, with a number of mature trees along the north side of the properties (reference Photographs 53 and 109 in Appendix B).

View of landscaping for the 500 building.

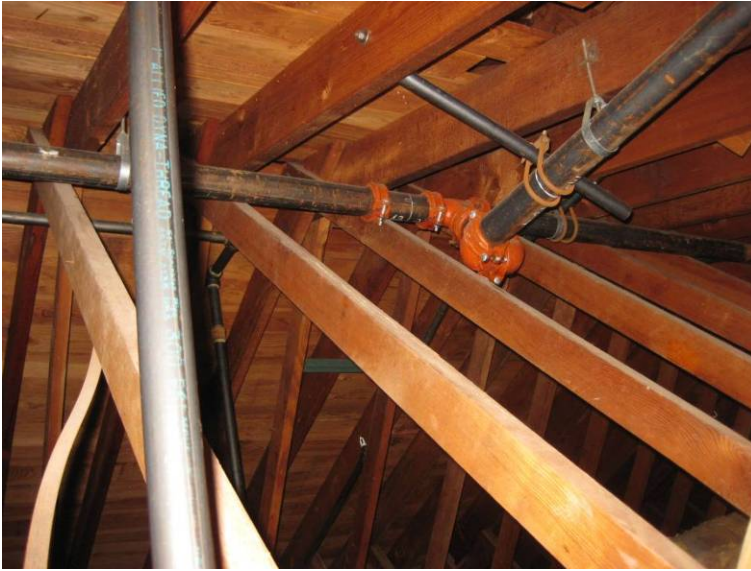
Photograph No. 57

View of the pitched roof construction of the 789 building.

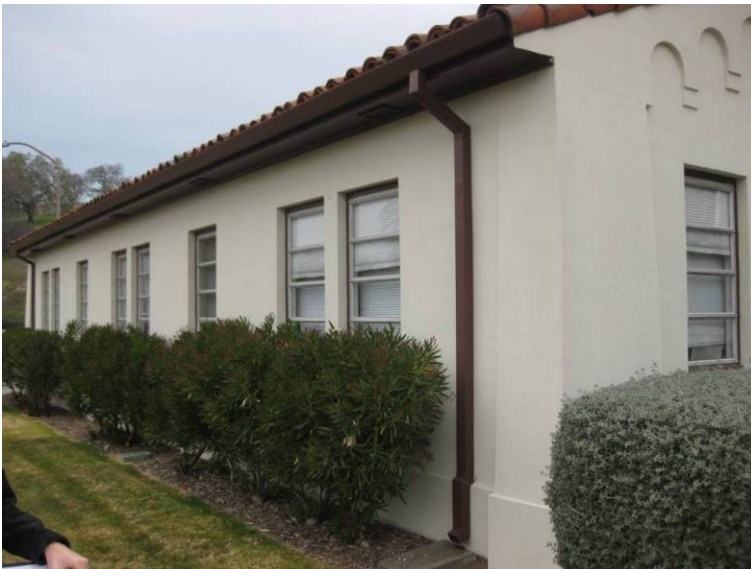
Photograph No. 58

View of the pitched roof construction of the 501 building.

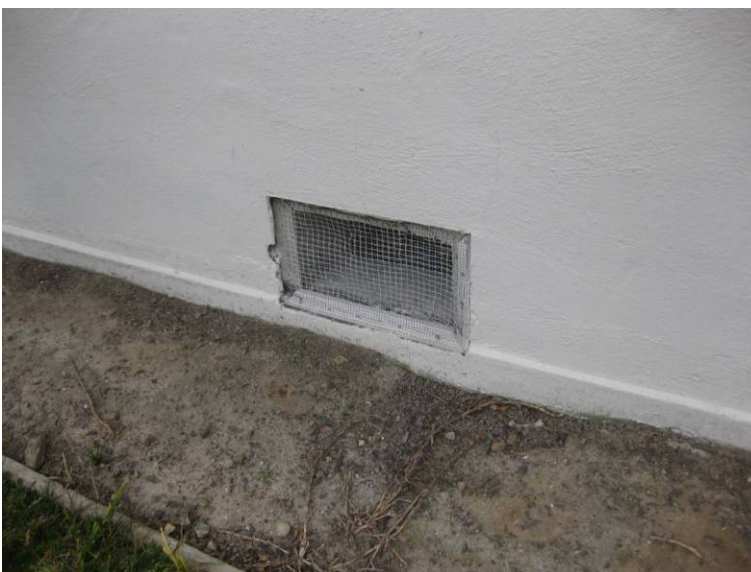
Photograph No. 59

View of the exterior walls finished with painted stucco.

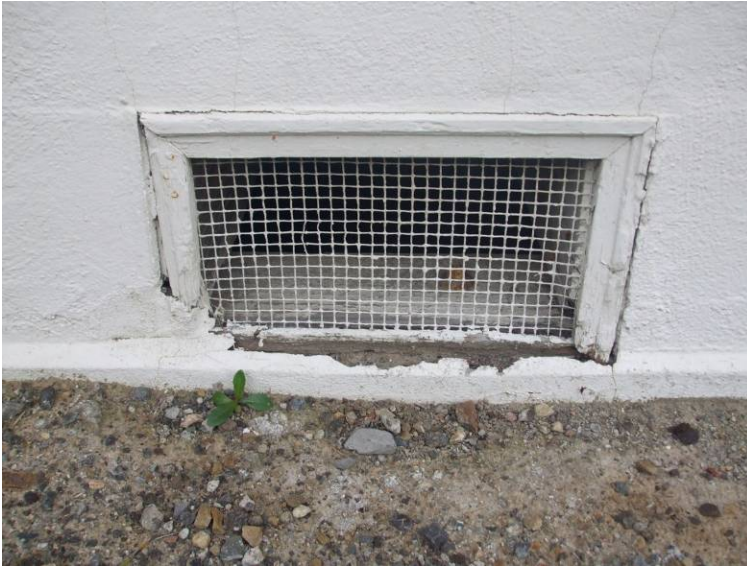
Photograph No. 60

View of a subfloor vent.

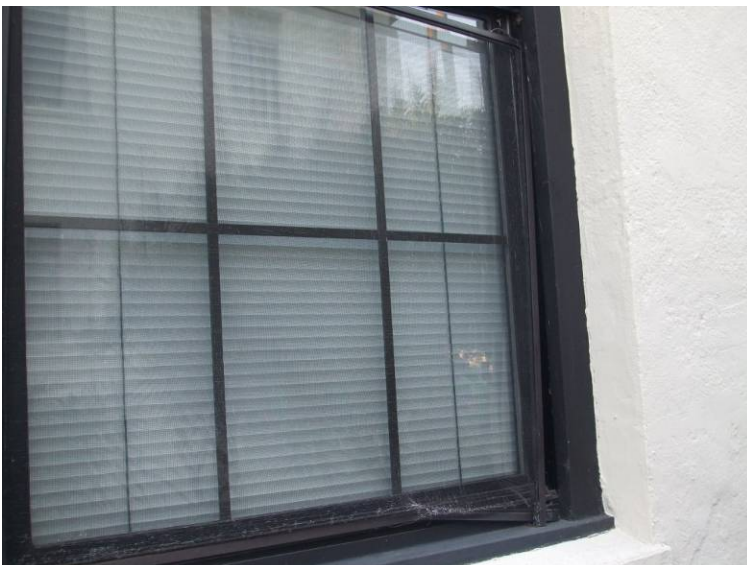
Photograph No. 62

View of 789 & 501 building windows.

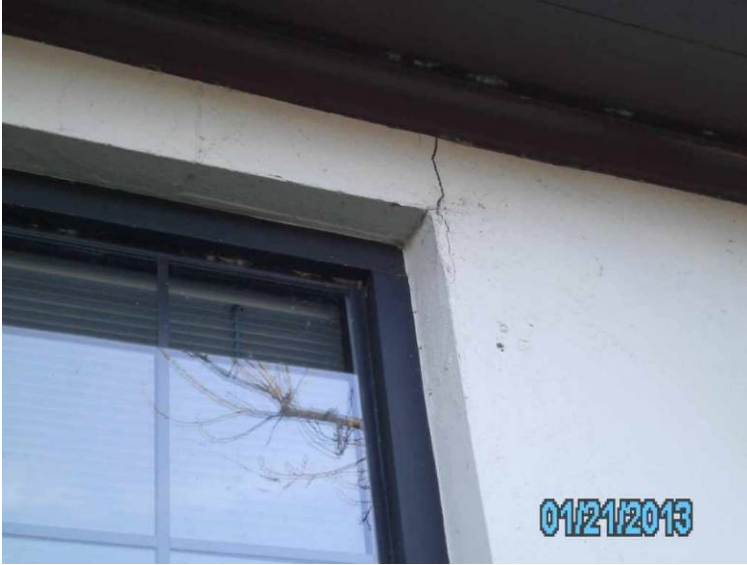
Photograph No. 63

Closer view of the newer aluminum windows on the 789 building.

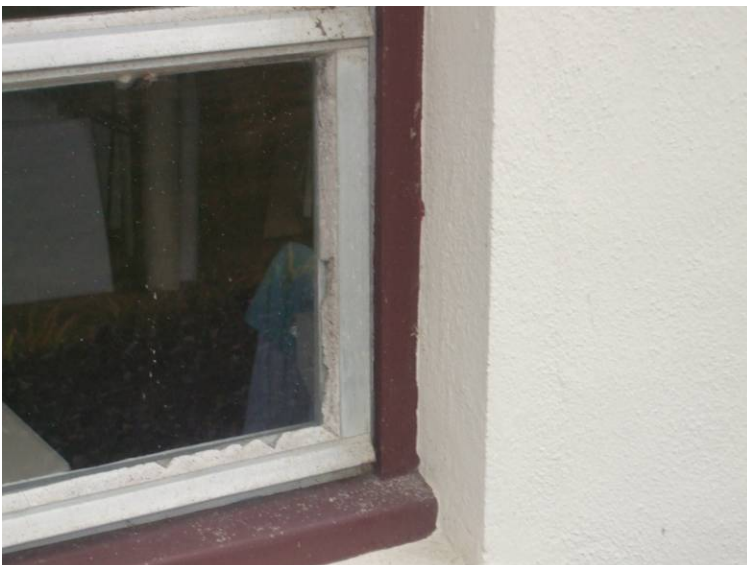
Photograph No. 65

View of the windows on the 501 building.

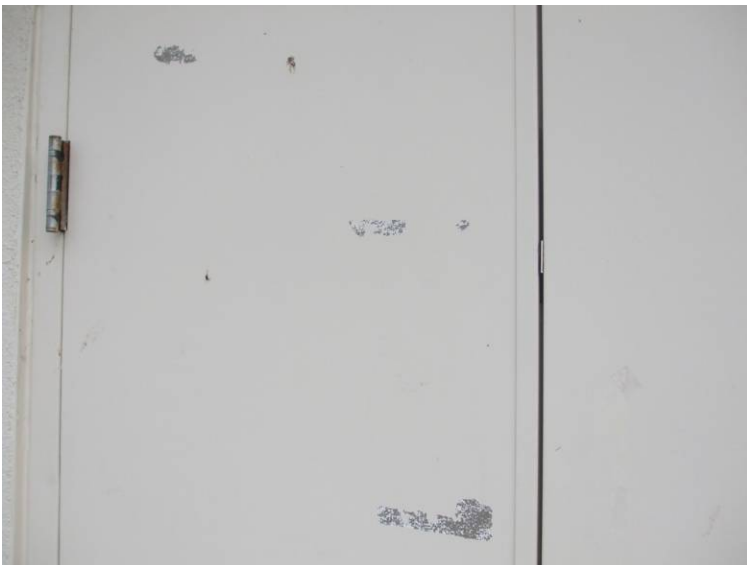
Photograph No. 68

View of the double hollow metal entrance door of building 501.

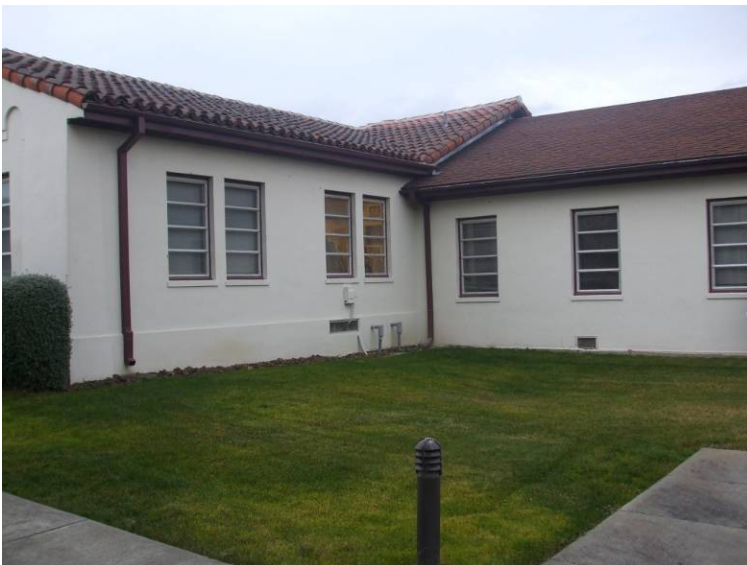
Photograph No. 71

View of alternative entrance door to 501 building.

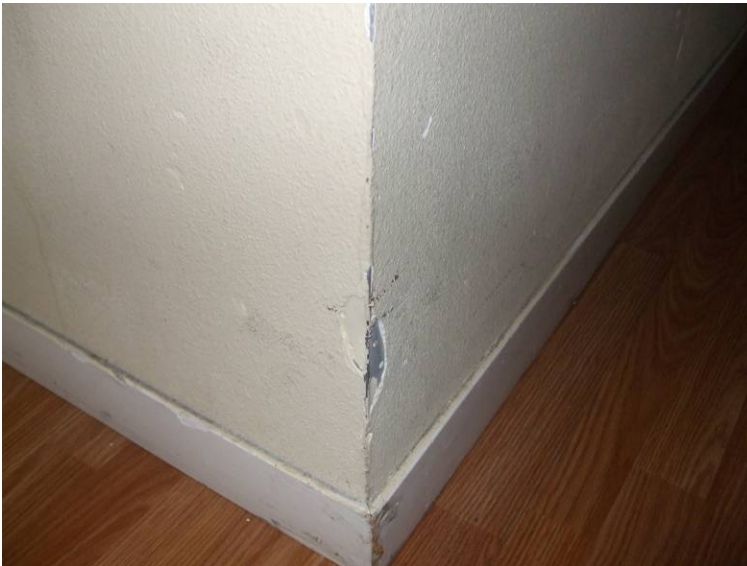
Photograph No. 79

Building 500 contained older VCT at the basement level as well as newer VCT at the kitchen areas at each level (reference Photograph 23 in Appendix B). The entryway and west hallway had 4" x 4" Saltillo tile laid in a straight pattern (reference Photograph 22 in Appendix B). The Hamilton Café contained a laminate wood floor throughout the dining area and hallway leading to the office and restrooms (reference Photograph 165 in Appendix B) and the restrooms have vinyl roll flooring (reference Photograph 164 in Appendix B). Building 789 contained a laminate wood floor on the north side of the building (reference Photograph 79 in Appendix B).

View of the painted wall finish in the 789 building. Also shows laminate wood floor.

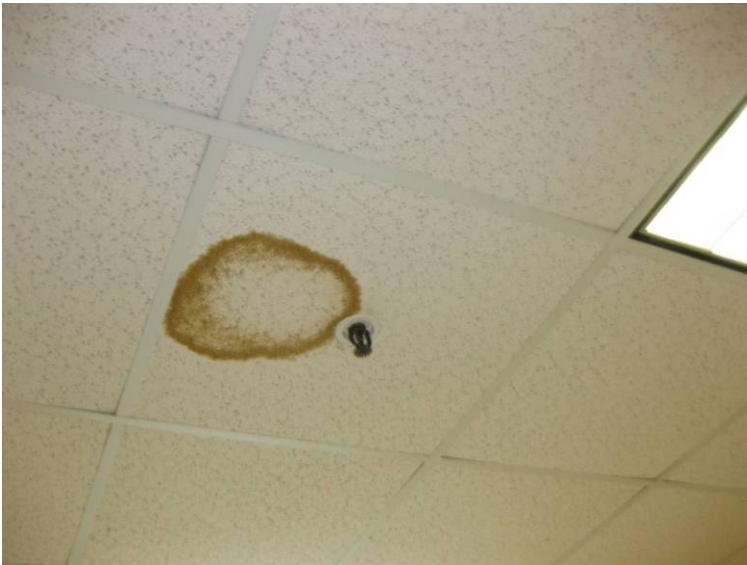
Photograph No. 88

View of acoustical ceiling tiles in the 789 building.

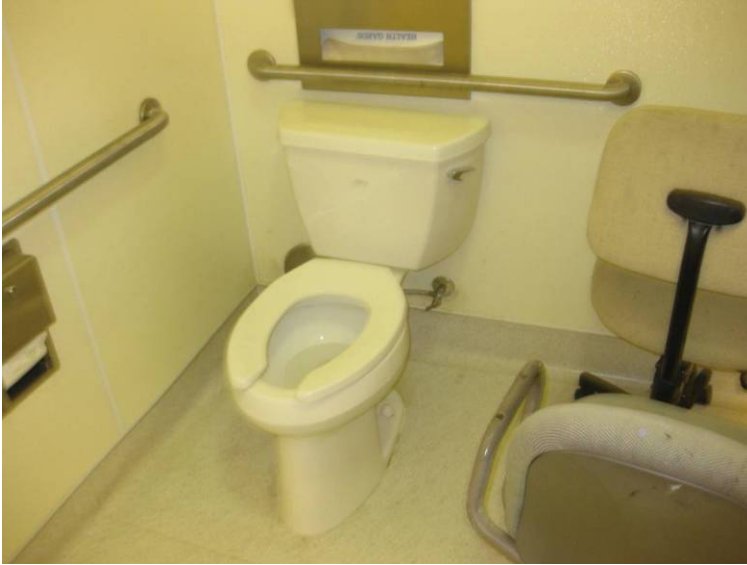
Photograph No. 90

View of ADA compliant vitreous china water closet located in the women's restroom of the 789 building.

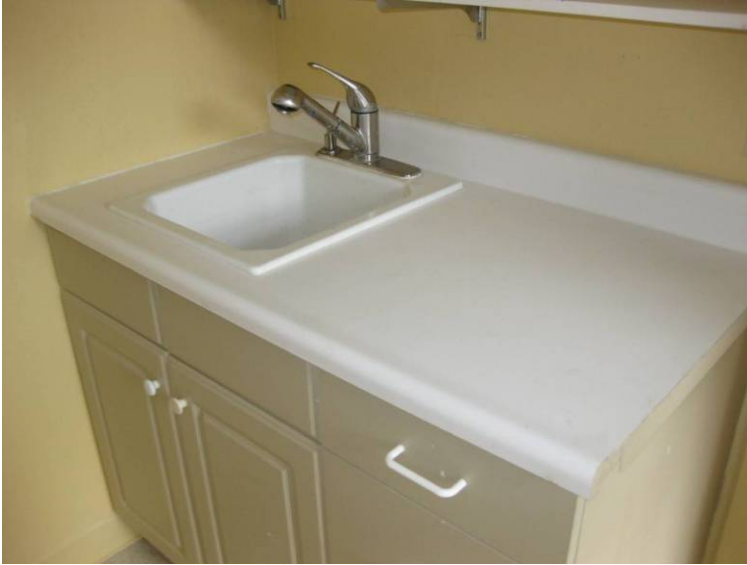
Photograph No. 93

The buildings contain vanity top vitreous china lavatories (reference Photographs 93, 135 and 169 in Appendix B). The lavatories contain single lever style handles with non-metered faucets.

View of vitreous china lavatories in the men's restroom, 789 building.

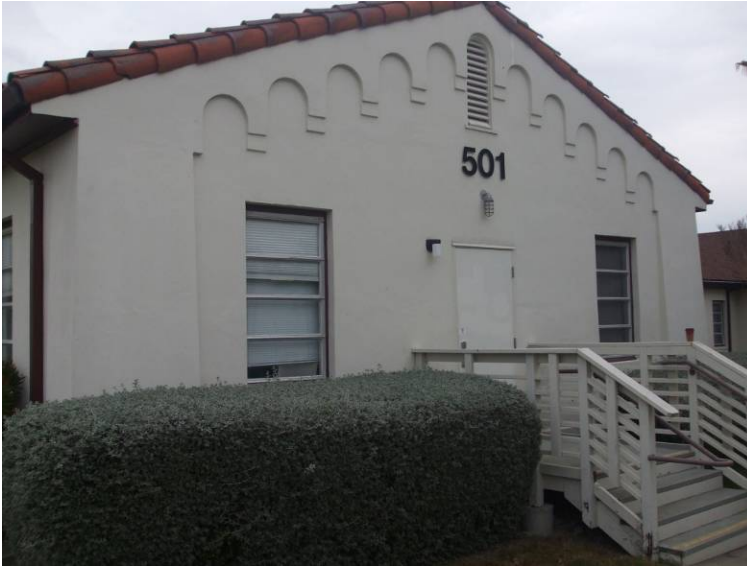
Photograph No. 111

View of a set of exterior wooden steps on the 789 building.

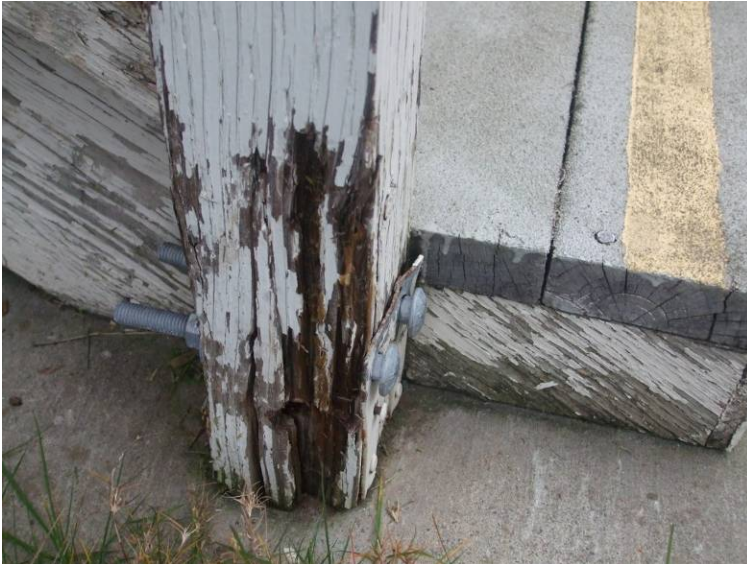
Photograph No. 112

View of another set of exterior steps.

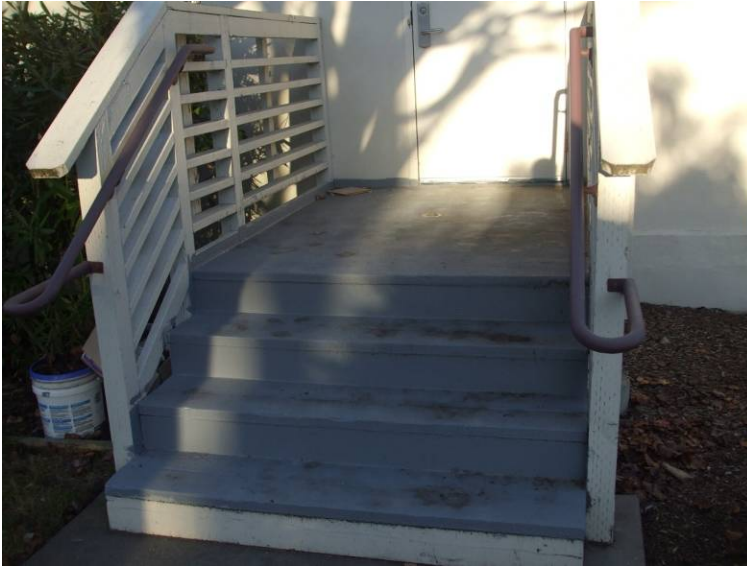
Photograph No. 114

Closer view of ramp handrails which needs repainting.

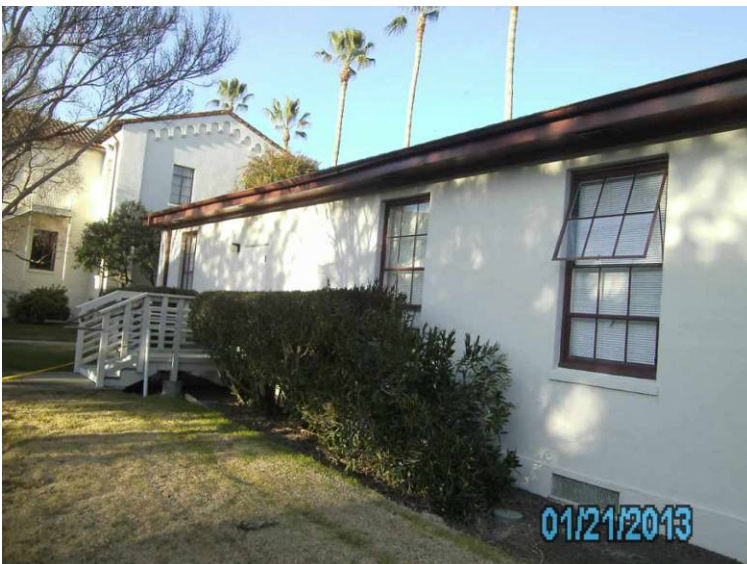
Photograph No. 116

Closer view of handrail on exterior steps which need repainting.

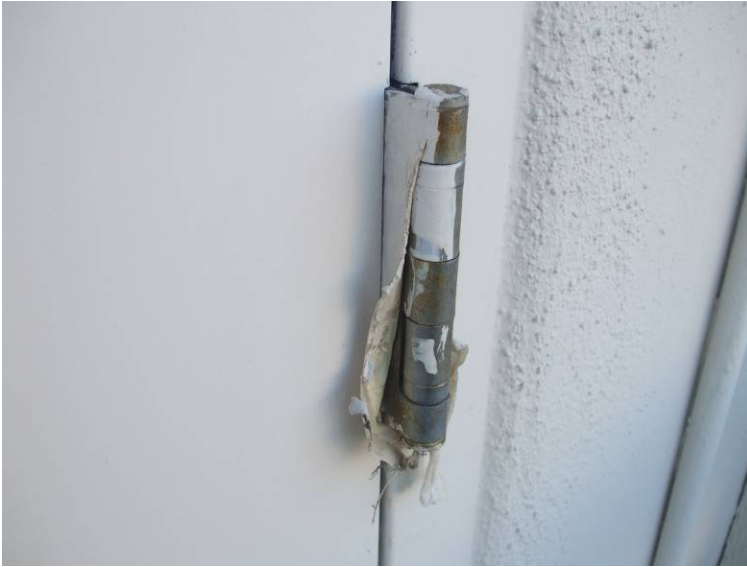
Photograph No. 120

View of single hollow metal door.

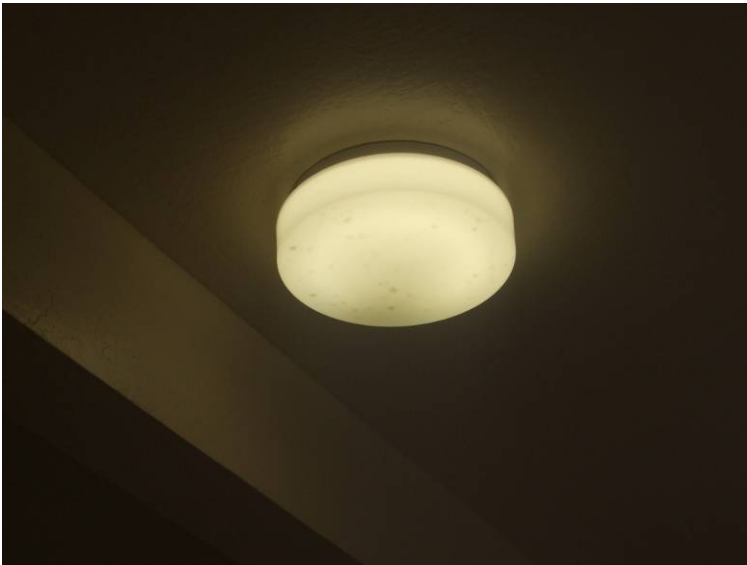
Photograph No. 139

View of a strip light fixture in the kitchen space.

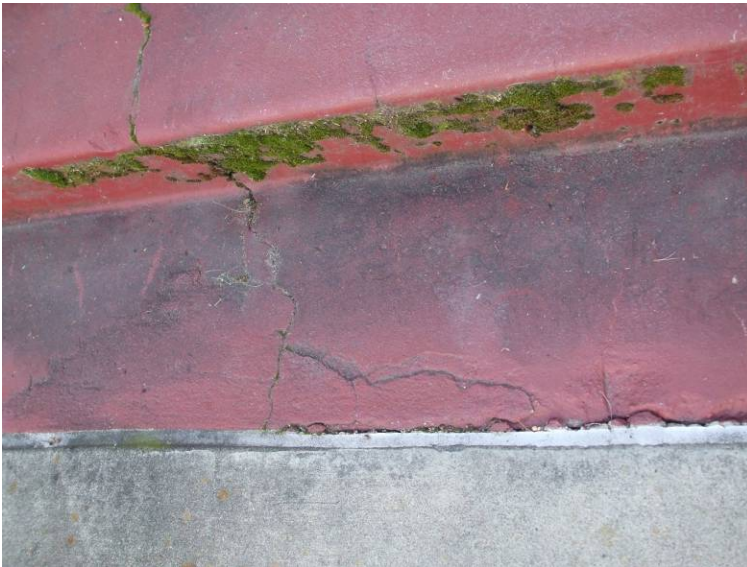
Photograph No. 142

View of paving leading to cast-in-place concrete exterior steps.

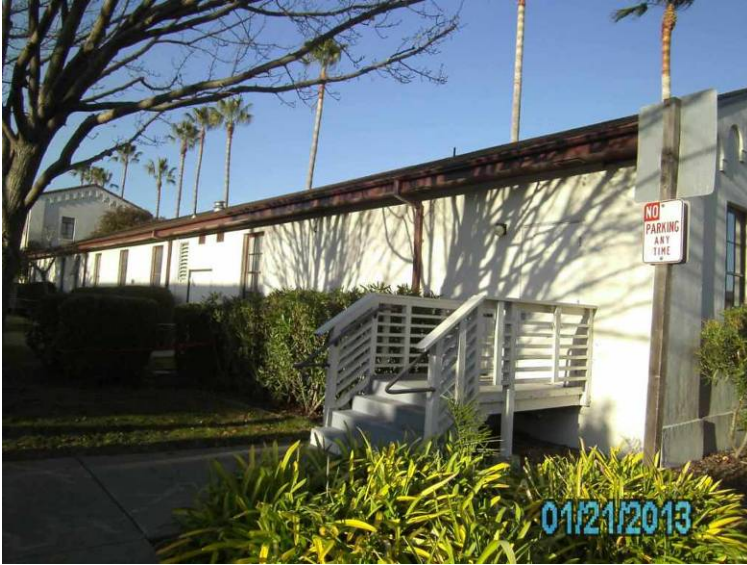
Photograph No. 144

View of a wall mounted exterior light.

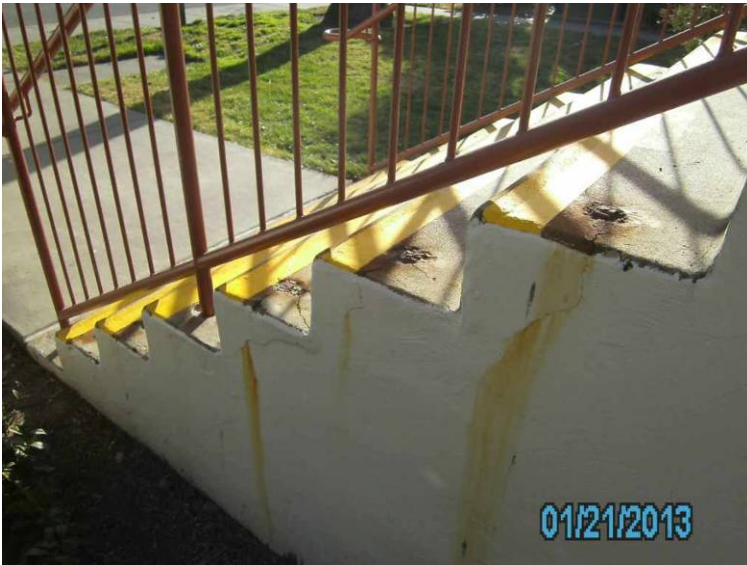
Photograph No. 152

View of exterior stairs leading to the entrance at the south side of the property.

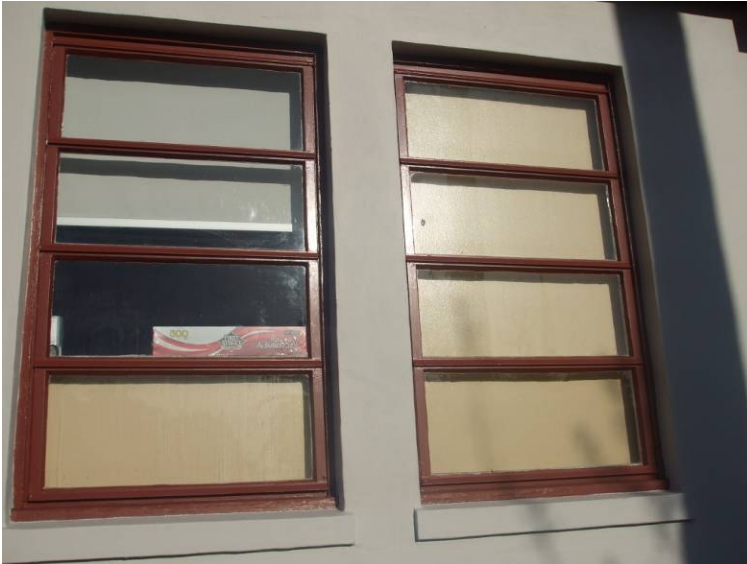
Photograph No. 155

View of the exterior walls finished with painted stucco. Also shows double glazed entrance door.

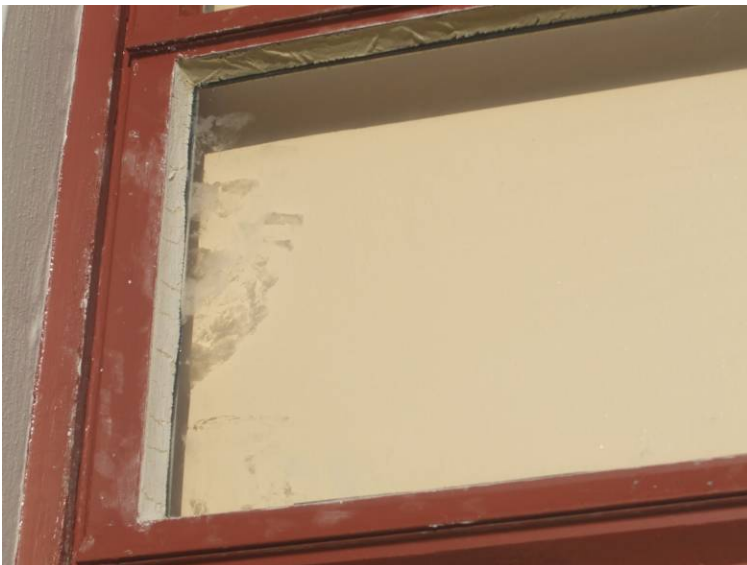
Photograph No. 156

View of the metal painted windows in wood subframes.

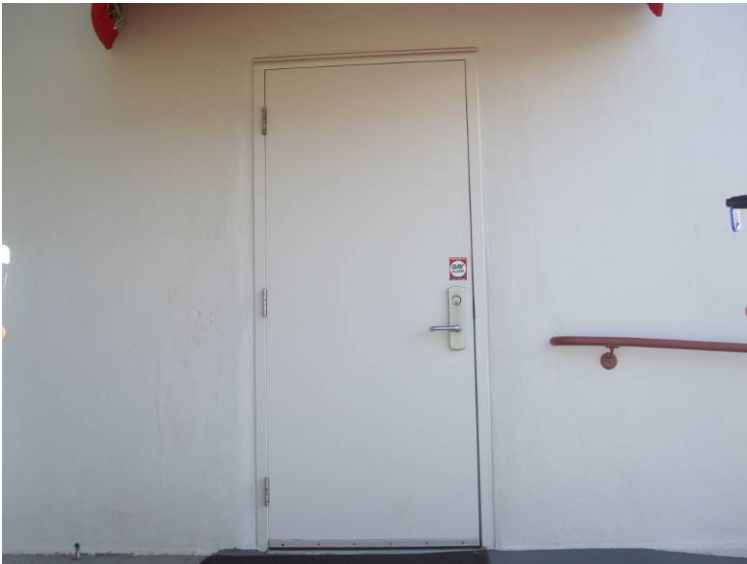
Photograph No. 158

View of hollow metal entrance door at the south of the property.

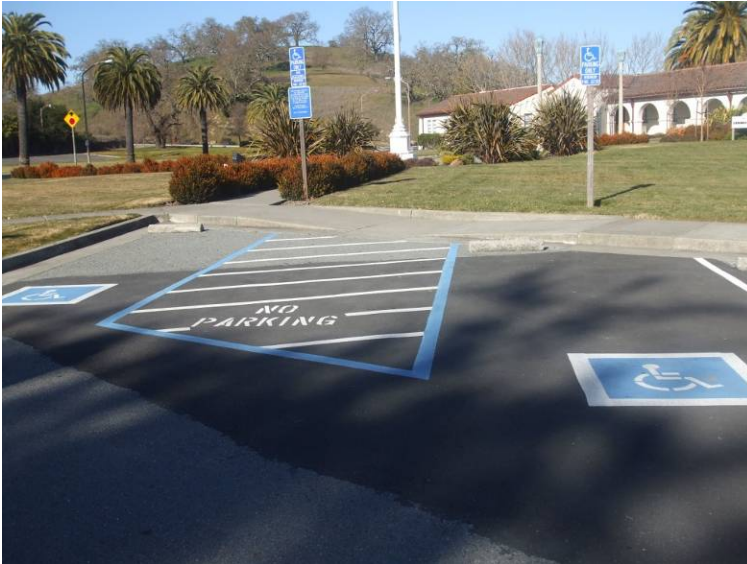
Photograph No. 185

The site contains parking areas located at two locations around the site. There is a main parking area located to the west of the complex and road parking along the east side of the complex on Hamilton Parkway (reference Photographs 185 and 186 in Appendix B). The parking lots have an asphalt surface with white line striping denoting areas of parking stalls. We were not provided with the original specification details of the paving and therefore cannot comment on the specific asphalt mix type, classification or its suitability for its existing use. Table G20-1 provides a summary of the site systems.

View of the site's parking lot.

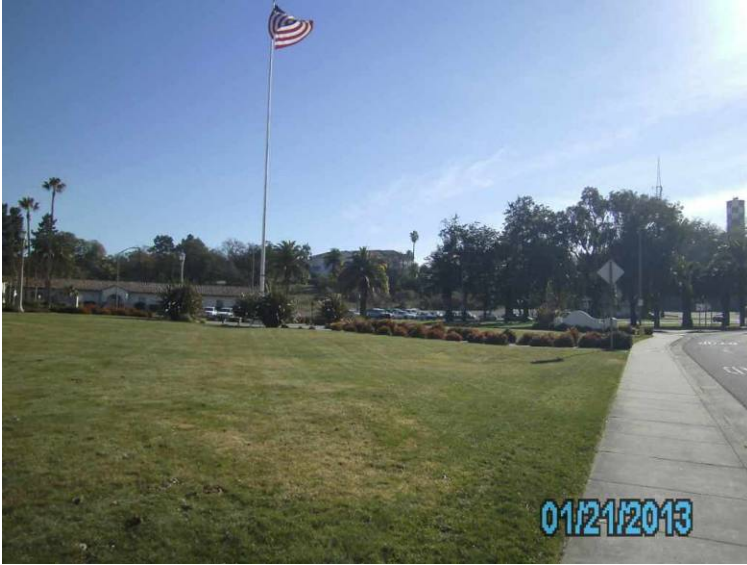
Photograph No. 187

View of site paving.

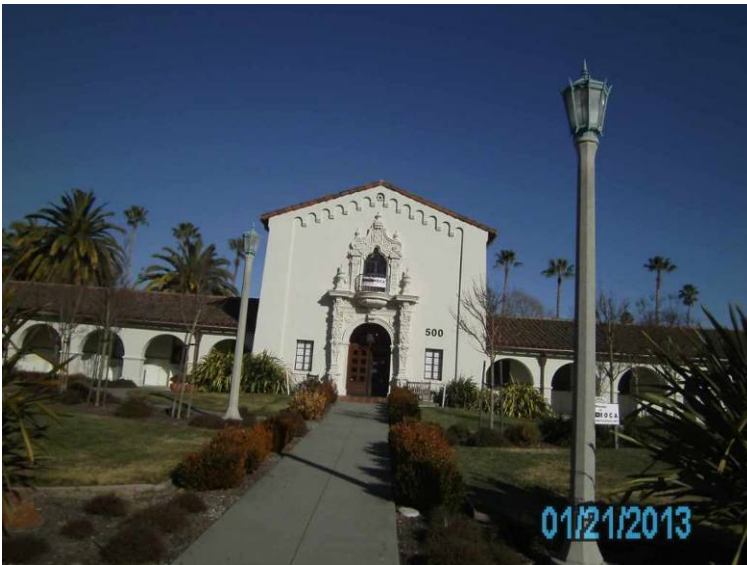
Photograph No. 189

Site lighting consisted of high pressure sodium up-lighting, bollard lights and pole mounted lights (reference Photographs 189 and 190 in Appendix B).

View of a site bollard light.
