**Citywide  
Facility Condition Assessment**

**Report of  
Facility Condition Assessment**

**For  
City of Novato  
Margaret Todd Senior Center, Community Room & Gymnasium  
1560 Hill Road, Novato, CA**

***March 4, 2013***

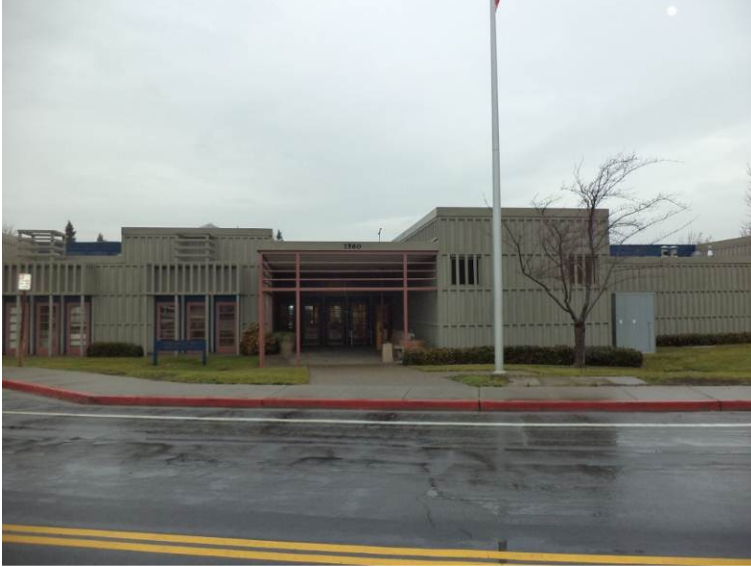
**Photograph No. 1**

View of the south elevation and the main entrance.

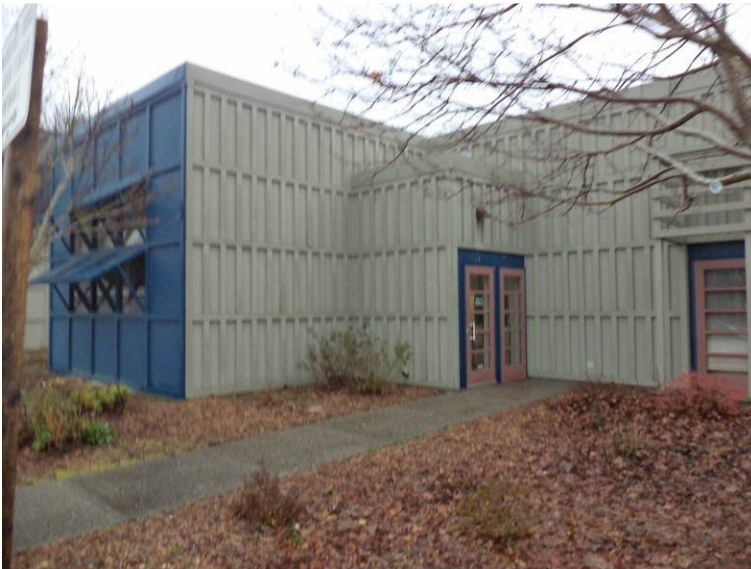
**Photograph No. 2**

View of the plywood board with batten detailing at the outside of the elevation wall constructions.

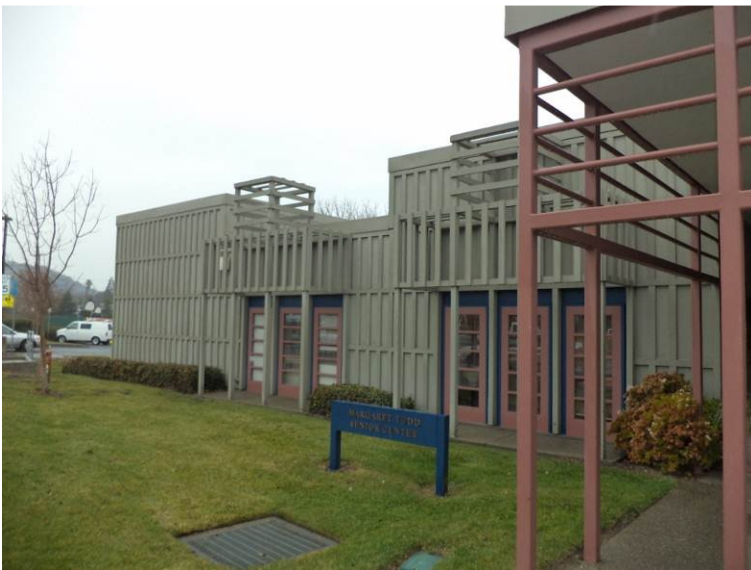
**Photograph No. 3**

View of the wall finish and the steel post supporting structure.

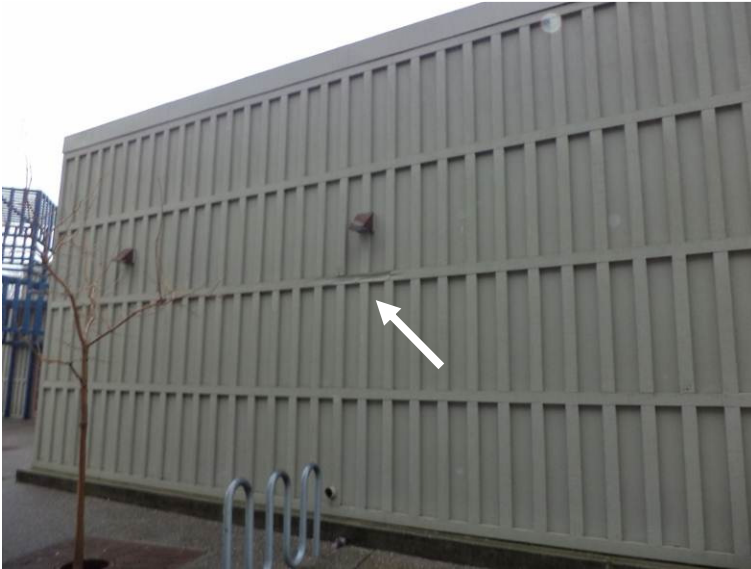
**Photograph No. 4**

View of the plywood and batten wall construction and a section of batten that has deteriorated through moisture penetration (below the light fixture).

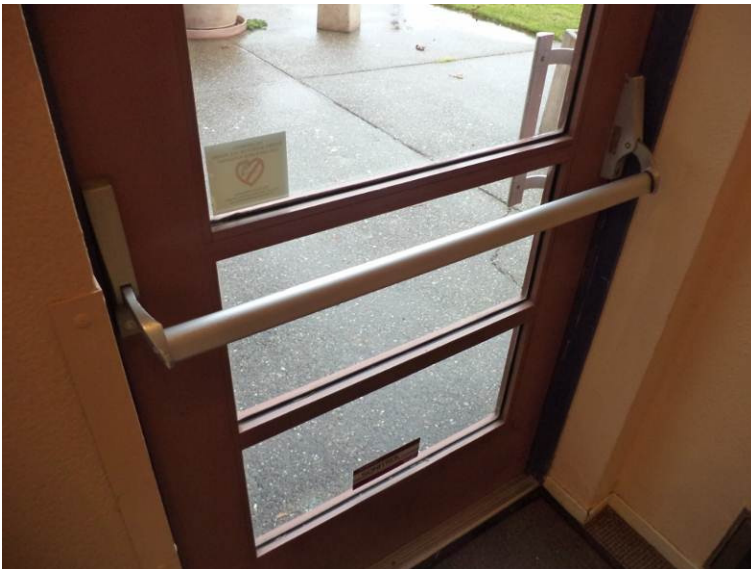
**Photograph No. 8**

View of the exterior glazed doors with push bar operation.

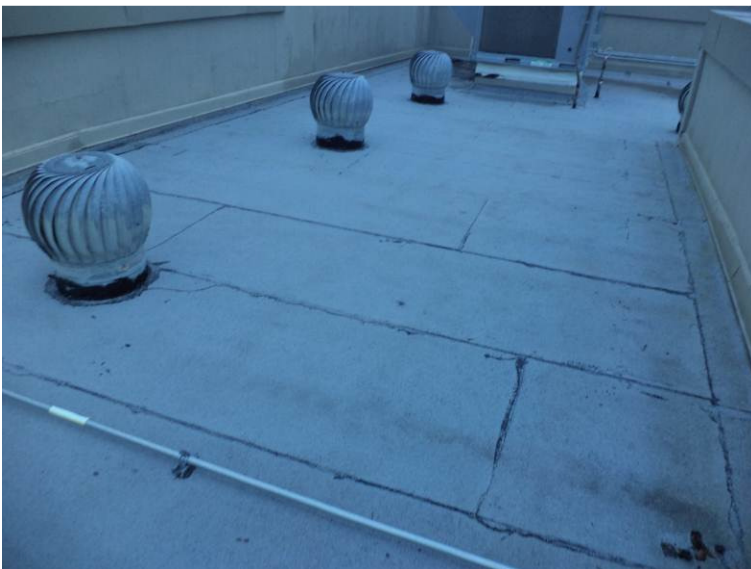
**Photograph No. 9**

The low-sloped roof areas 1 through 21 at the Margaret Todd Senior Center contained a Built-Up Roofing (BUR) system with a mineral cap sheet surface (reference Photographs 9 through 11 in Appendix B). The perimeter parapet wall constructions are a continuation of the exterior elevations and contain metal capping at the top and plywood boarding at the inner side of the parapet which is combined with a metal counter flashing and mineral cap sheet base flashings. The age of the roof covering system is assumed original to when the building was constructed; and therefore twenty-years old. The roof level slopes via a gradient to the roof and overflow outlets connected to interior leaders.

View of the BUR system at roof level.

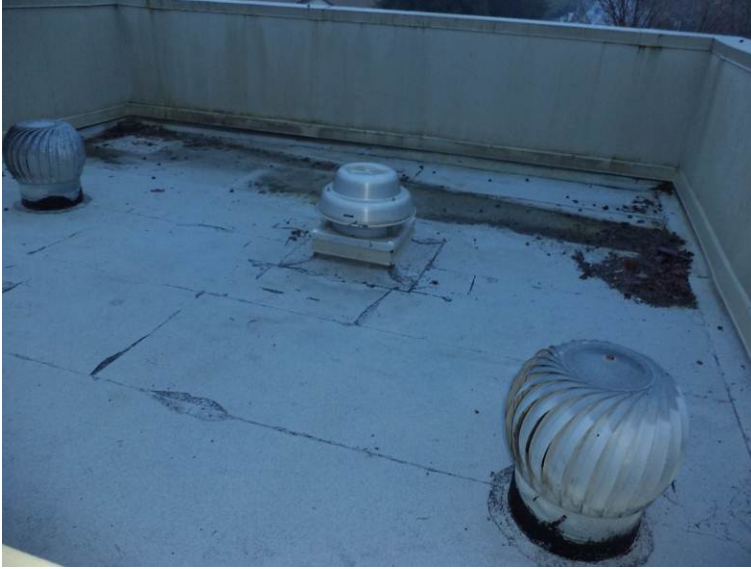
**Photograph No. 10**

View of the BUR covering and plywood parapet walls.

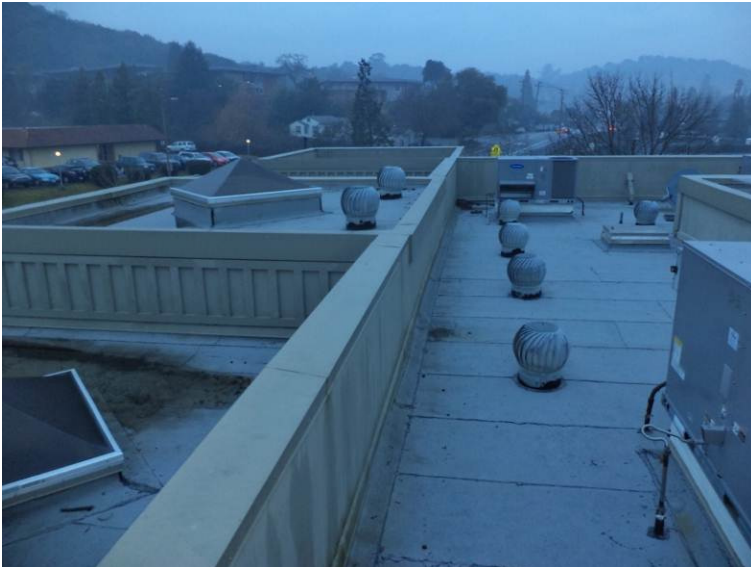
**Photograph No. 11**

View of multiple roof levels and the skylights. Also shows the metal capping at the top of the parapets.

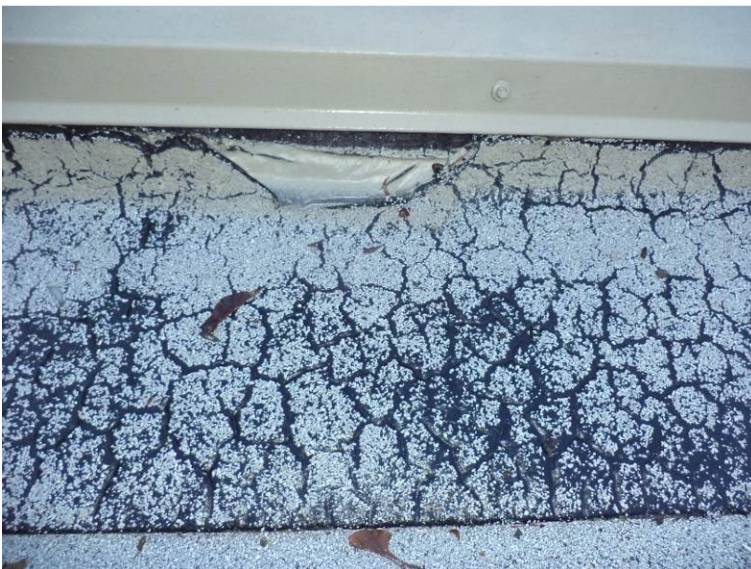
**Photograph No. 12**

However the mineral cap sheet base flashing at the parapets and rooftop equipment up stands contained alligator cracking (reference Photograph 12 in Appendix B). In addition the plywood boarding at the inner side of the parapets was also experiencing moisture saturation and subsequent damage/deterioration (reference Photographs 14 and 15 in Appendix B). We recommend that these areas are made water tight at the start of the study period with the mineral cap sheet base, metal counter flashing and plywood boarding being removed from all of the parapet wall constructions and new mineral cap sheet installed from the roof level up the entire inner side of the parapet and finished below the metal capping. We recommend this work is undertaken to preserve the integrity of the building structure.

View of the cracked mineral cap sheet at the up stands of the lower parapets.

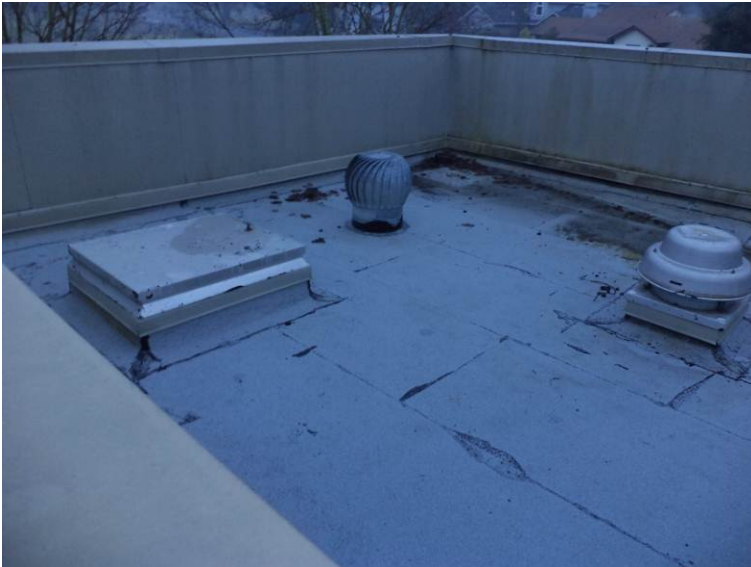
**Photograph No. 17**

View of the roof hatch.

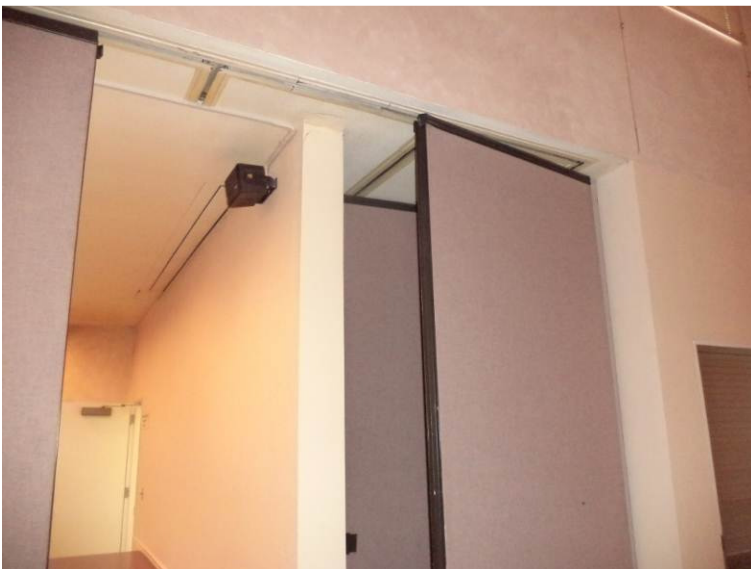
**Photograph No. 18**

The building contains a retractable acoustic partition with fabric surfaces separating the assembly rooms (reference Photograph 18 in Appendix B).

View of the moveable partition.

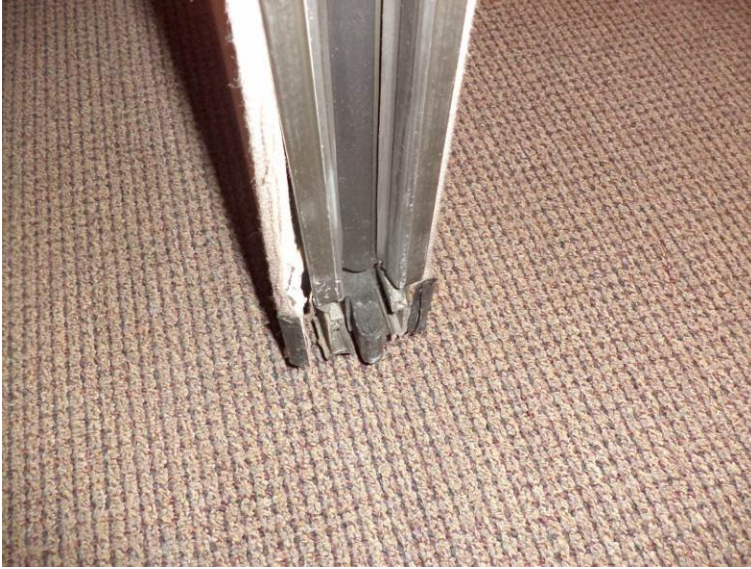
**Photograph No. 19**

View of one of the worn and aged panels belonging to the moveable partition.

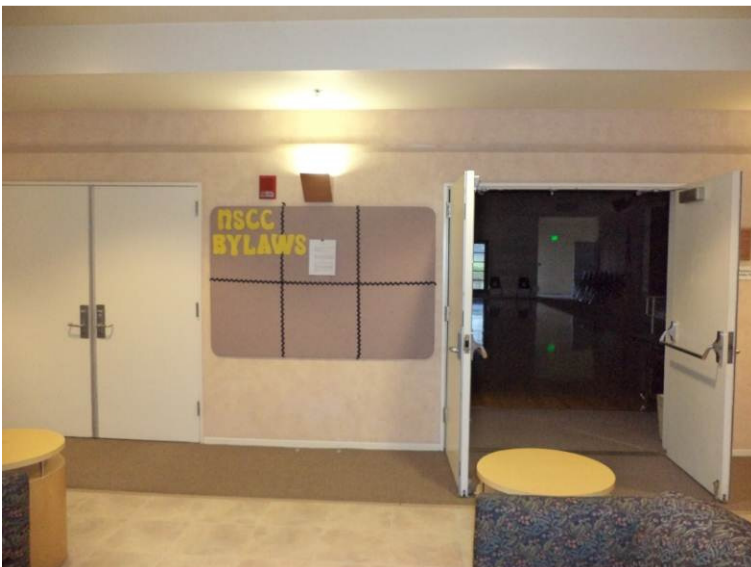
**Photograph No. 21**

The buildings contained single and double flush wood doors which are housed within metal frames. The doors all appeared to be one directional swing operation (reference Photographs 20 and 21 in Appendix B).

View of the double wood interior doors.

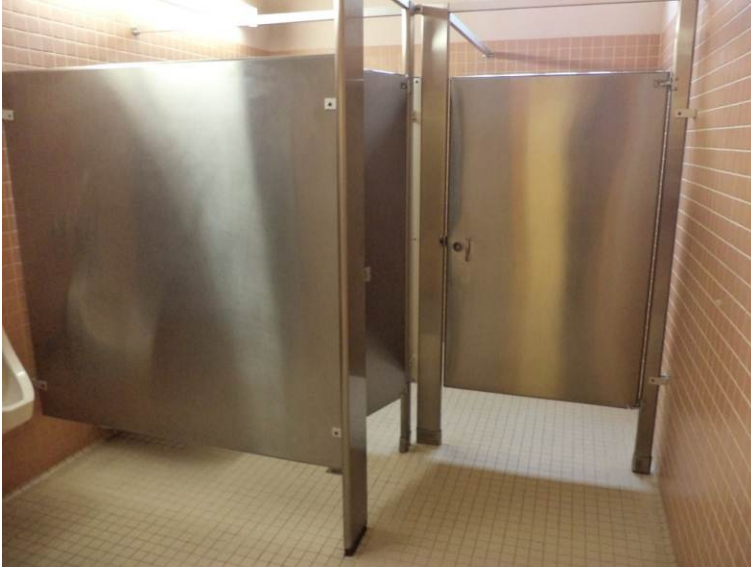
**Photograph No. 22**

View of the stainless steel restroom partitions.

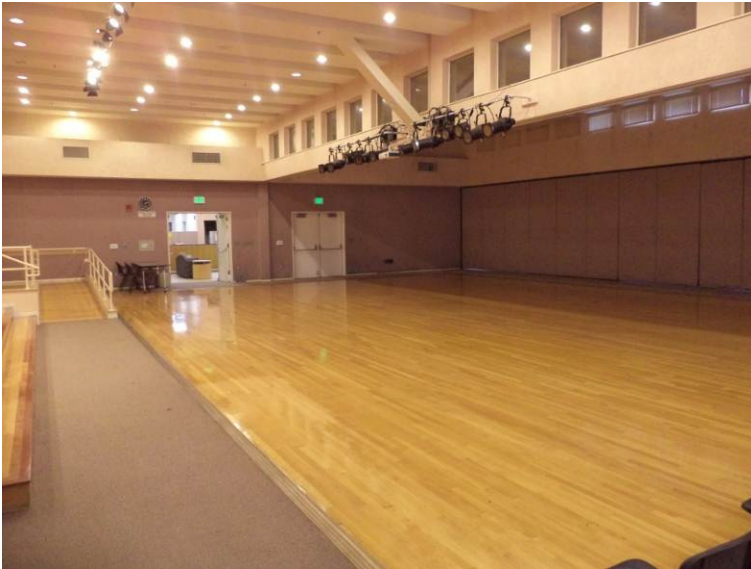
**Photograph No. 23**

The interior lighting within the buildings is provided by recessed and surface mounted 2' x 4' fluorescent fixtures contained F32 T8 32W lamps and electronic ballasts (reference Photographs 23, 24, 26, 29, 59 and 82 in Appendix B). Recessed compact fluorescent fixtures are also present mainly within the Margaret Todd Senior Center within the solid and suspended ceiling systems. All of the in-room lighting is controlled via local switching in the respective rooms as well as a lighting dimming control system manufactured by Elesco within the Margaret Todd Senior Center (reference Photographs 57, 58 and 61 in Appendix B).

View of the finishes within the assembly room.

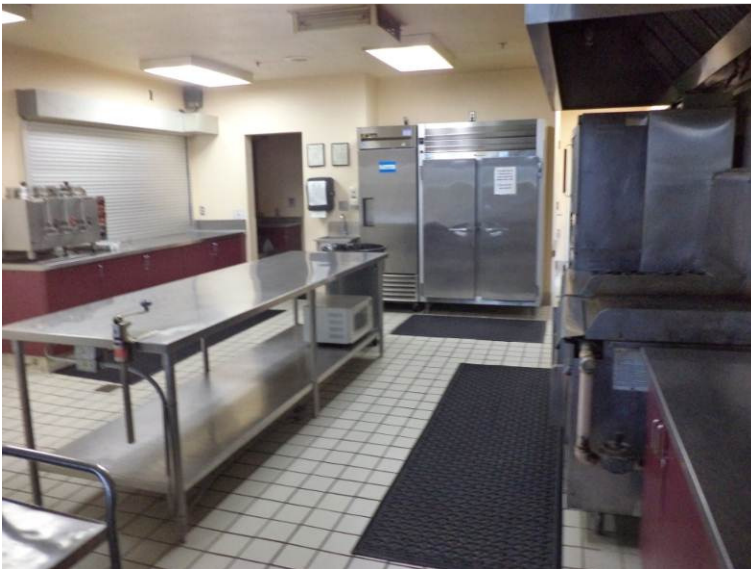
**Photograph No. 24**

The commercial kitchen within the Margaret Todd Senior Center contained 16 GA stainless steel work tables/benches, counter tops, wall shelves and under counter shelves (reference Photographs 24, 64 and 65 in Appendix B). At the back of the griddle and range there is 1" insulated stainless steel wall lining, and above is an 18 GA stainless steel vapor hood class F exhaust hood.

View of the finishes within the commercial kitchen area.

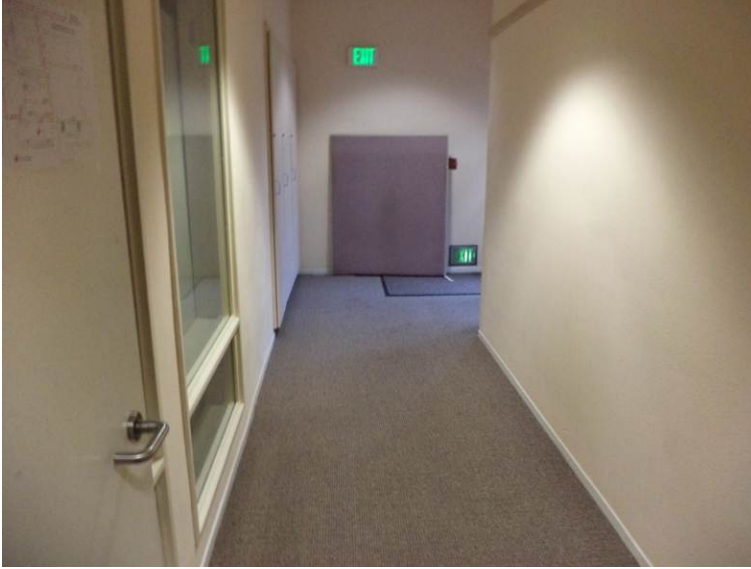
**Photograph No. 25**

The buildings contained wood stud gypsum board partitions throughout forming the interior spaces (reference Photographs 2, 21 and 25 in Appendix B).

View of the finishes within the corridors.

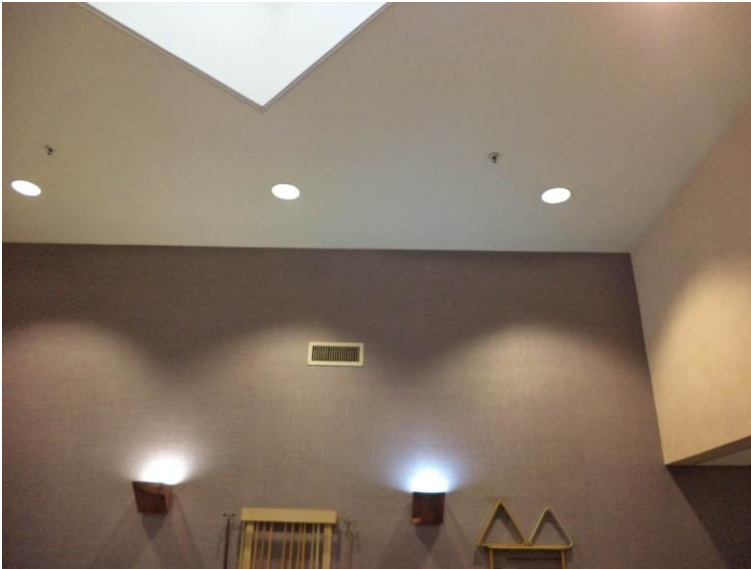
**Photograph No. 26**

View of the wall and ceiling finishes within one of the game rooms.

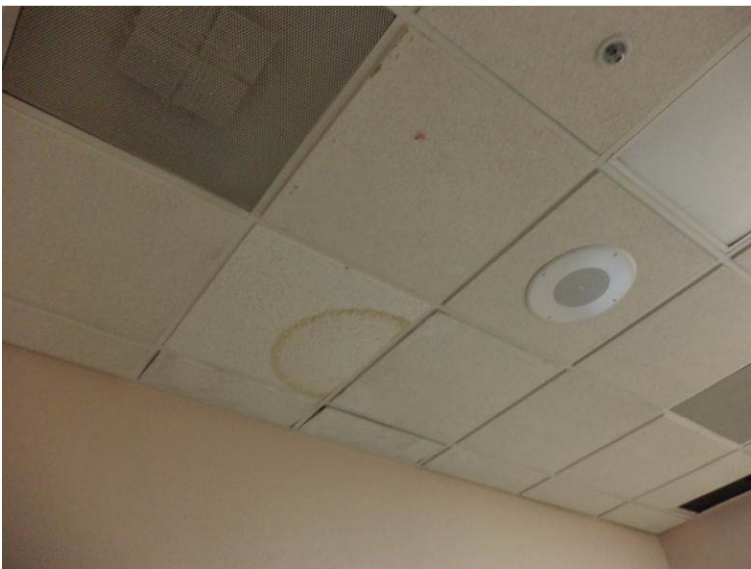
**Photograph No. 30**

View of a stained ceiling tile.

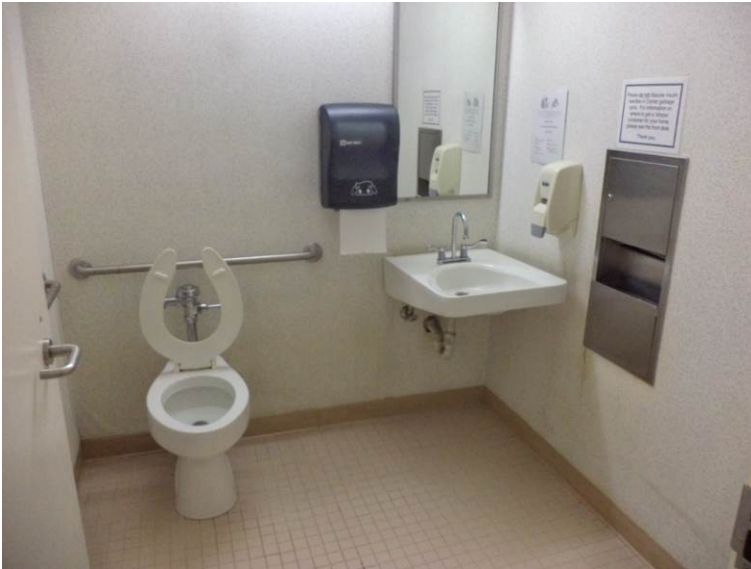
**Photograph No. 32**

View of floor mounted water closet and wall mounted lavatory within the individual restrooms.

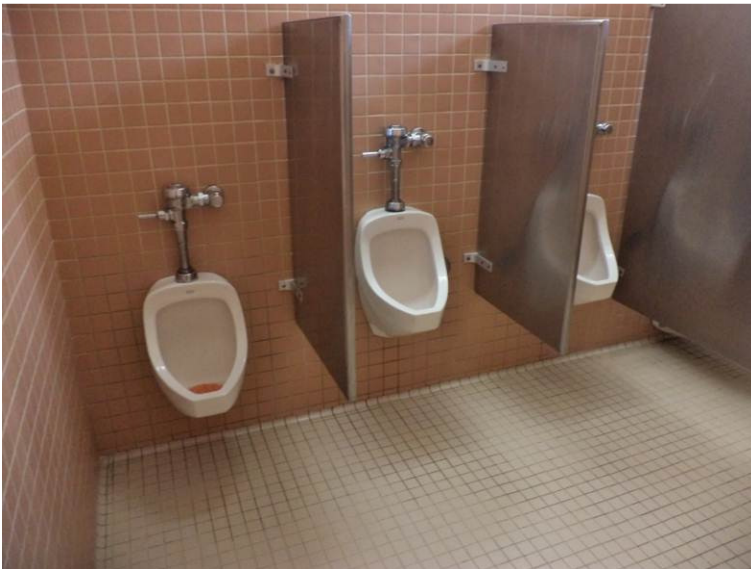
**Photograph No. 33**

View of the wall mounted urinals.

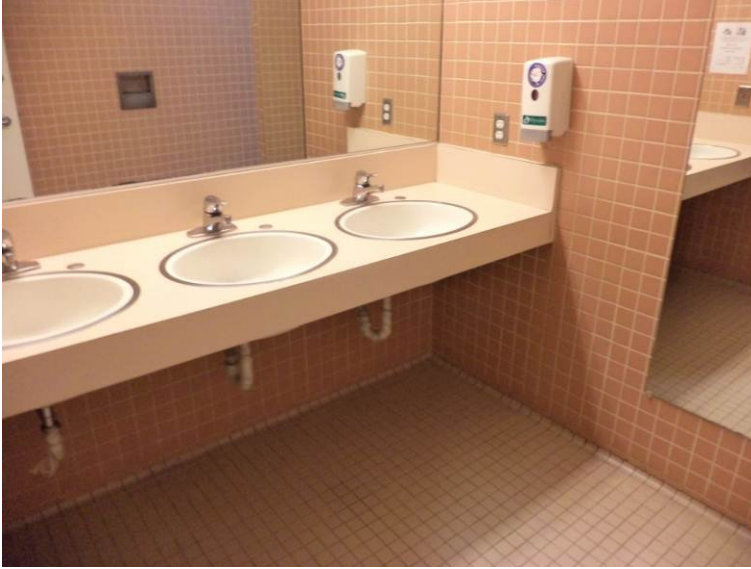
**Photograph No. 34**

View of the vanity top lavatories.

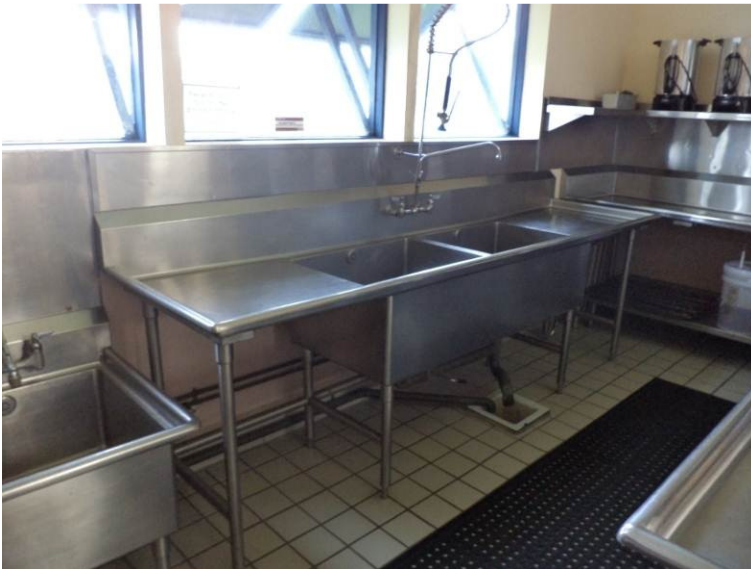
**Photograph No. 36**

View of the commercial kitchen sink.

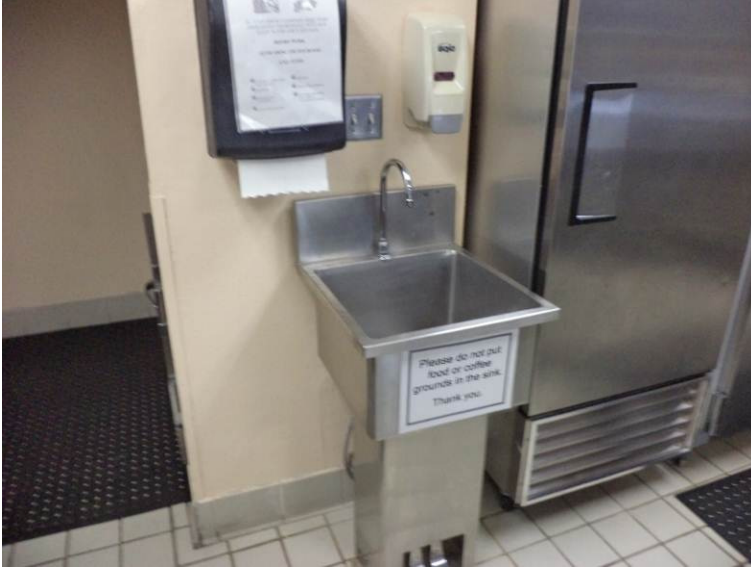
**Photograph No. 37**

The building contains a commercial kitchen consisting of a double deck gas convection oven, griddle with oven, 6 open burner range with oven, high temp booster dishwasher, coffee urn, 1 door freezer and 2 door refrigerator (reference Photographs 25, 37 and 57 in Appendix B). The ovens griddle and burner equipment is manufactured by Vulcan-Hart Corp.

View of the stainless steel hand wash sink in the kitchen.

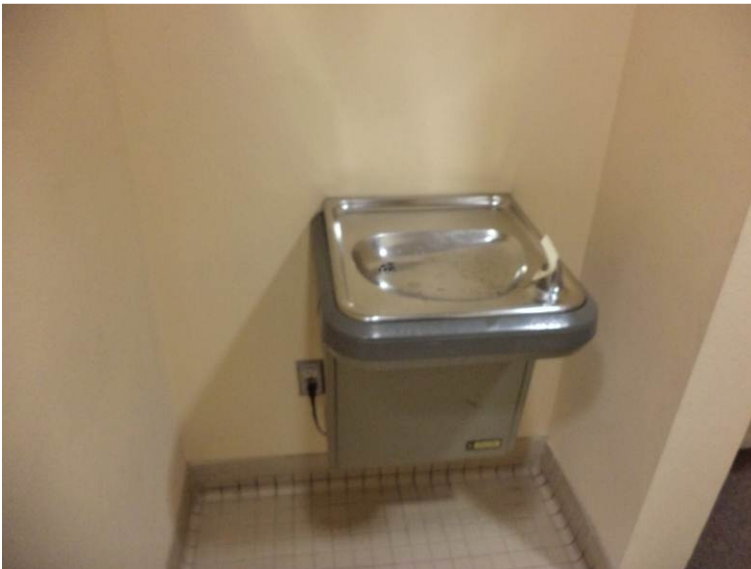
**Photograph No. 39**

View of a drinking fountain.

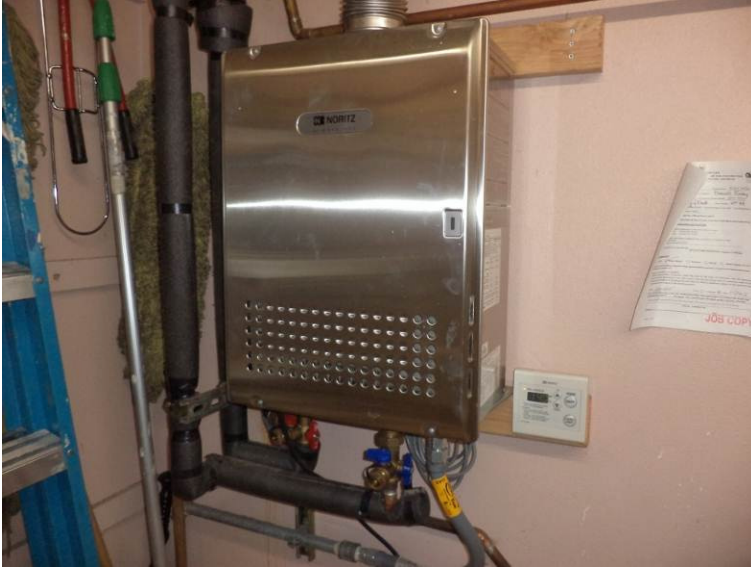
**Photograph No. 40**

View of the water heater.

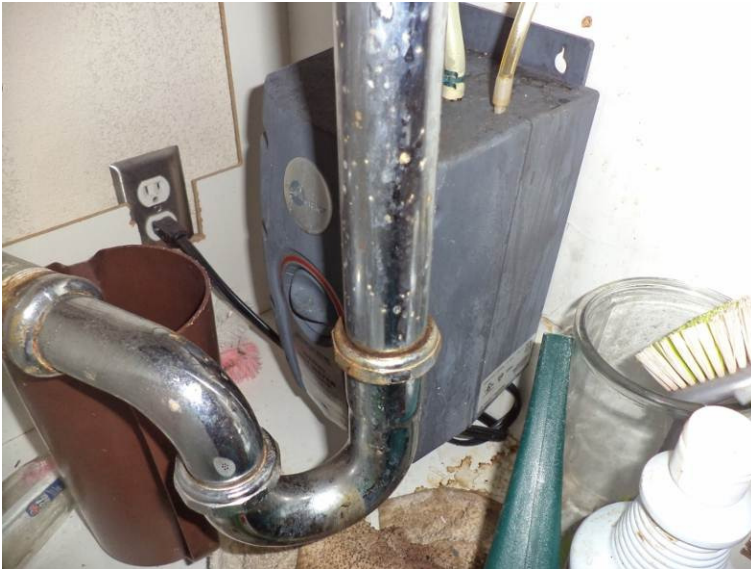
**Photograph No. 41**

View of the below counter water heater.

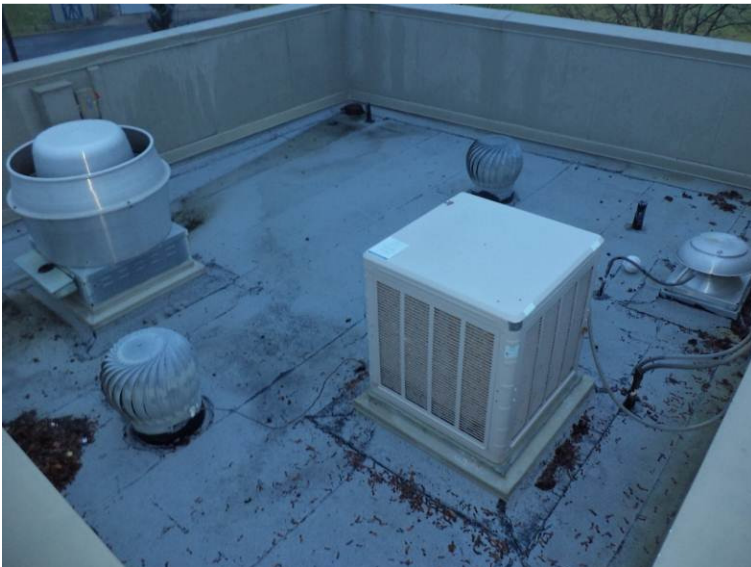
**Photograph No. 42**

View of the roof top exhaust fan and evaporative cooler unit.

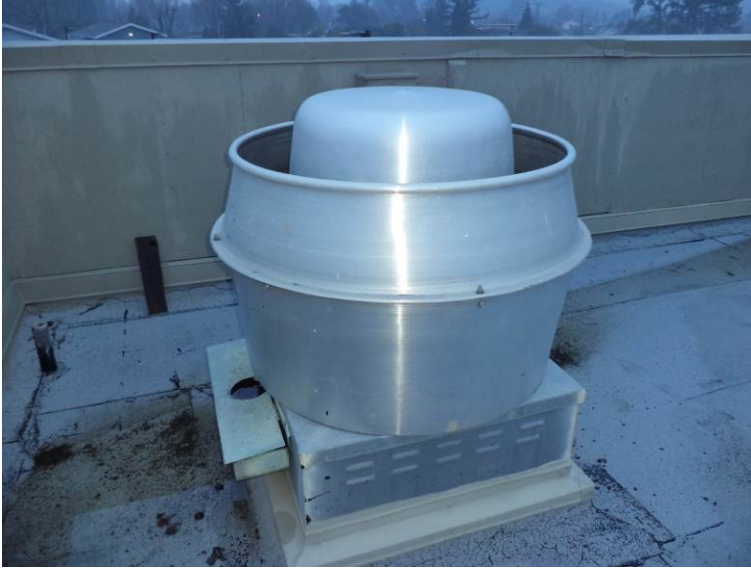
**Photograph No. 43**

View of one of the up blast centrifugal exhaust fans.

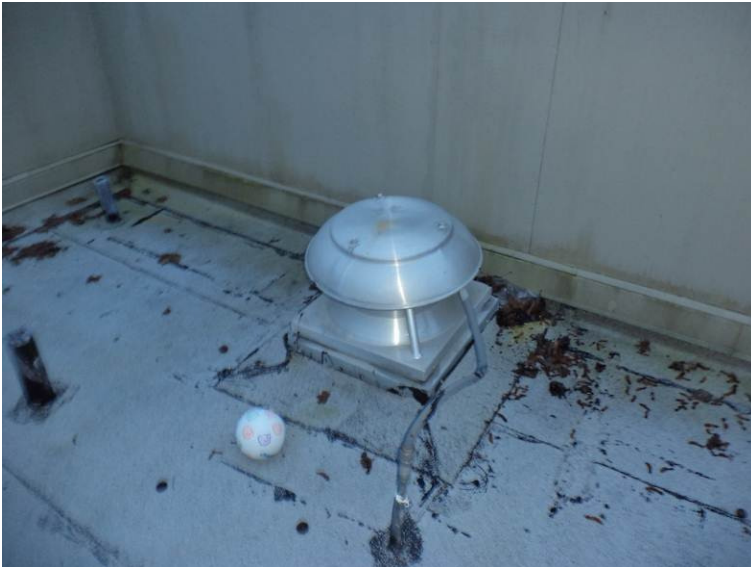
**Photograph No. 44**

View of one of the smaller capacity exhaust fans.

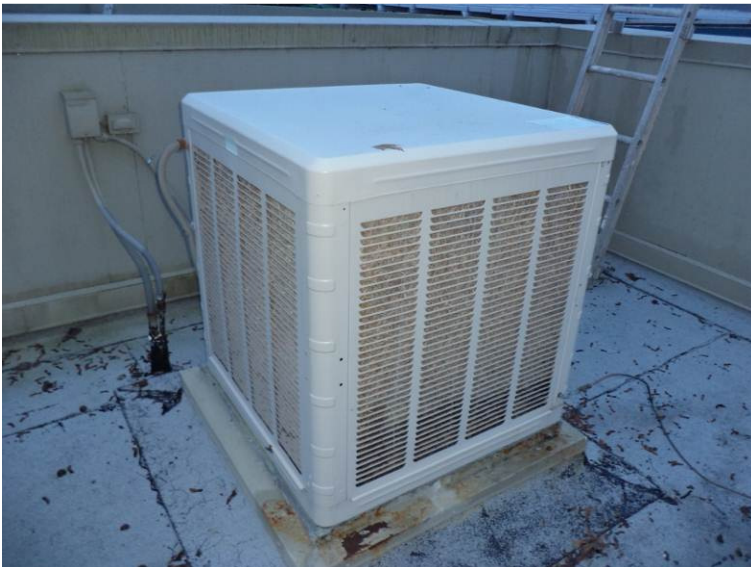
**Photograph No. 45**

View of the evaporative cooler unit for the kitchen area.

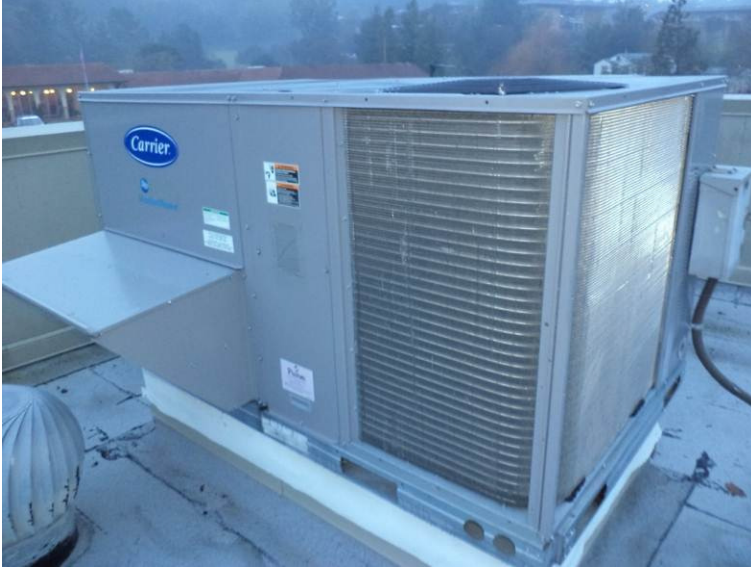
**Photograph No. 46**

View of one of the rooftop package units.

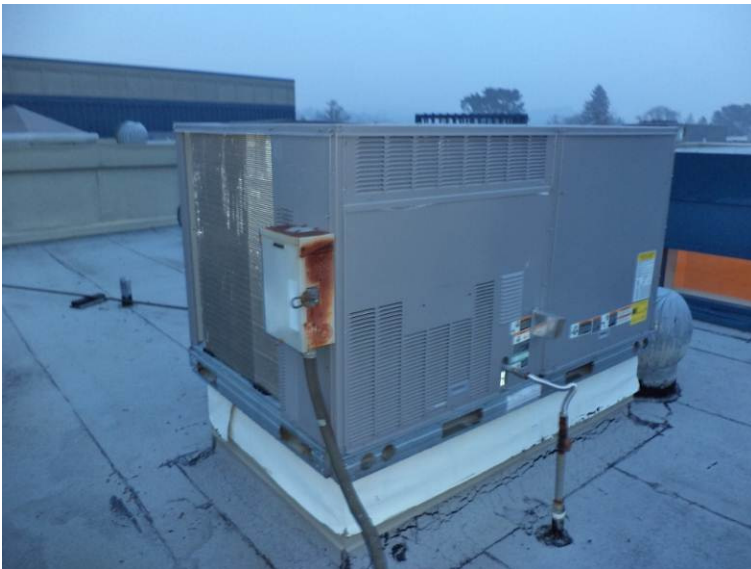
**Photograph No. 47**

View of one of the rooftop package units.  
Also shows the corroded safety switch.

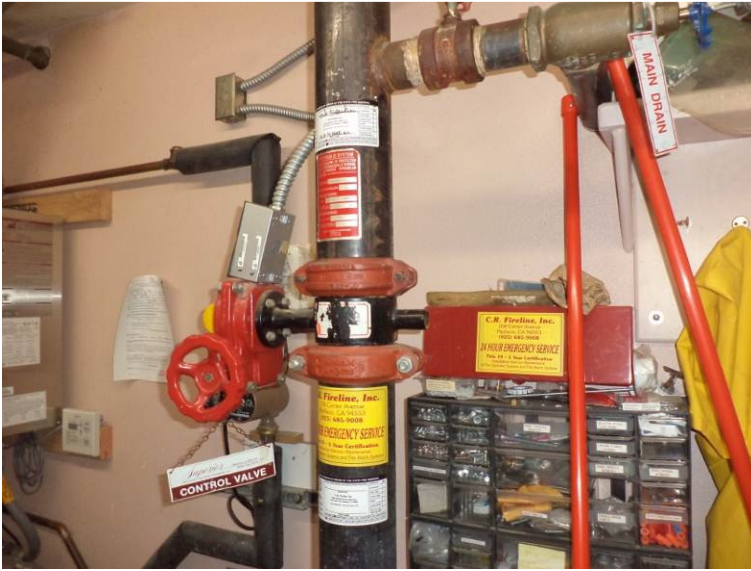
**Photograph No. 49**

View of the sprinkler riser.

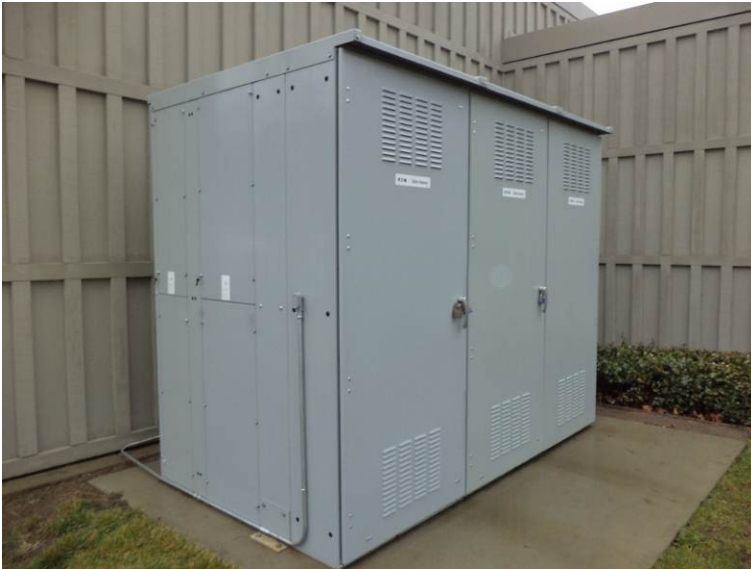
**Photograph No. 50**

Electrical power is supplied by the local utility provider to a dedicated, utility owned pad mounted transformer located at the south side of the site. The Main Distribution Panel (MDP) is manufactured by Cutler Hammer and is rated at 208Y/120 volts at 1,200-amps and is located within an exterior enclosure also at the south side of the Margaret Todd Senior Center. We understand that the Hill Gymnasium building is fed from this MDP to a 600-amp panel board within the building. Branch panels are located throughout the building and are rated at varying amps (reference Photographs 50, through 52 in Appendix B). A redundant MDP manufactured by Challenger is located in the janitor's room of the Margaret Todd Senior Center.

View of the MDP enclosure.

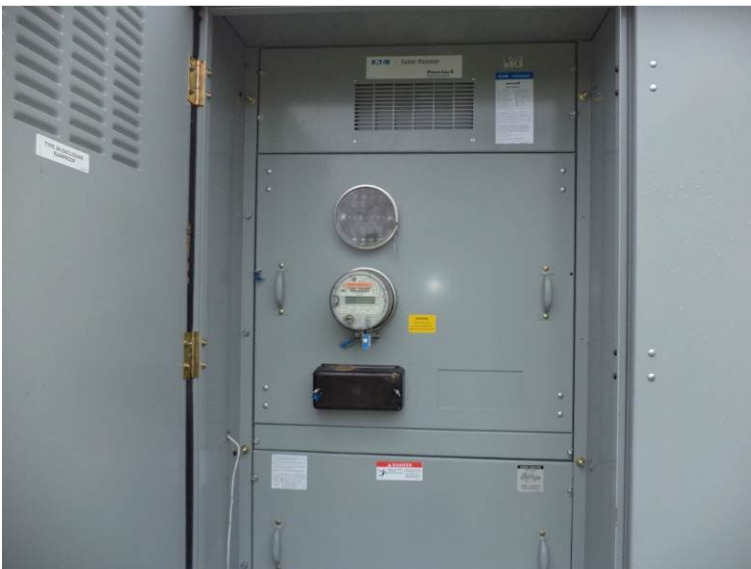
**Photograph No. 51**

View of the MDP and meter.

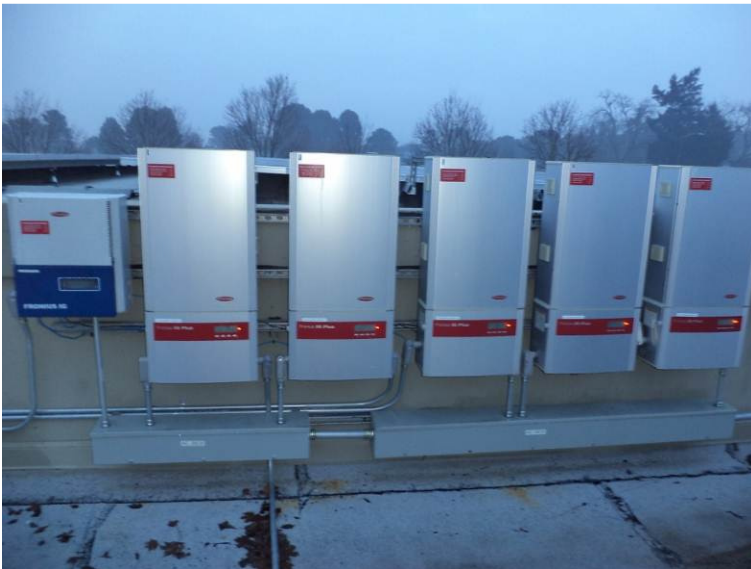
**Photograph No. 53**

The buildings also contained a photovoltaic array consisting of roof mounted multipurpose modules and grid-connected PV inverter control units manufactured by Sharp and Fronius respectively. The systems use Fronius IG Plus control units which are located at roof level of each building (reference Photographs 53 through 56, 96 and 97 in Appendix B). The PV panels convert the sun's energy to electricity through the use of light-sensitive, solid state semi-conductor cells.

View of the the roof level solar panels.

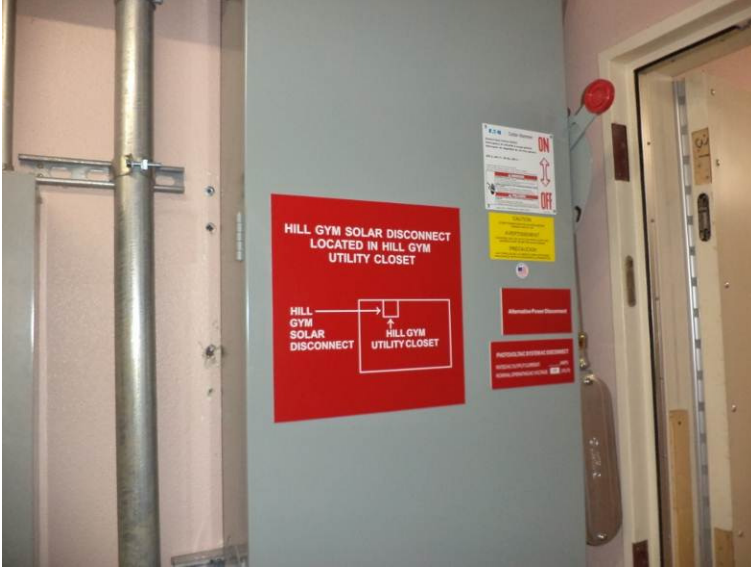
**Photograph No. 54**

View of the solar electrical units.

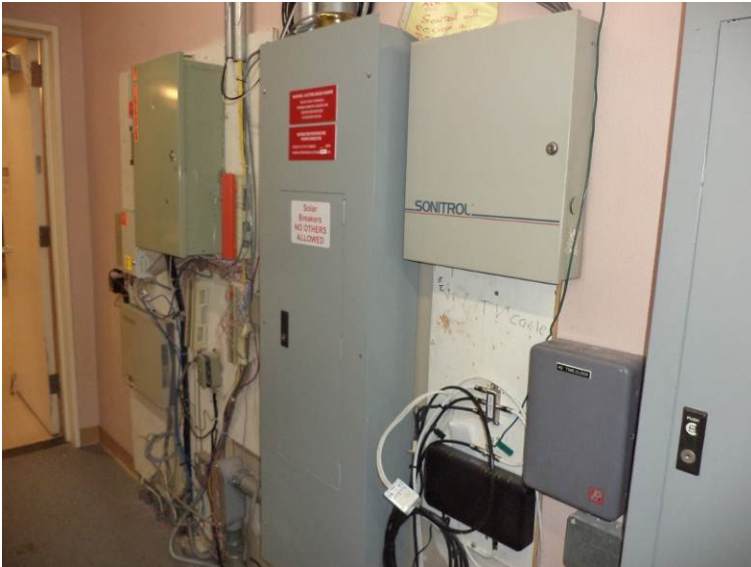
**Photograph No. 55**

View of the solar disconnect switch for the gymnasium building.

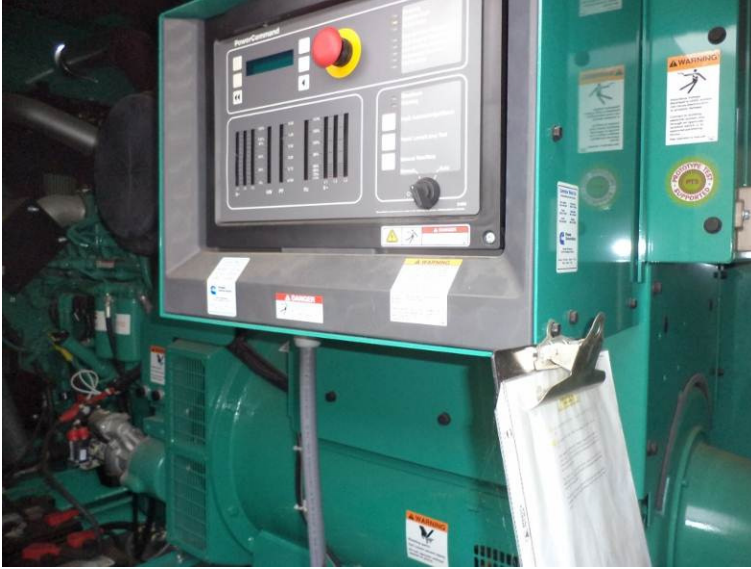
**Photograph No. 66**

The building is backed-up by a 250 kW 132.5 KVA diesel generator which is located at the east side of the buildings. The transfer switch is located within the generator (reference Photographs 66 through 68 in Appendix B). The generator has a 600 gallon capacity diesel storage tank which is located below the generator.

View of the emergency generator.

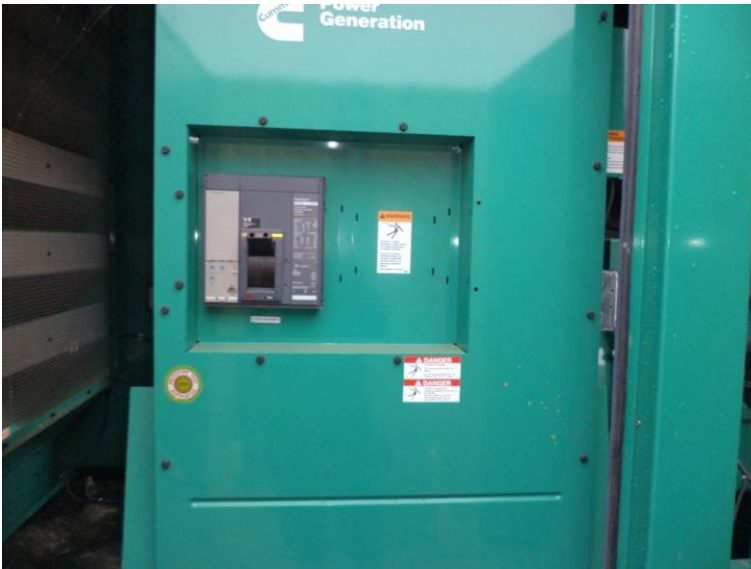
**Photograph No. 67**

View of the emergency generator control unit.

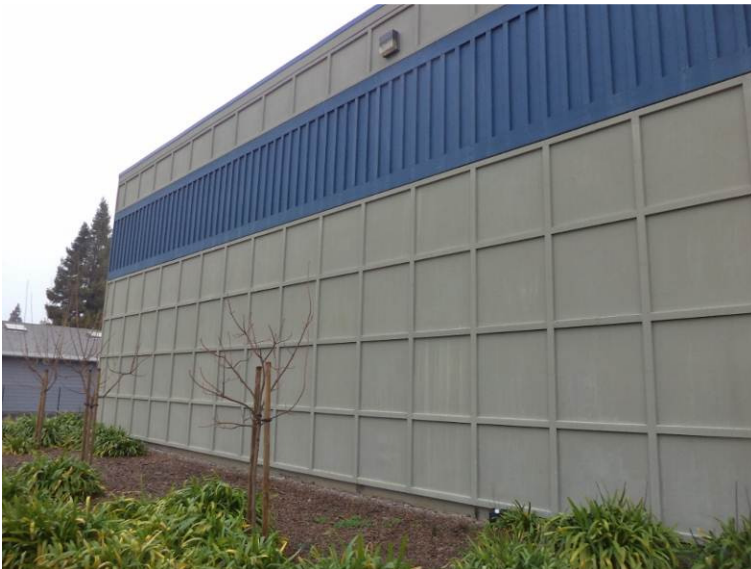
**Photograph No. 70**

Painted wood and metal trellis constructions are present at both buildings around window systems and also entrance doors (reference Photographs 3 and 70 in Appendix B). The Hill Gymnasium also has metal framed canopy structures that protrude out from the exterior wall construction over the exit doors; they contain standing seam metal panel sloped roofs (reference Photographs 70 and 74 in Appendix B).

View of the exterior wall constructions.

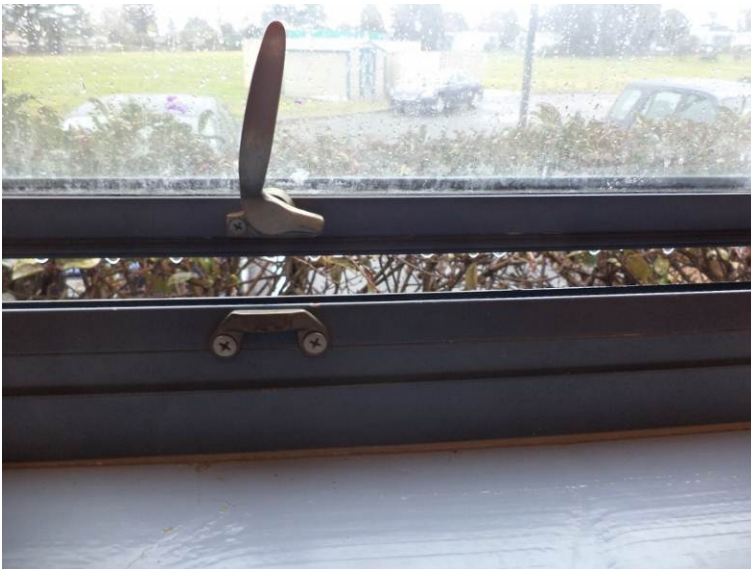
**Photograph No. 72**

View of the window units.

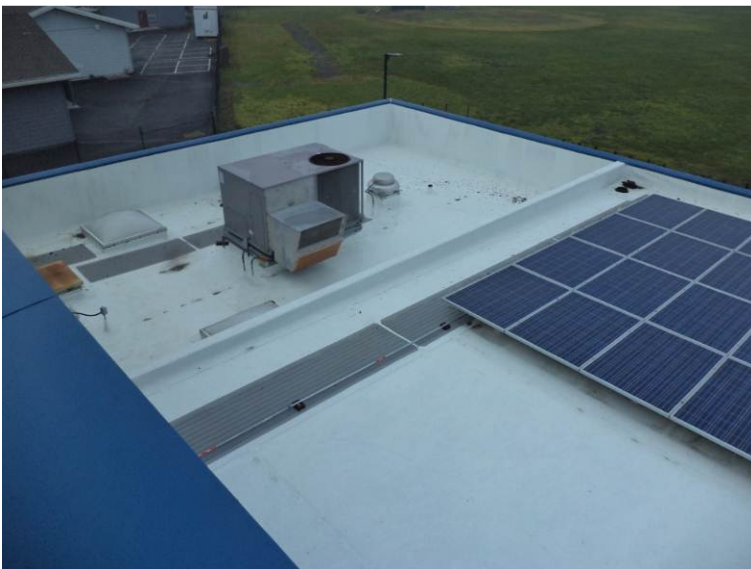
**Photograph No. 76**

View of the roof level single-ply membrane.

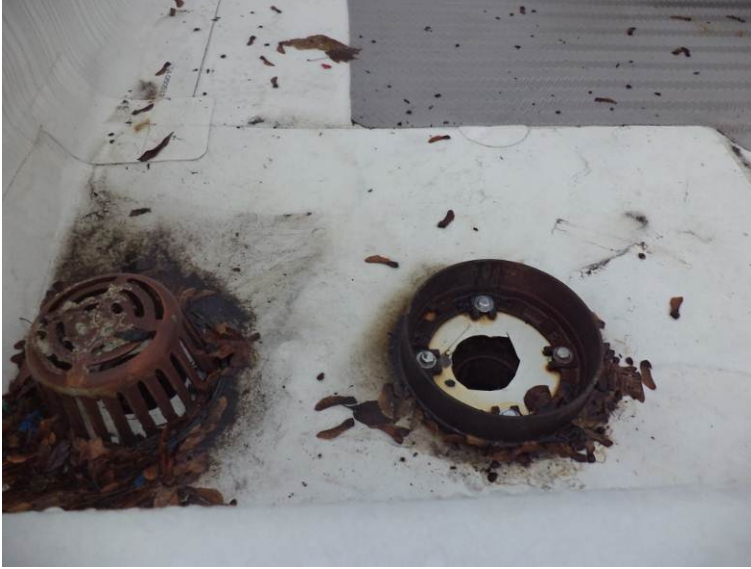
**Photograph No. 77**

View of the lower level roof membrane.

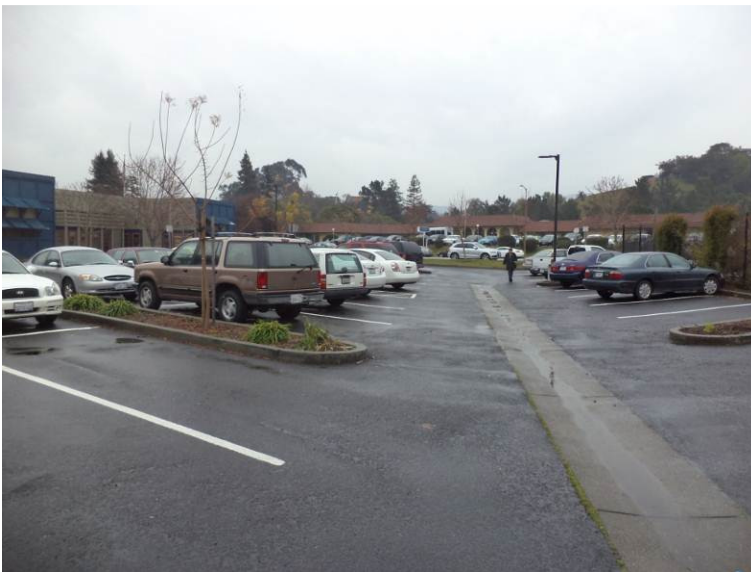
**Photograph No. 99**

The facility has an asphalt paved parking lot at the east and west sides of the building, as well as parking spaces at the north side off the roadway. The parking lot is accessed from Hill Road and has an asphalt surface with white line striping denoting areas of parking stalls (reference Photographs 99 through 101 in Appendix B). We were not provided with the original specification details of the paving and therefore cannot comment on the specific asphalt mix type, classification or its suitability for its existing use. Table G20-1 provides a summary of the site systems.

The building contained precast concrete pavers surrounding the buildings (reference Photographs 99 and 101 in Appendix B). We assume the paving is supported via a flexible base of sand setting bed and compacted sub grade.

View of the parking lot at the west side of the site.

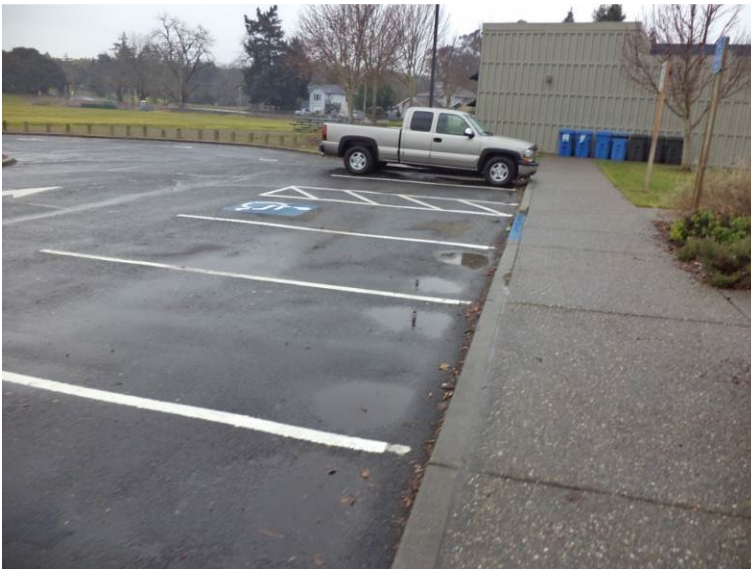
**Photograph No. 100**

View of the parking lot at the west side of the site.
