**Citywide  
Facility Condition Assessment**

**Report of  
Facility Condition Assessment**

**For  
City of Novato  
Margaret Todd Senior Center, Community Room & Gymnasium  
1560 Hill Road, Novato, CA**

***March 4, 2013***

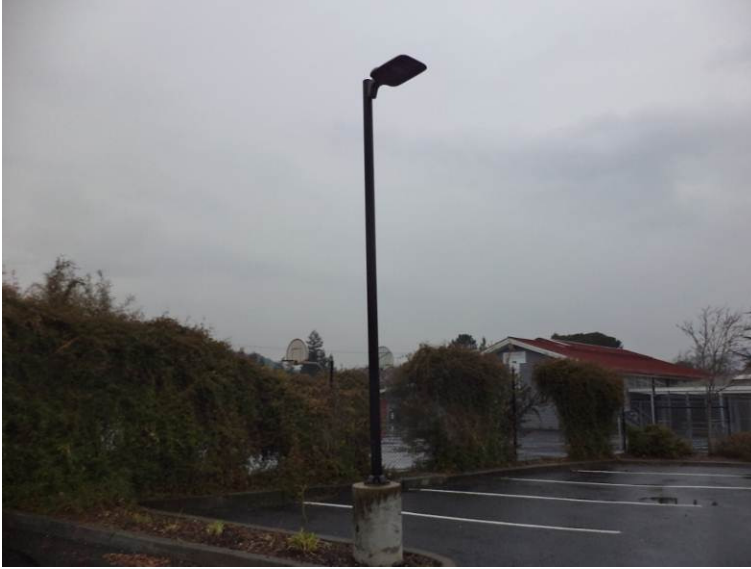
**Photograph No. 101**

The facility has an asphalt paved parking lot at the east and west sides of the building, as well as parking spaces at the north side off the roadway. The parking lot is accessed from Hill Road and has an asphalt surface with white line striping denoting areas of parking stalls (reference Photographs 99 through 101 in Appendix B). We were not provided with the original specification details of the paving and therefore cannot comment on the specific asphalt mix type, classification or its suitability for its existing use. Table G20-1 provides a summary of the site systems.

The building contained precast concrete pavers surrounding the buildings (reference Photographs 99 and 101 in Appendix B). We assume the paving is supported via a flexible base of sand setting bed and compacted sub grade.

View of the parking lot at the east side of the site.
