Citywide
Facility Condition Assessment

Report of
Facility Condition Assessment

For
City of Novato
Maintenance Buildings
(Vehicle Maintenance and Divis & Lockers)
550 Davidson, Novato, CA

March 4, 2013

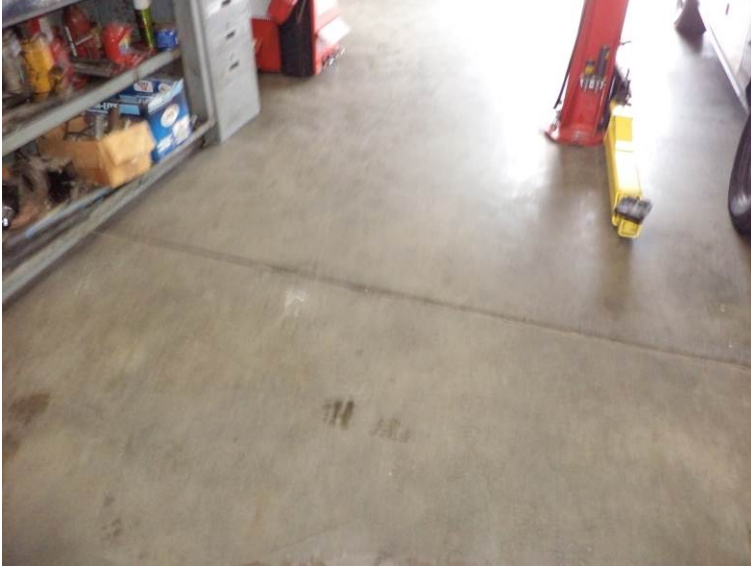
Photograph No. 1

The first floor level at Buildings B and C consisted of cast-in-place concrete slab-on-grade, reinforced with welded wire fabric. The reviewed drawings indicate that the floor slab was placed over a vapor barrier and compacted gravel fill, with the thickness of the slab being 6" laid over a 2" sand bed 10 mil. vapor barrier and 4" compacted crushed rock. The reviewed drawings indicate that the compressive strength of the concrete slab at this building is 4,000 psi. We assume that the concrete slab at Building A was of a similar construction; however the compressive strength of the floor slab was not available for comment and is unknown (reference Photograph 1 in Appendix B).

View of the concrete floor with the seal coating finish.

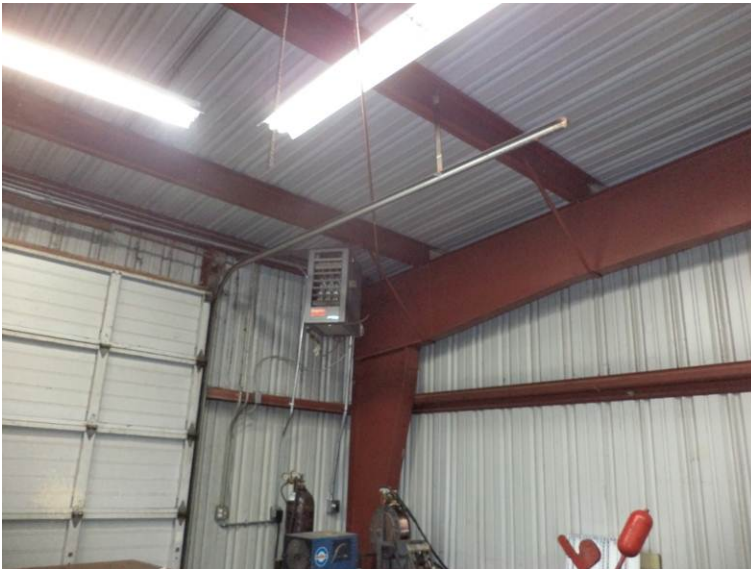
Photograph No. 2

View of the steel portal frame and purlins.

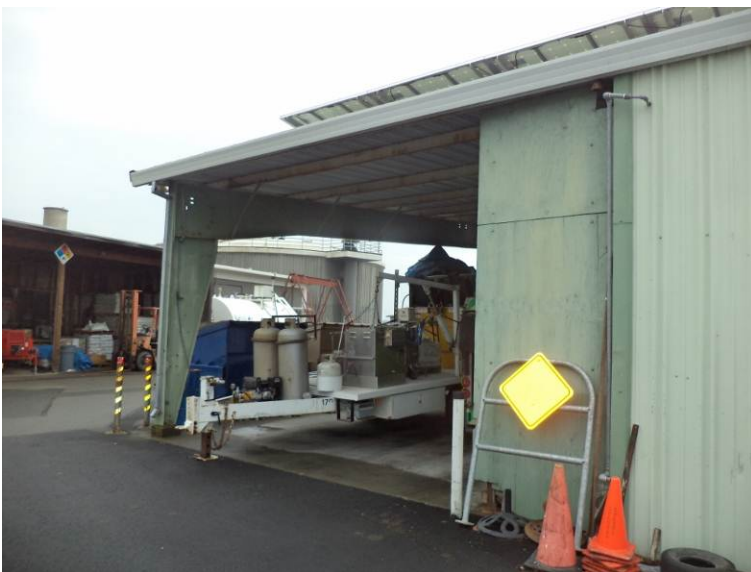
Photograph No. 3

Further view of the steel portal frame.

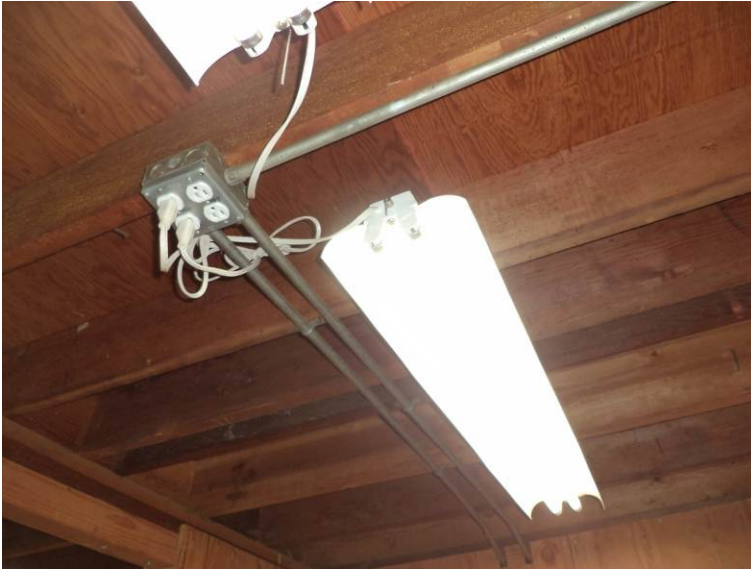
Photograph No. 4

View of wood joists at the mezzanine levels.

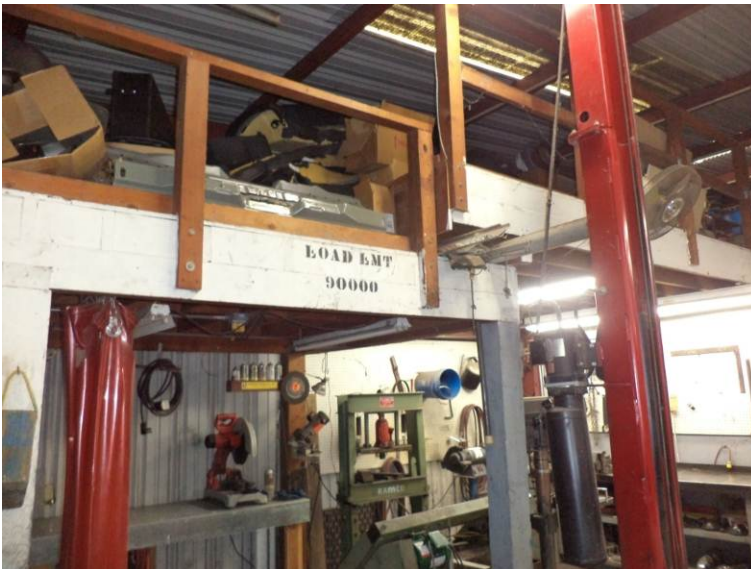
Photograph No. 5

View of one of the load weights for the mezzanine.

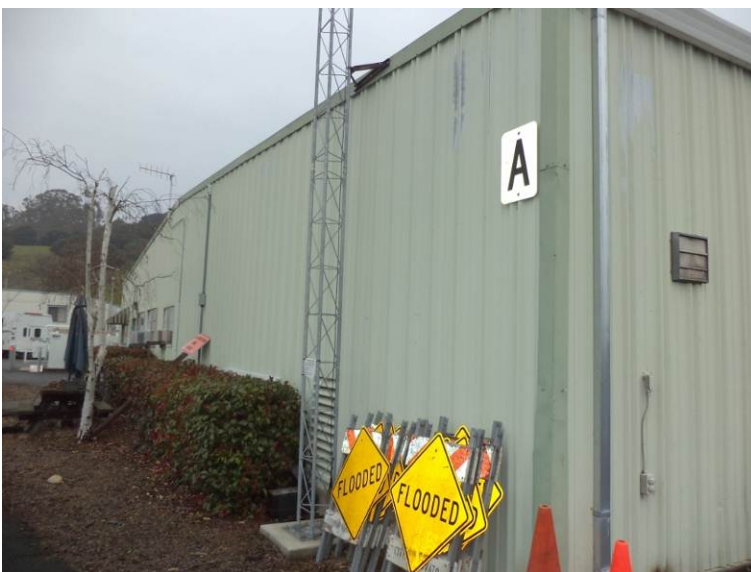
Photograph No. 6

View of the exterior metal corrugated siding. Also shows building as "A" and downspout.

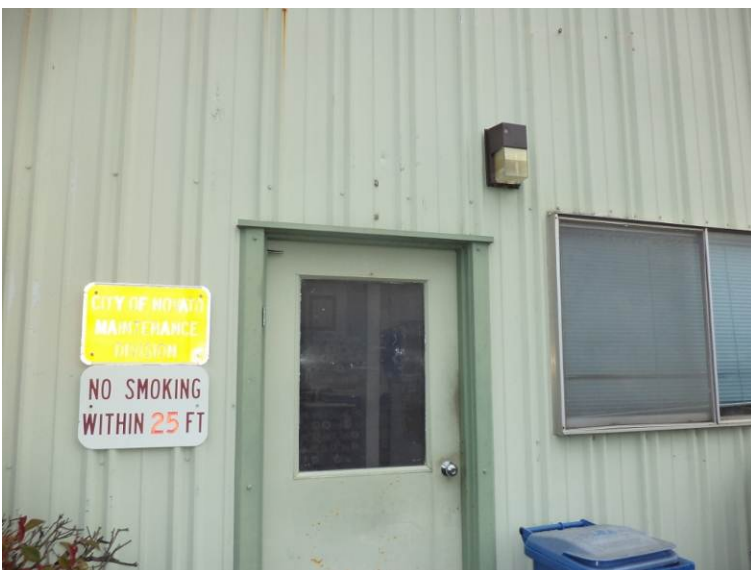
Photograph No. 9

View of the window units and door sets. Also shows the knob handles and wall pack exterior light fixture.

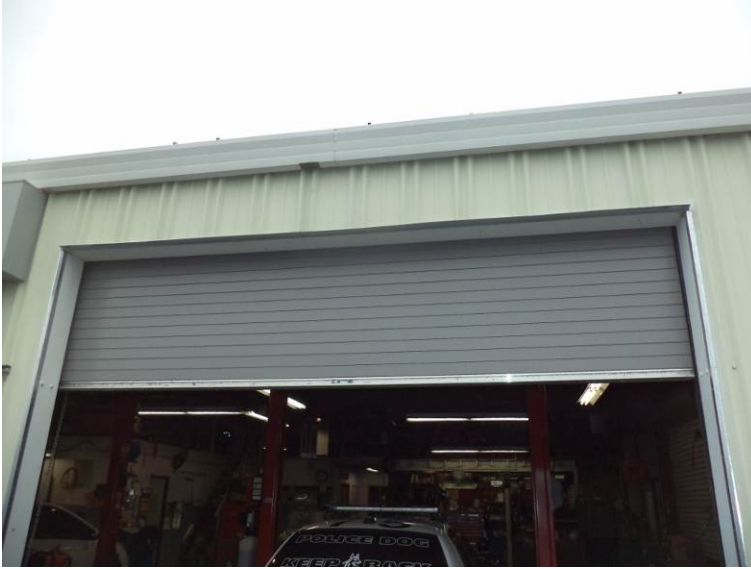
Photograph No. 10

The overhead doors generally appeared to be in poor to fair condition, with the exception of the recently replaced coiling overhead door at the south elevation which we have been informed was replaced in 2007. We understand that there are jamming issues with the older overhead panel doors; furthermore the panels are heavily marked with impact damage observed at their exterior surfaces (reference Photographs 10 and 11 in Appendix B). When open, the overhead door opposite the south vehicle repair bay is in a fixed horizontal position, above the door opening and therefore interferes with the raising and lowering of the vehicles when the door is in an open position.

View of the newer overhead coiling door.

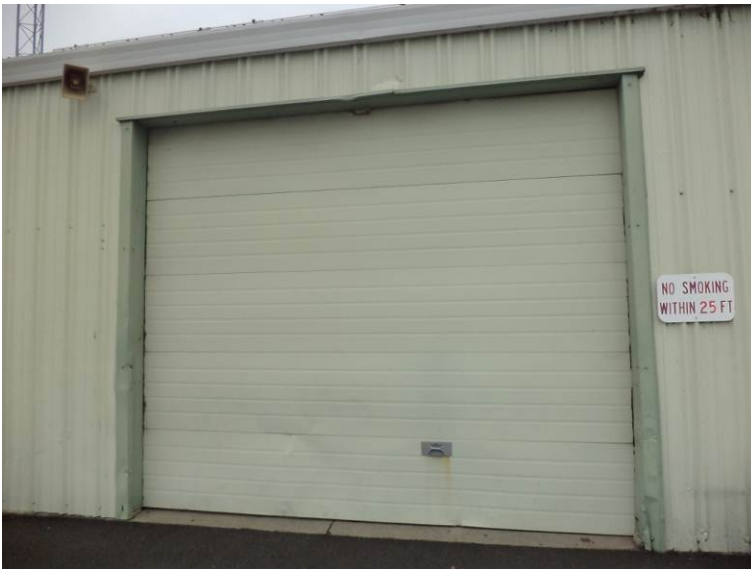
Photograph No. 11

View of one of the original overhead doors at the south elevation.

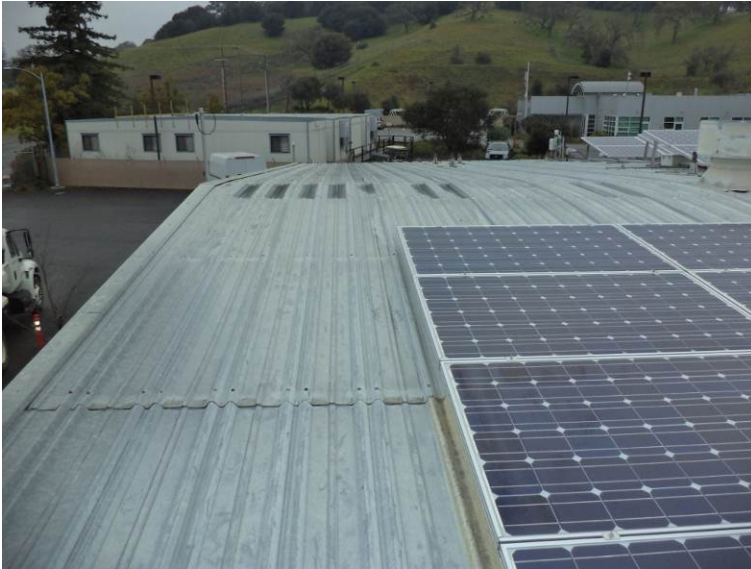
Photograph No. 13

The low-sloped roof area 1 contained a preformed corrugated metal roof covering and roof areas 2 through 4 contained standing seam metal roof coverings (reference Photographs 13, 14, 50 and 51 in Appendix B). The reviewed drawings indicate that the standing seam metal roof covering contains R-30 unfaced batt insulation with dual liners at the underside; no insulation was observed at Building A. The roof levels at Buildings B and C contain a sloped gradient of $\frac{1}{4}:12$ running from west-east. Roof area 1 also appears to have a sloped gradient through a shallow ridge at the center of the roof field. The metal roofs at each of the buildings are installed on structural steel purlins with Building A containing screws to secure the panels to the purlins, and Buildings B & C containing concealed clips. The screws used at Building A help to stitch the panels together at the side and end laps.

View of the metal roof covering and solar modules.

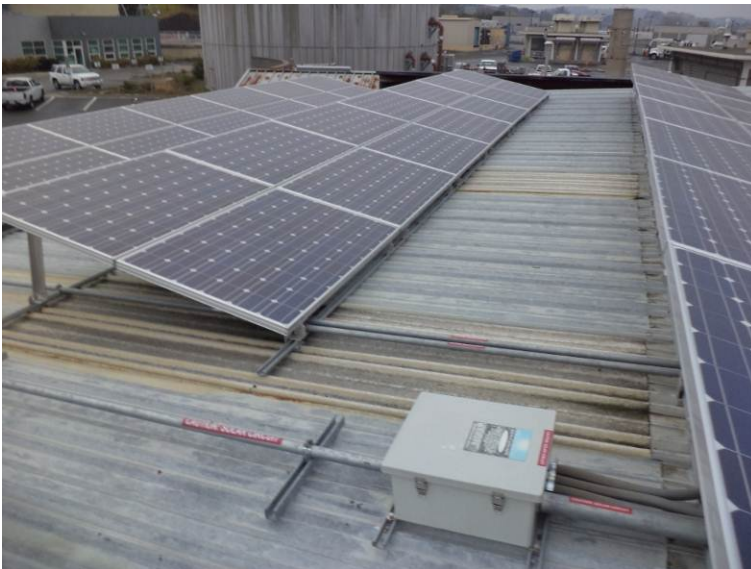
Photograph No. 14

Further view of the metal roof covering and the incorporated skylights.

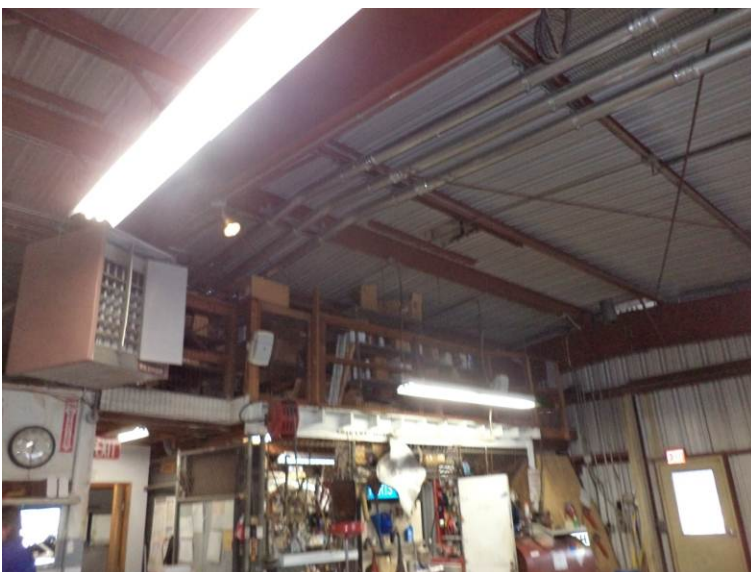
Photograph No. 15

View of exposed ceiling surfaces within the vehicle repair area.

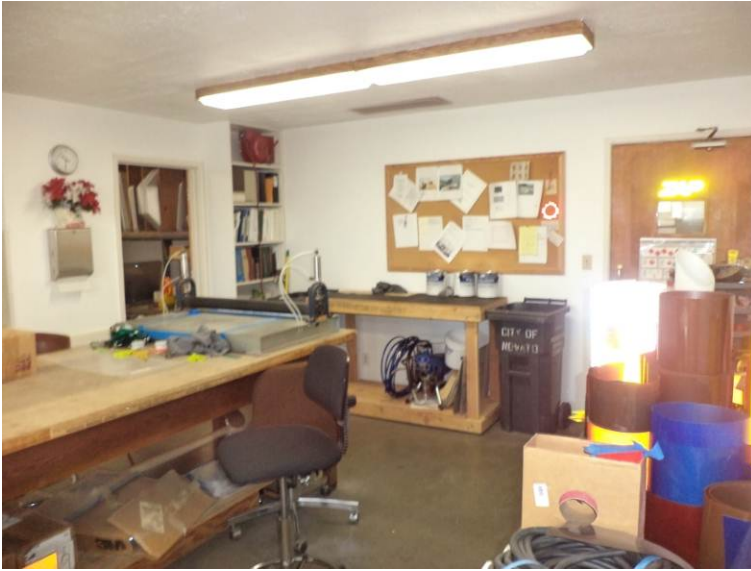
Photograph No. 16

View of the finishes within the drawing room.

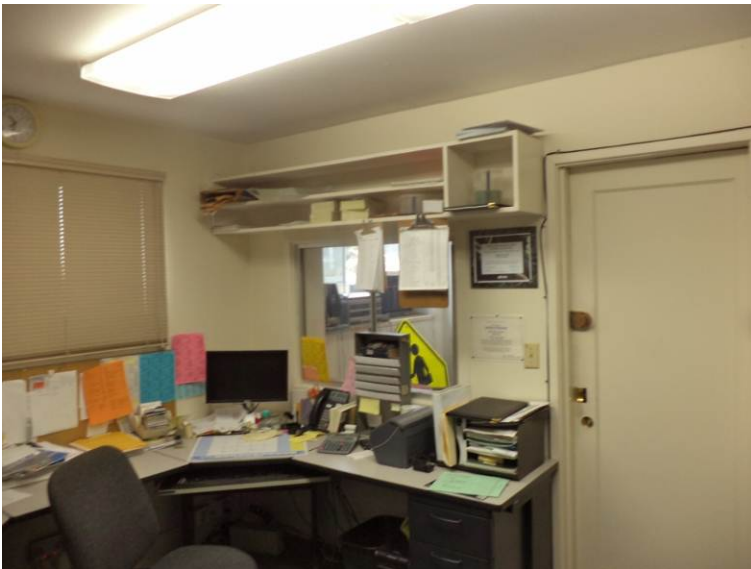
Photograph No. 17

View of the finishes within the office.

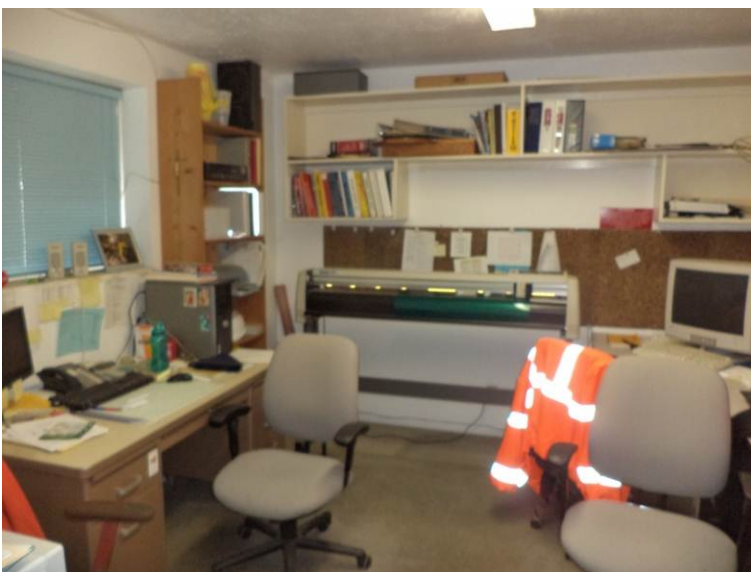
Photograph No. 18

View of the finishes within the other office at the north-west corner.

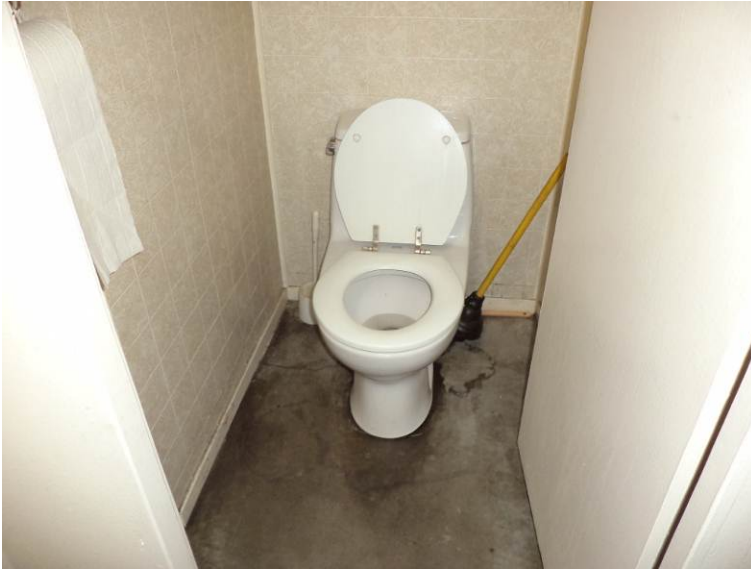
Photograph No. 19

There are wall mounted vitreous china water closets with manual flush valves within Buildings B & C and a floor mounted vitreous china water closet with tank within Building A (reference Photographs 19, 62 and 63 in Appendix B).

View of the floor mounted water closet.

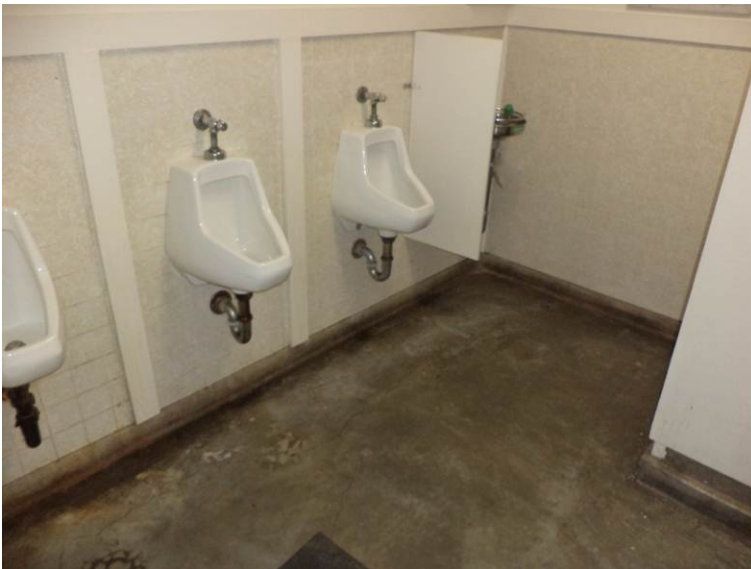
Photograph No. 20

The buildings contained vitreous china wall hung urinals with flush valves, within the men's restrooms (reference Photographs 20 and 64 in Appendix B).

View of the wall mounted urinals.

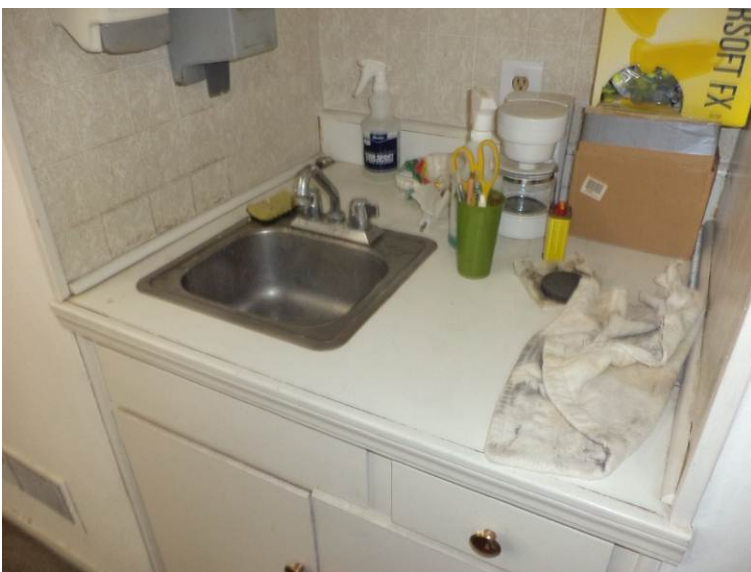
Photograph No. 21

Both Buildings A and B contained single stainless steel sinks (reference Photographs 21 and 67 in Appendix B). The sinks contained a combination of single level mixing value non-metering type faucets in the Building B and double knob handle non-metering faucets in the Building A. The stainless steel sinks are self rimming and mounted within counters that consisted of a plastic laminated faced counter tops.

View of the stainless steel sink and fixed counter.

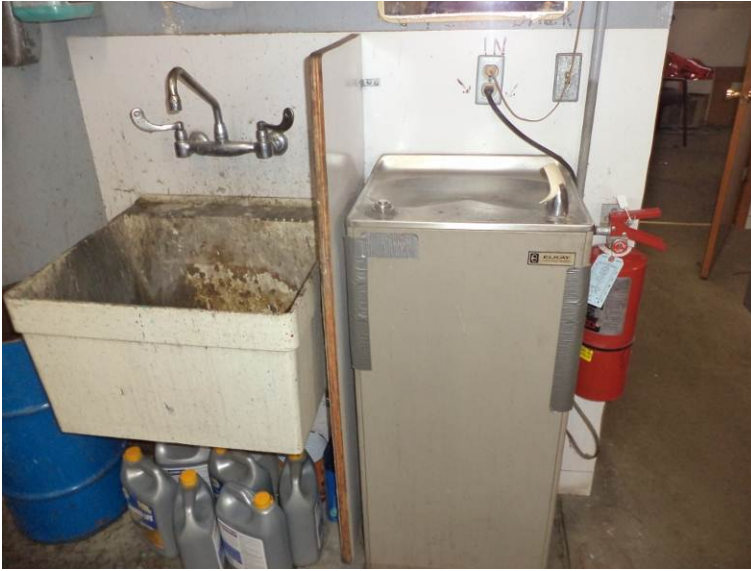
Photograph No. 22

A floor mounted plastic mop sink was present within the vehicle repair area of Building A; the wash area of Building C contained a floor mounted concrete wash sink within the janitor's room (reference Photographs 22 and 66 in Appendix B).

Both Buildings A & C contained stainless steel drinking fountains, the one within Building A is floor mounted and the one in Building C contains dual wall mounted units. The water fountains are controlled either by top or front mounted push-button valve (reference Photographs 22 and 69 in Appendix B).

View of the plastic wash sink and also the floor mounted drinking fountain. Also shows the wall mounted fire extinguisher.

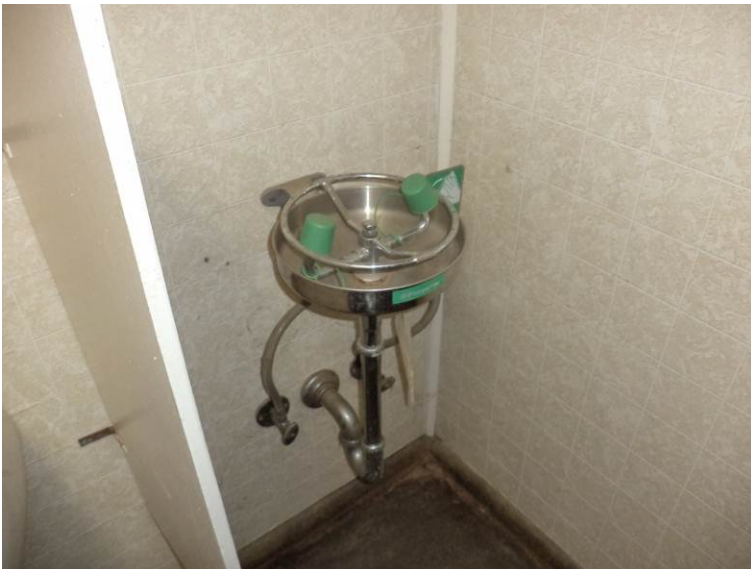
Photograph No. 23

The building contained one eye wash facility within the restroom (reference Photograph 23 in Appendix B).

View of the eye wash.

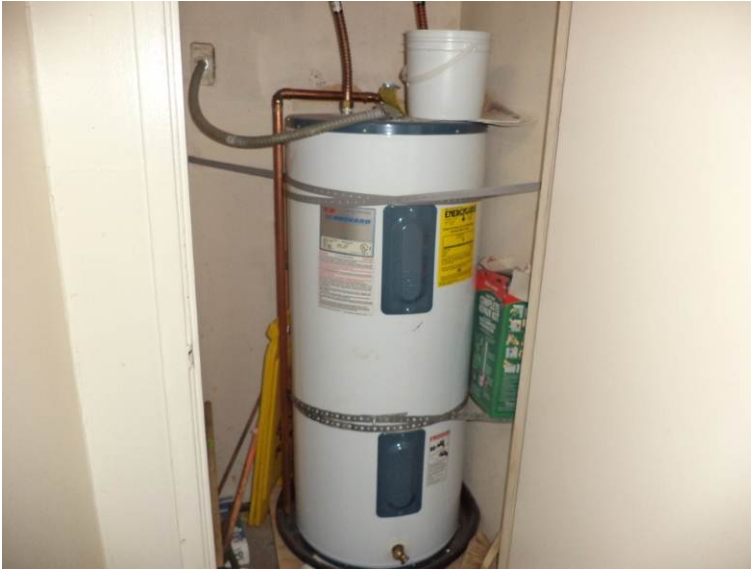
Photograph No. 25

View of the domestic water heater.

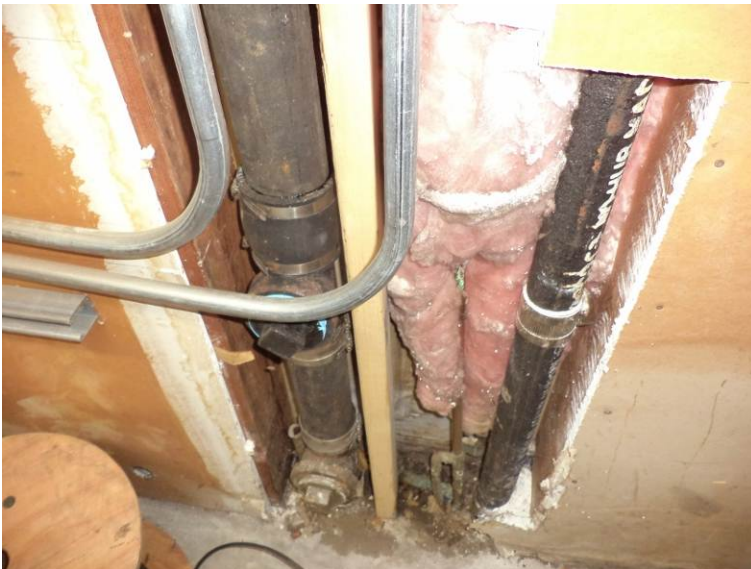
Photograph No. 26

View of the vent pipes and interior stud wall construction with insulation present.

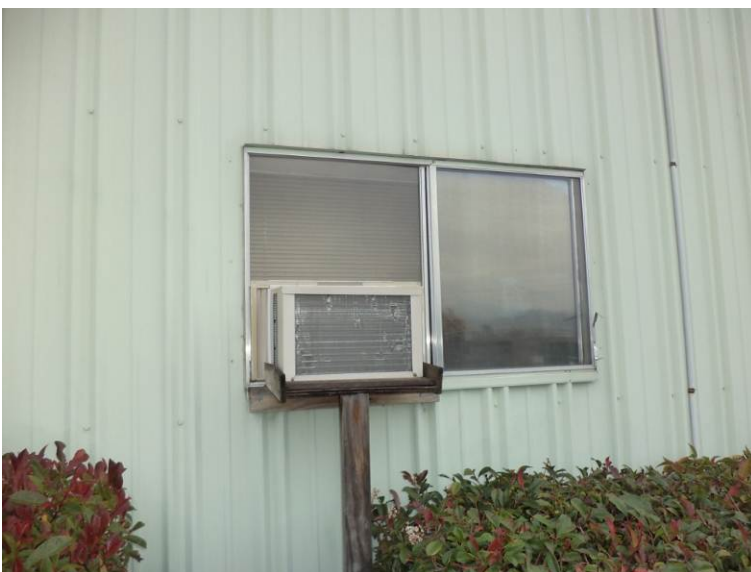
Photograph No. 27

The office sections of the building contained terminal through window air conditioning units. Manufacturer details were not present, however we assume the units to have a capacity of 1-ton each (reference Photograph 27 in Appendix B).

View of the through window a/c unit.

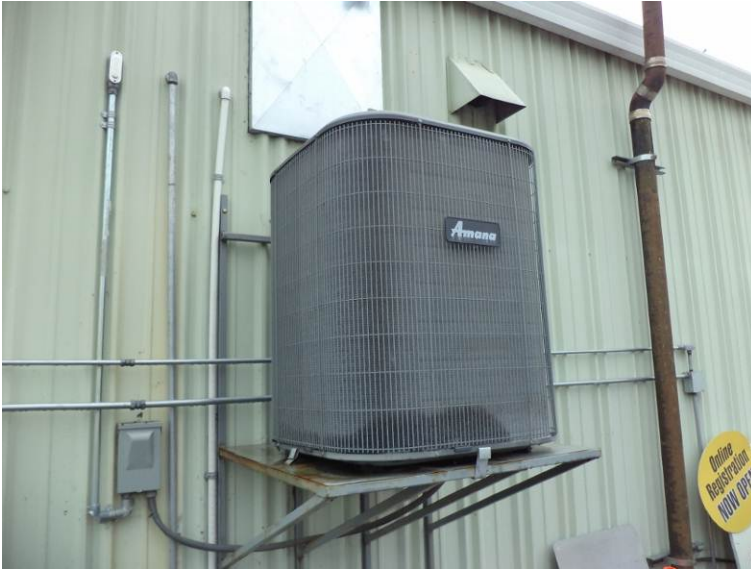
Photograph No. 28

Building A is partially heated and cooled via one split-system, consisting of a fan coil unit with electric heat located on the mezzanine level and an outdoor condensing unit at the north side of the building, mounted on the exterior wall (reference Photograph 28 in Appendix B). The system is manufactured by Amana.

View of exterior condenser unit and safety switch.

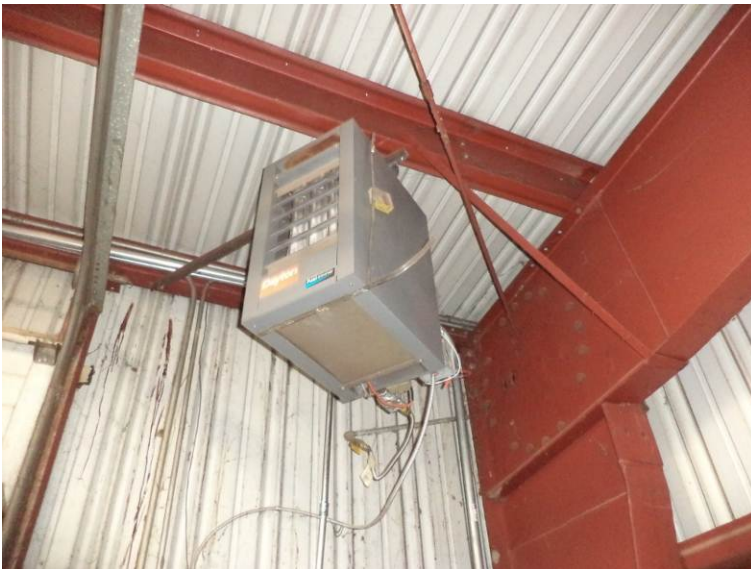
Photograph No. 29

Building A also contained two roof hung natural gas unit heaters (reference Photographs 29 and 30 in Appendix B). They are manufactured by Dayton and Reznor within the workshop and vehicle repair area.

View of the Dayton unit heater.

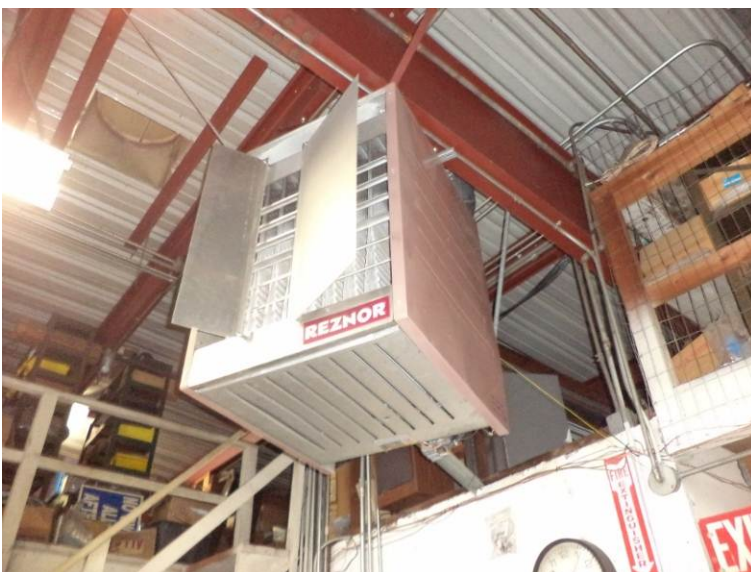
Photograph No. 30

View of the Reznor unit heater.

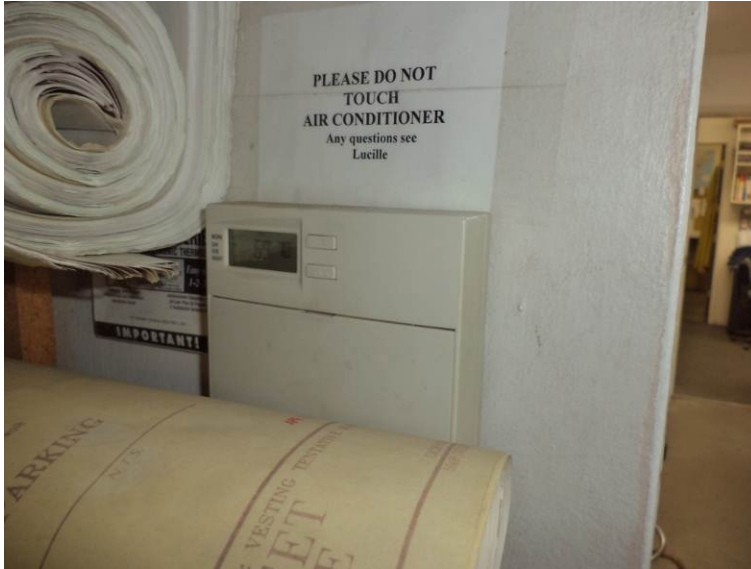
Photograph No. 31

The buildings HVAC system is controlled by individual wall mounted digital thermostats located in the areas the units serve (reference Photographs 31, 77, 79 and 82 in Appendix B).

View of the wall mounted thermostat.

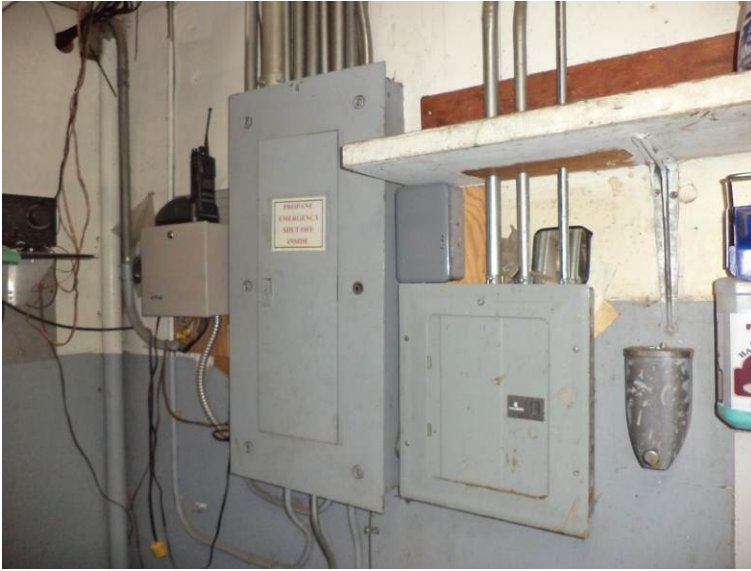
Photograph No. 34

View of the electrical panel boards at the building.

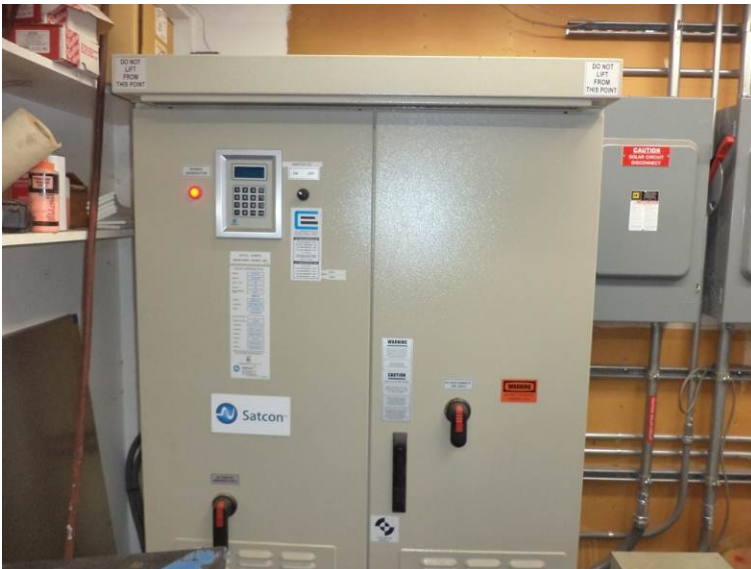
Photograph No. 35

View of the solar array inverter unit.

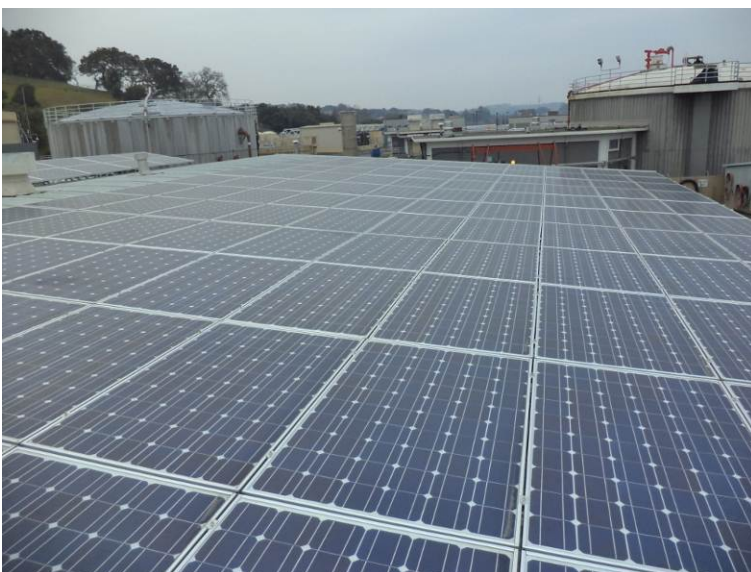
Photograph No. 36

View of the rooftop solar array modules.

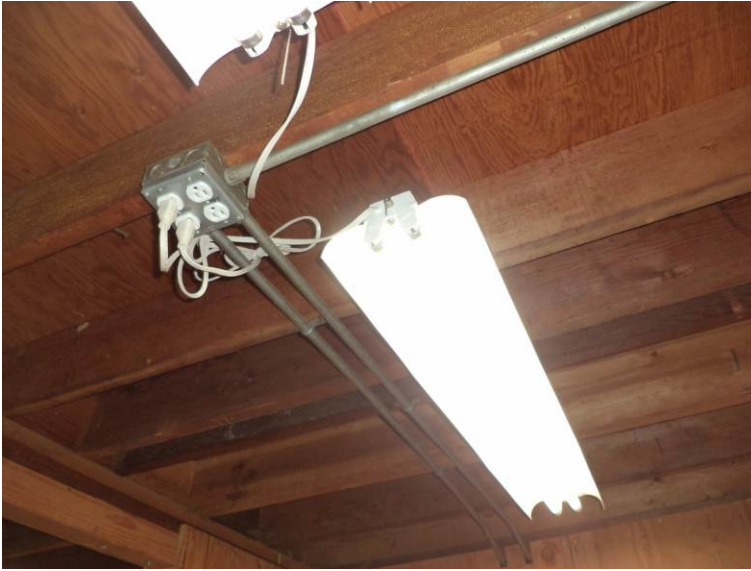
Photograph No. 37

View of the strip light fixtures at the building.

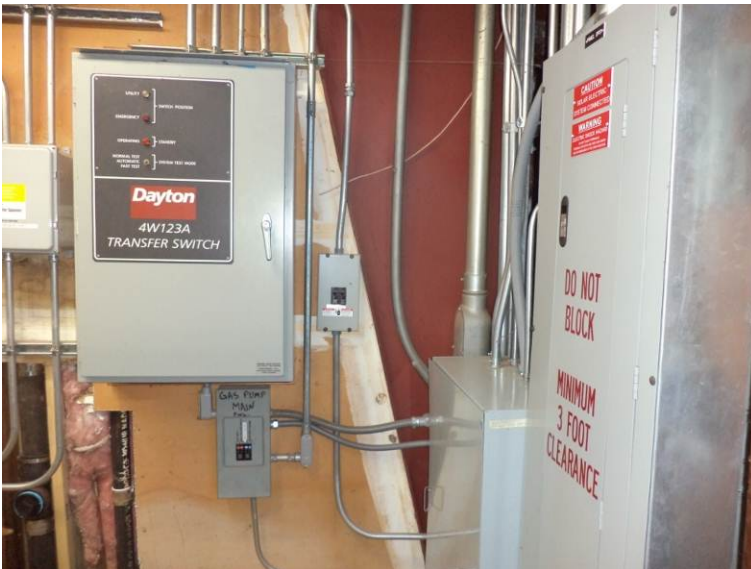
Photograph No. 38

View of the generator transfer switch.

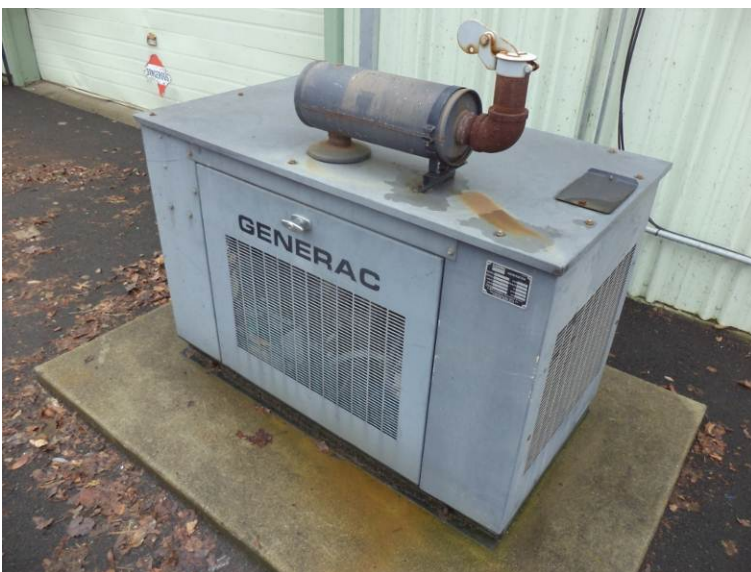
Photograph No. 39

View of the generator.

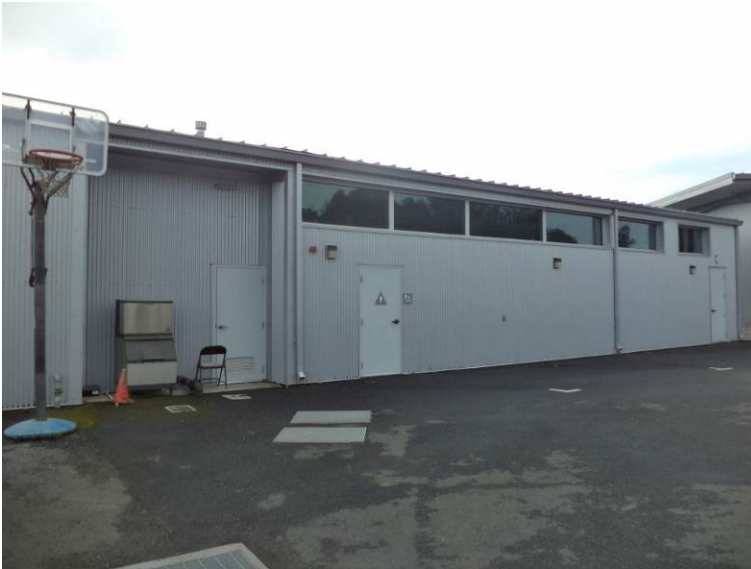
Photograph No. 41

View of the Building C's east elevation.

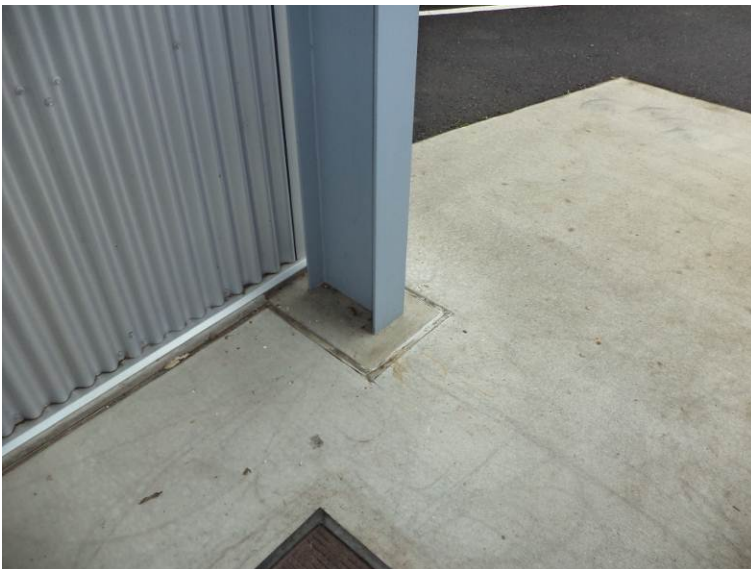
Photograph No. 42

View of the pad foundation for the steel column at Building B.

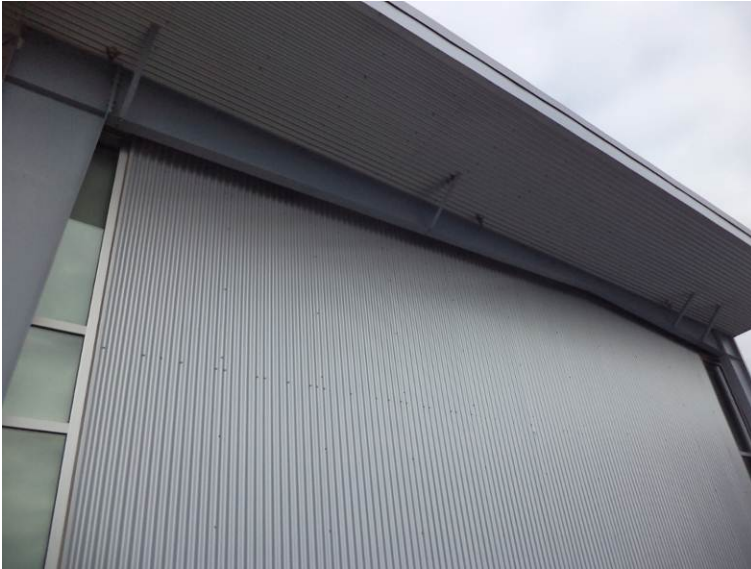
Photograph No. 43

View of the portal steel frame and the corrugated metal siding and soffit at Building B.

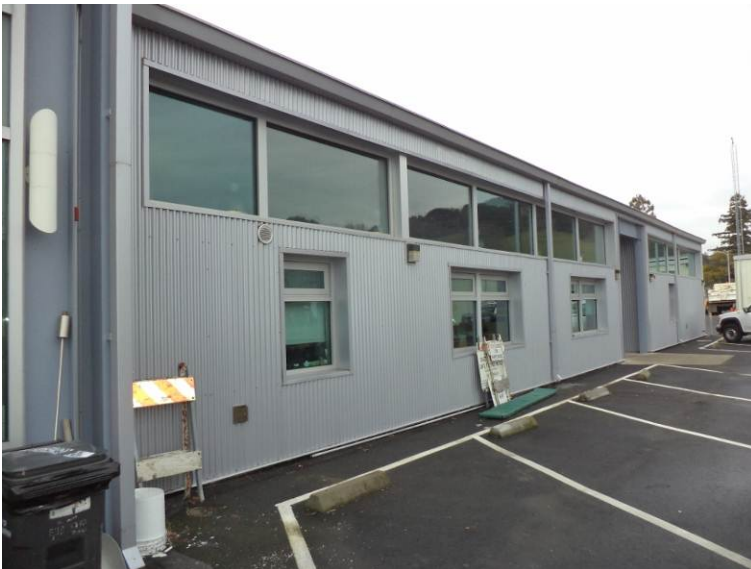
Photograph No. 44

View of the metal siding and insulated fixed and operable window units at Building B.

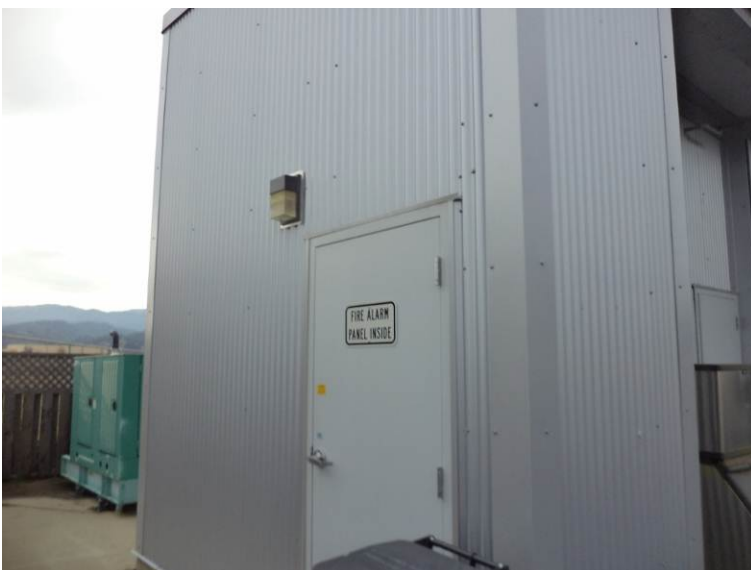
Photograph No. 45

View of the hollow metal door at Building C.

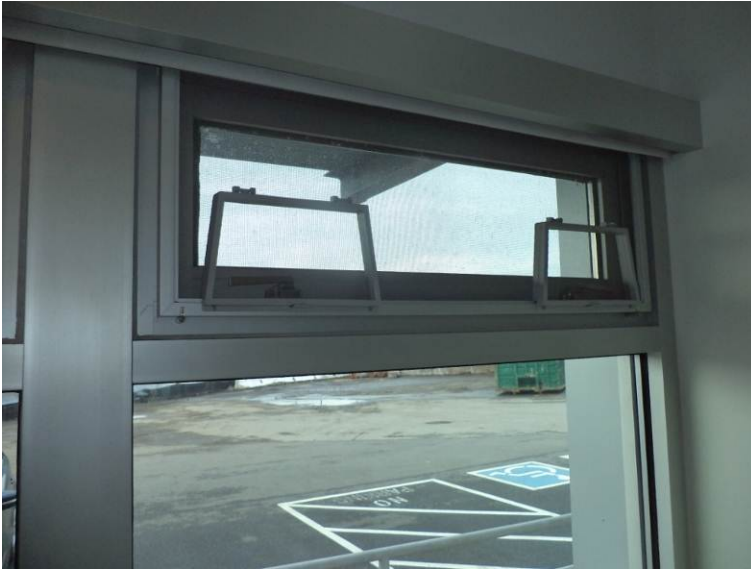
Photograph No. 46

View of openable awning type window unit at Building B.

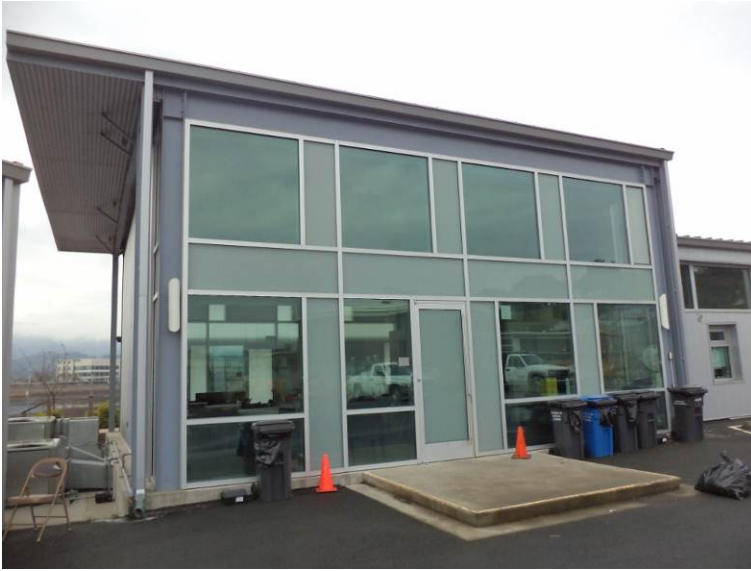
Photograph No. 49

View of the glazed curtain walling system and single glazed door at Building B.

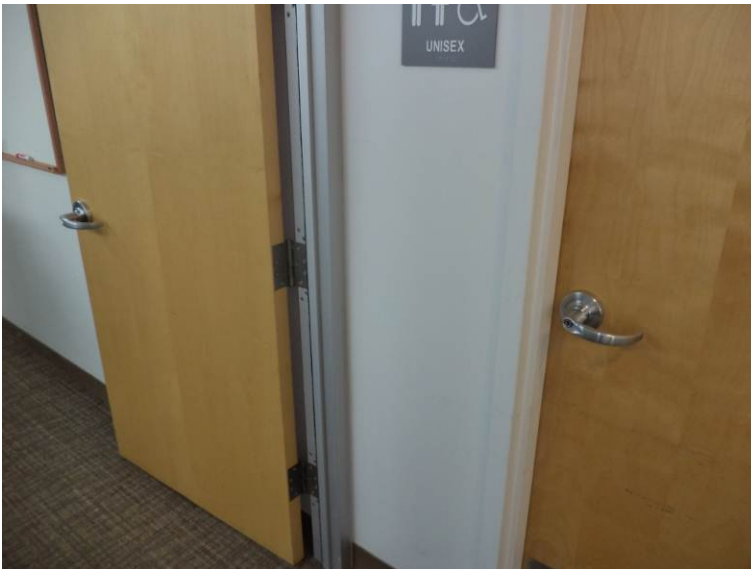
Photograph No. 53

The doors contained aluminum hardware consisting of lever door handles at Buildings B & C and knob handles at the Building A (reference Photograph 53 in Appendix B).

View of the wood interior doors and lever handles in Building B.

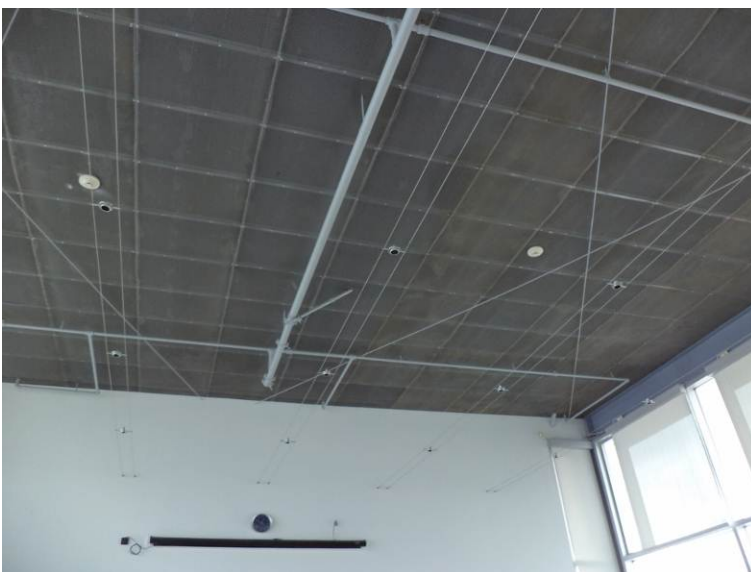
Photograph No. 60

Building B contained 2' x 4' suspended acoustical tiled ceilings within a white enameled exposed grid within the janitor's room and unisex restroom (reference Photograph61 in Appendix B). The system is supported with wires that are attached to the roof purlin's above. The ceiling panels are generally 5/8" thick mineral board in fissured pattern. The rest of the building contained perforated metal ceiling panels which are also attached to the roof purlin's (reference Photograph 60 in Appendix B).

View of the perforated metal ceiling panels. Also shows the fire detectors and pipe lines for the suppression system in Building B.

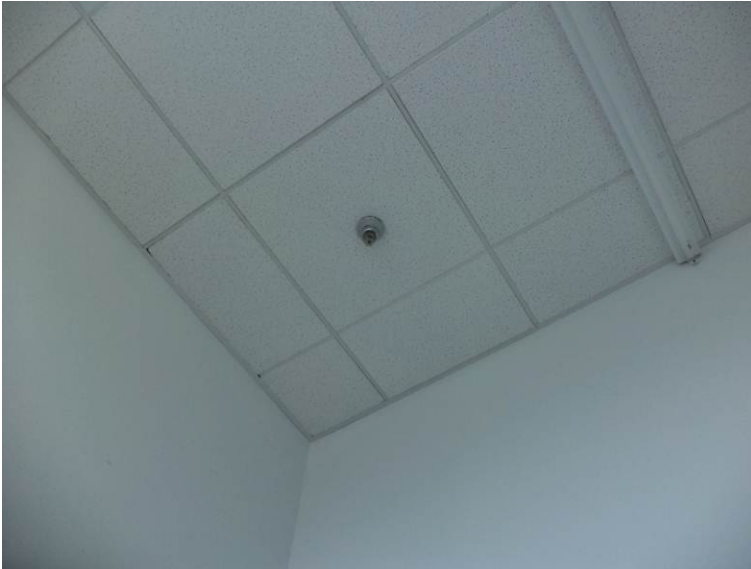
Photograph No. 61

The buildings are protected with an automatic wet-pipe fire suppression systems utilizing standard pendent and upright commercial sprinkler heads fixed to fire-line pipes which are supported via the upper structures (reference Photograph 61 in Appendix B). The systems are monitored by water flow and tamper switches connected to the main fire alarm system. The sprinkler mains and risers are present within Building B at the north-east corner within the janitor's room and within Building C in the water heater room (reference Photographs 84 and 85 in Appendix B). The water main incoming is a 6" line at the point of service.

View of the suspended ceiling system and sprinkler head in Building B.

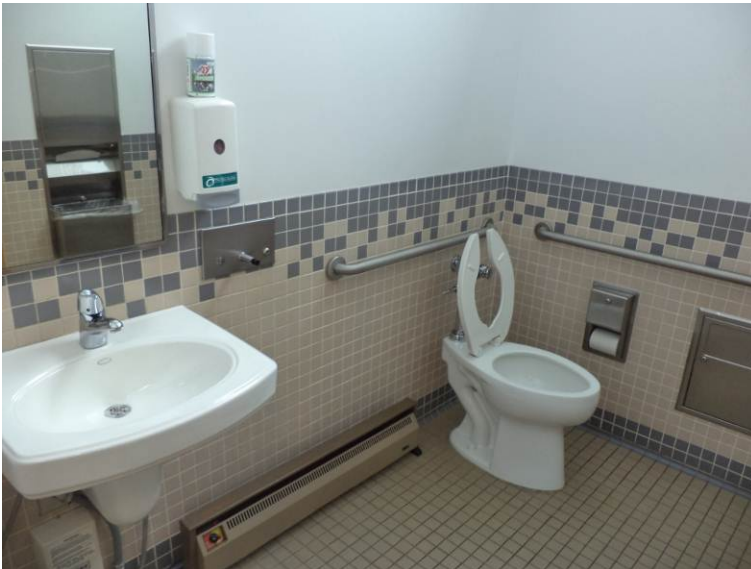
Photograph No. 62

The buildings contained 18" x 18" ceramic floor tiles within the break area of Building B and 2" x 2" ceramic floor tiles within the unisex restroom of Building B and wash areas of Building C (reference Photographs 55, 59 and 62 in Appendix B).

The restrooms contained wall mounted vitreous china lavatories with single lever handle non-metered mixing faucets (reference Photograph 62 in Appendix B).

View of the unisex restroom in Building B, with ceramic floor and wall tiles, wall mounted lavatory and floor mounted water closet with manual flush valve.

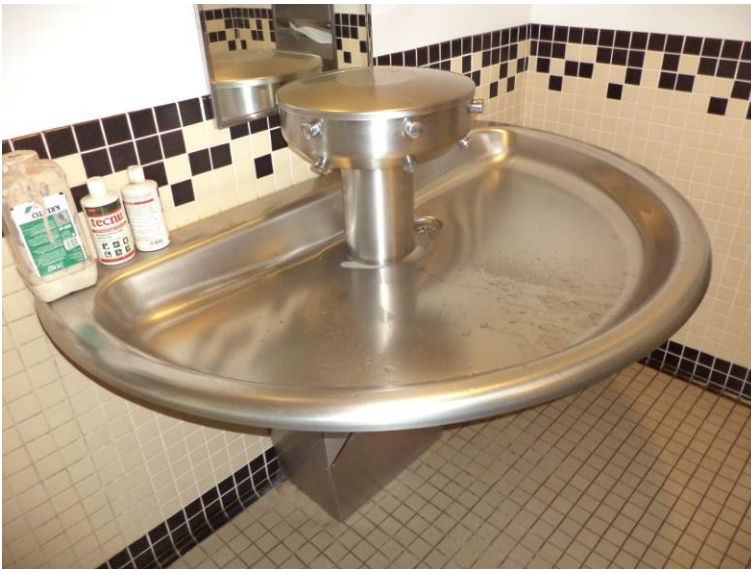
Photograph No. 65

The wash area within Building C contained a stainless steel floor/wall mounted service sink, incorporating stainless steel metered push button operated faucets (reference Photographs 65 in Appendix B).

View of the stainless steel wash sink at Building C.

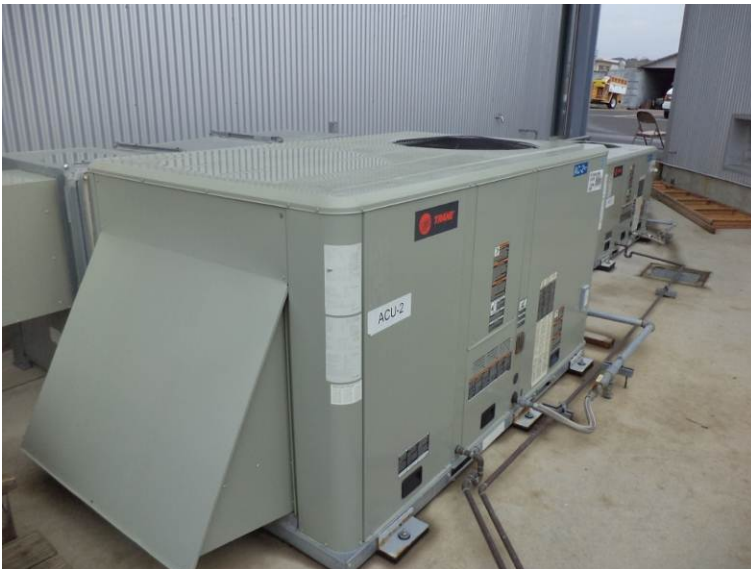
Photograph No. 74

Heating and cooling at the building is supplied via three constant volume DX cooling and natural gas heat high efficient package units that are manufactured by Trane. They have heating and cooling capacities ranging from 3- to 12-tons of cooling and 48,000 to 120,000-btuh of heating provided by natural gas fired burner sections (reference Photographs 74, 75 and 80 in Appendix B). The units are situated at ground level.

View of one of the package units that serve Building B.
