Citywide
Facility Condition Assessment

Report of
Facility Condition Assessment

For
City of Novato
Maintenance Buildings
(Vehicle Maintenance and Divis & Lockers)
550 Davidson, Novato, CA

March 4, 2013

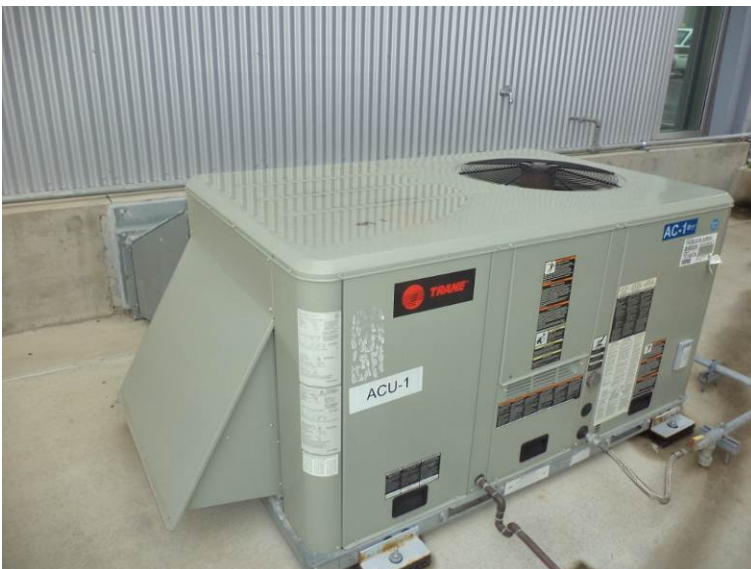
Photograph No. 75

Heating and cooling at the building is supplied via three constant volume DX cooling and natural gas heat high efficient package units that are manufactured by Trane. They have heating and cooling capacities ranging from 3- to 12-tons of cooling and 48,000 to 120,000-btuh of heating provided by natural gas fired burner sections (reference Photographs 74, 75 and 80 in Appendix B). The units are situated at ground level.

View of the other package unit that serves Building B.

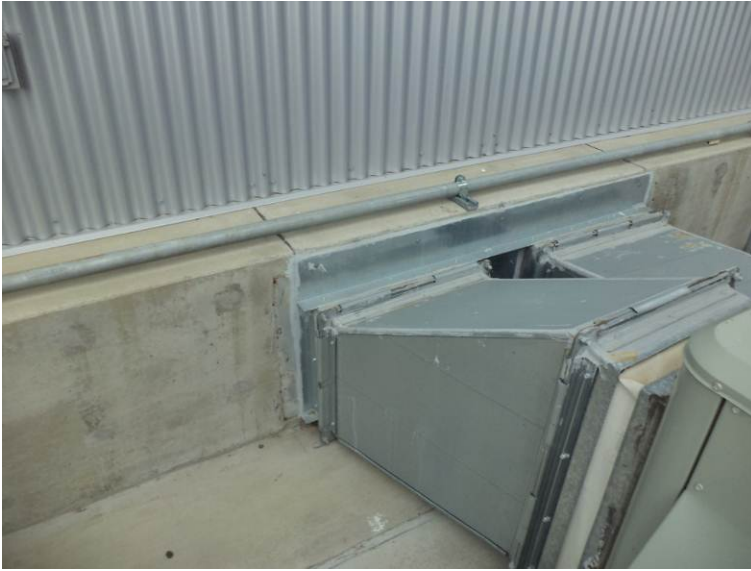
Photograph No. 76

The conditioned air is distributed throughout the buildings via metal ductwork located below the raised access floor in Building B and above the ceiling in Building C; through metal grills recessed in the floors and ceilings (reference Photographs 76 and 81 in Appendix B).

View of the ductwork for Building B, entering the building below the raised access floor through the stem wall.

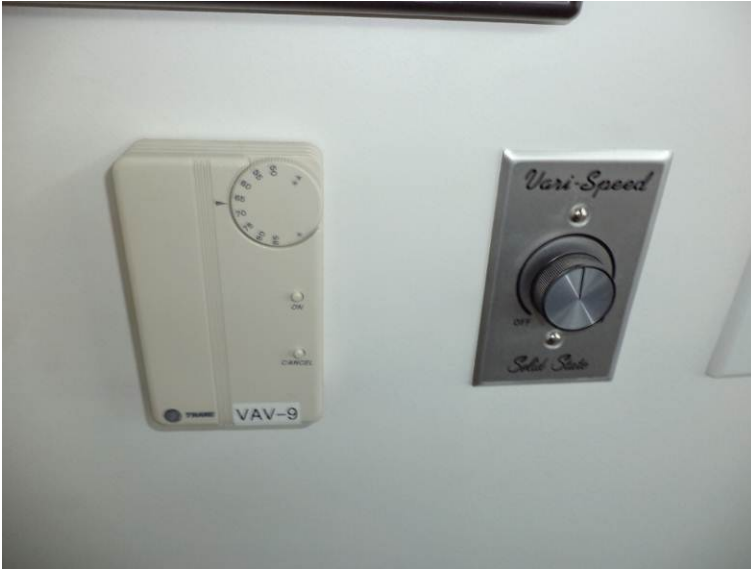
Photograph No. 79

Building C contains centrifugal roof level exhaust fans and the unisex restroom within Building A contains an inline exhaust fan. They are designed to remove air from specific areas (reference Photographs 79 and 83 in Appendix B). The units are manufactured by Cook, with capacities of 450-cfm at room level and 140-cfm at the unisex restroom.

View of the thermostat for VAV 9 and also the control for the inline exhaust fan for the unisex restroom in Building B.

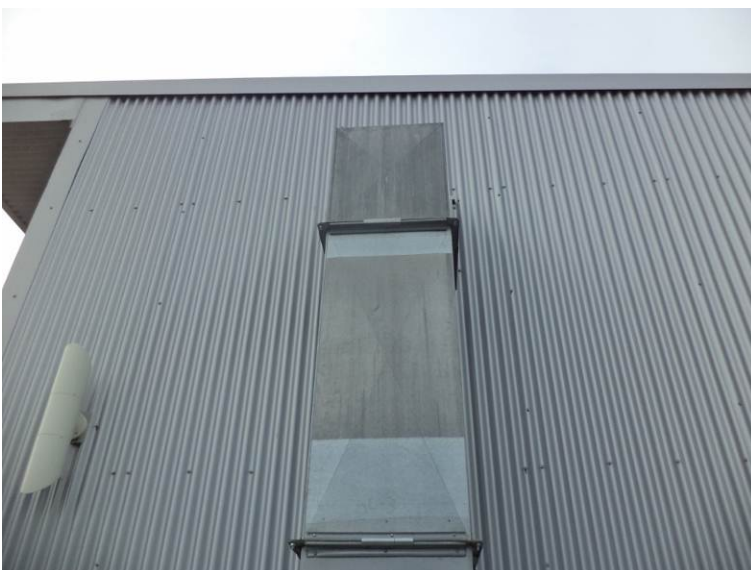
Photograph No. 80

View of the package unit that serves Building C.

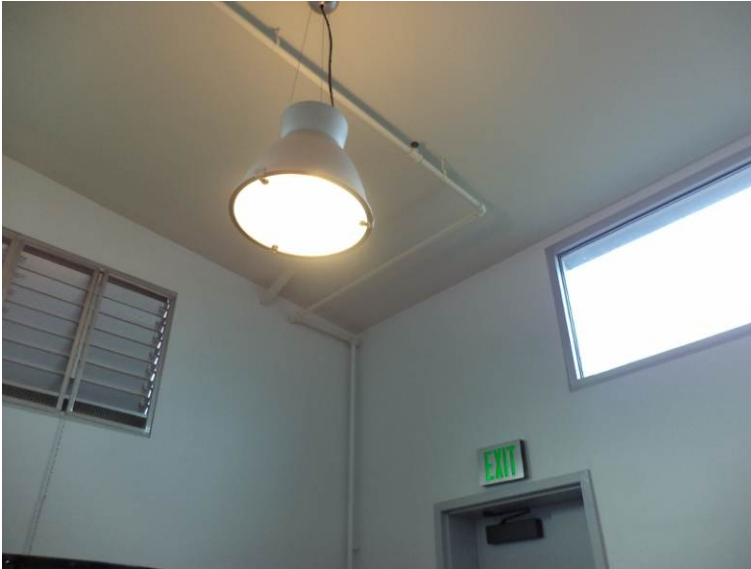
Photograph No. 90

View of the pendent light fixtures at Building B.

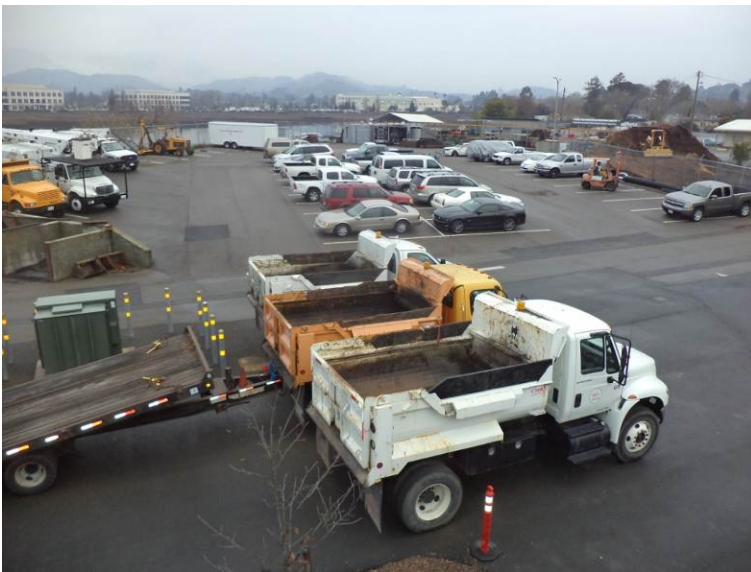
Photograph No. 96

The facility has an asphalt paved parking lot, yards and roadways surrounding each of the buildings and is access from Davidson Street. The parking lot area has white line striping denoting areas of parking stalls (reference Photographs 96 through 98 in Appendix B). We were not provided with the original specification details of the paving and therefore cannot comment on the specific asphalt mix type, classification or its suitability for its existing use. Table G20-1 provides a summary of the site systems.

View of the yard at the south-west side of the site.

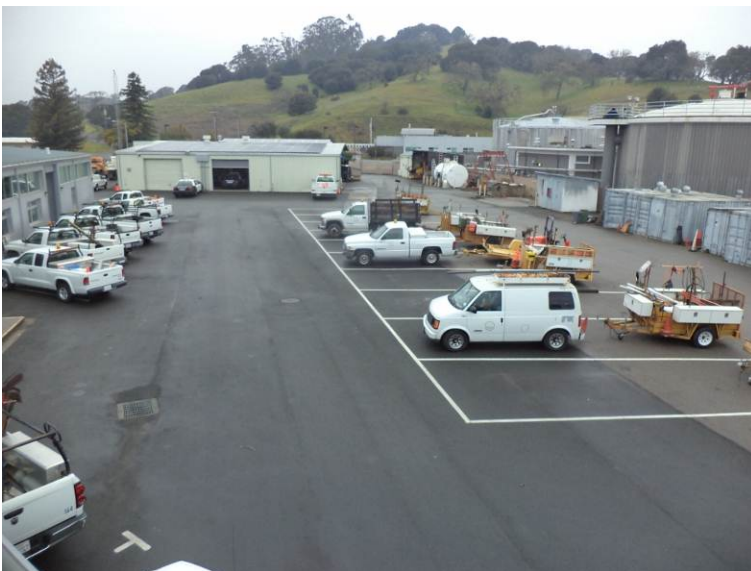
Photograph No. 97

View of the parking lot at the west side of the site.

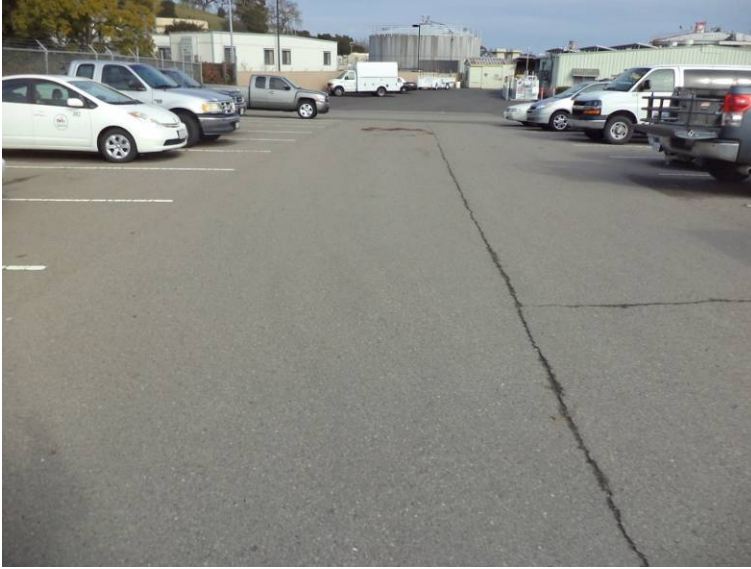
Photograph No. 98

View of the parking lot at the east side of the site.

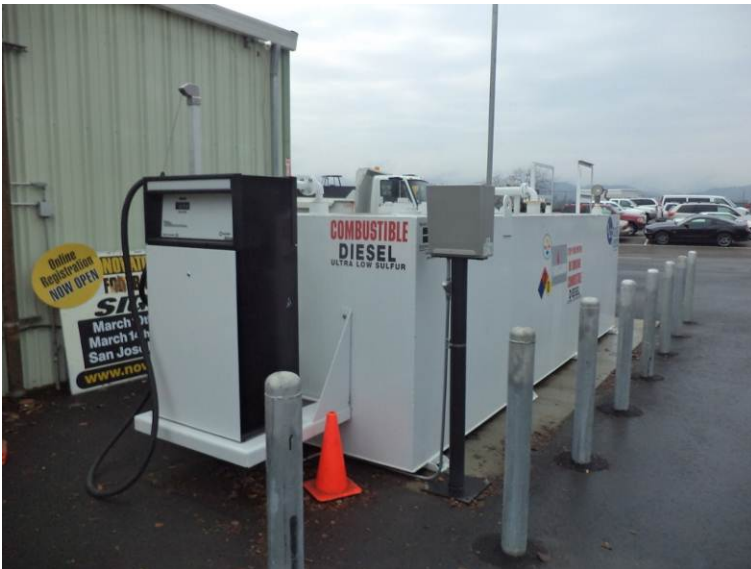
Photograph No. 102

The site contained two above ground 50,000 gallon steel storage tanks with integral steel foundations (reference Photographs 102 through 104 in Appendix B). Table G30-1 provides a summary of the fuel storage tanks:

View of the 50,000 gallon storage tank at the north side of the site.

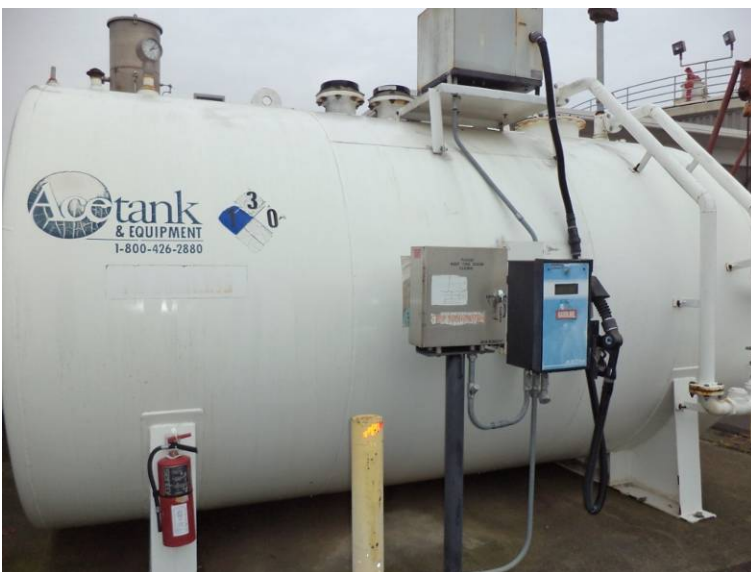
Photograph No. 103

A fleet fuel dispensing station is present at both of the storage tanks (reference Photographs 103 and 104 in Appendix B).

Further view of the fuel storage tank and fuel dispenser.

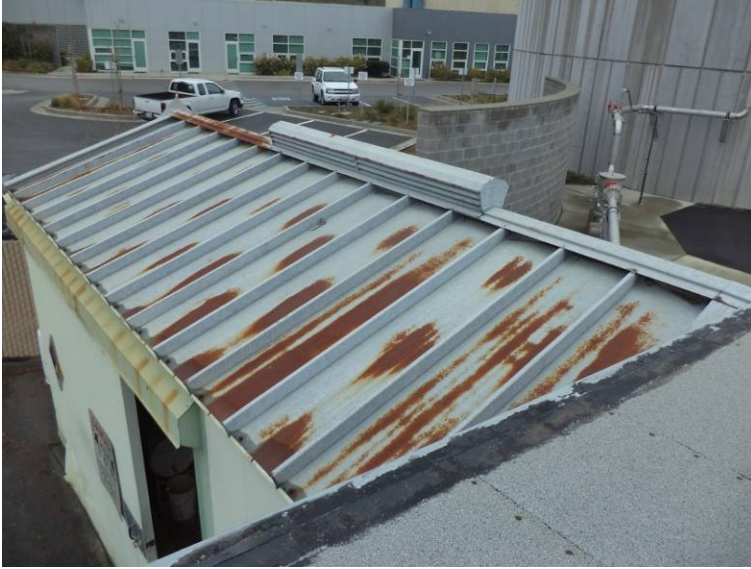
Photograph No. 110

The exterior metal wall and roof panels are in fair condition; although we observed surface corrosion present. Furthermore the door and window unit are also showing signs of corrosion and therefore we have included for replacement of the wall and roof panels, as well as the window unit and sliding access door prior to mid-term in the study period (reference Photographs 110 through 112 in Appendix B).

View of the metal panel wall and metal sliding door.

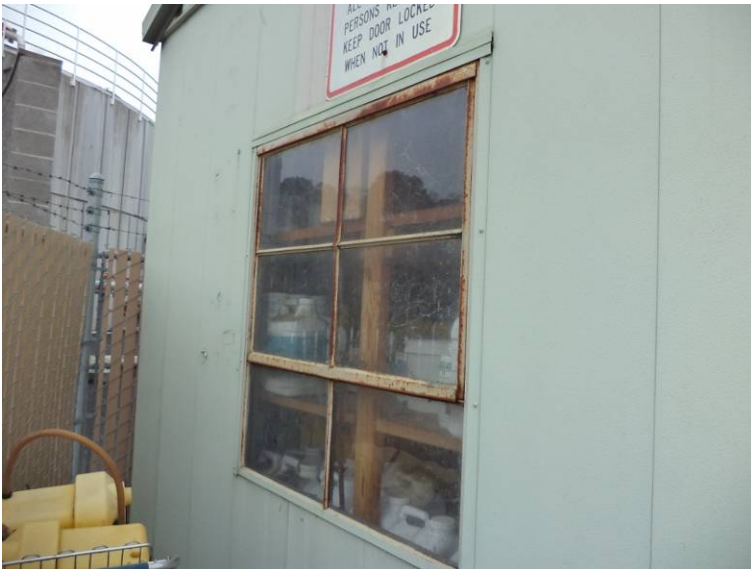
Photograph No. 111

View of the metal roof construction.
